DEPARTMENT OF TRANSPORTATION

Quality Assurance and Source Inspection

Contract #: 04-0120F4Cty: SF/ALA Rte: 80 PM: 13.2/13.9File #: 1.28**WELDING INSPECTION REPORT****Resident Engineer:** Casey, William**Address:** 333 Burma Road**City:** Oakland, CA 94607**Report No:** WIR-029131**Date Inspected:** 12-Feb-2013**Project Name:** SAS Superstructure**OSM Arrival Time:** 700**Prime Contractor:** American Bridge/Fluor Enterprises, a JV**OSM Departure Time:** 1730**Contractor:** American Bridge/Fluor Enterprises, a JV**Location:** Job Site**CWI Name:** See below.**CWI Present:** Yes No**Inspected CWI report:** Yes No N/A**Rod Oven in Use:** Yes No N/A**Electrode to specification:** Yes No N/A**Weld Procedures Followed:** Yes No N/A**Qualified Welders:** Yes No N/A**Verified Joint Fit-up:** Yes No N/A**Approved Drawings:** Yes No N/A**Approved WPS:** Yes No N/A**Delayed / Cancelled:** Yes No N/A**Bridge No:** 34-0006**Component:** Tower**Summary of Items Observed:**

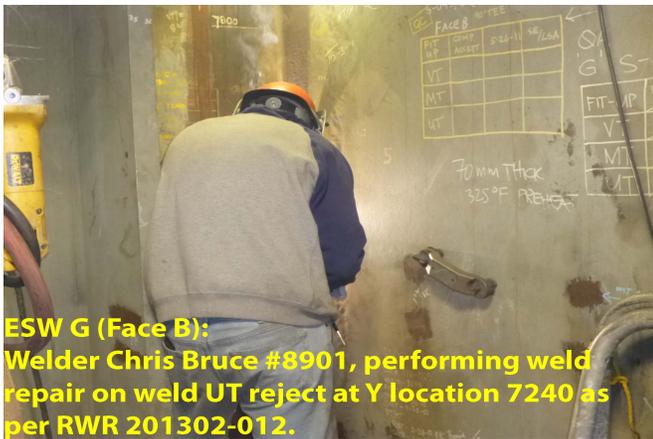
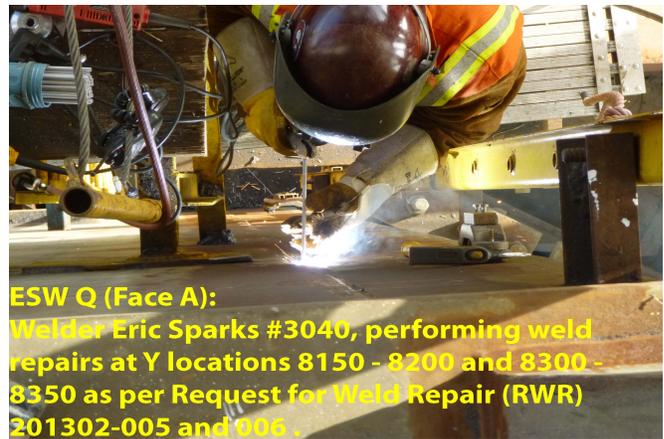
The welder was observed performing the weld repair on the Electroslag Weld "G" at face B, welding at Y location 7240 as per Request for Weld Repair (RWR) 201302-012 in way of an Ultrasonic Testing rejected indication. The welder was observed preheating the weld to 300 degrees Fahrenheit prior to welding using the Miller ProHeat 35 with heat induction blankets. The welder utilized the Welding Procedure Specification (WPS) ABF-WPS-D15-1000-Repair Rev.3 for Shield Metal Arc Welding (SMAW). The welding parameters were verified by QC Inspector William Sherwood throughout the day and appeared to be in compliance with the WPS noted above.

The welder was observed performing weld repairs on Electroslag weld "Q" at face A, welding at Y locations 8150 - 8200 and 8300 - 8350 as per Request for Weld Repair (RWR) 201302-005 and 006 in way of Ultrasonic Testing rejected indications. The welder was observed preheating the weld to 300 degrees Fahrenheit prior to excavating and welding using the Miller ProHeat 35 with heat induction blankets. The welder utilized the Welding Procedure Specification (WPS) ABF-WPS-D15-1000-Repair Rev.3 for Shield Metal Arc Welding (SMAW). The welding parameters were verified by QC Inspector William Sherwood throughout the day and appeared to be in compliance with the WPS noted above.

- Weld repairs at Y 8600, 8750, 8830, 8980 & 9030. (Face A, MPT Accept)
- Weld repairs at Y 8600, 8750, 8830, 8980 & 9030. (UT Recordable Indications noted**)
