DEPARTMENT OF TRANSPORTATION

Quality Assurance and Source Inspection

Contract #: 04-0120F4Cty: SF/ALA Rte: 80 PM: 13.2/13.9File #: 99.28**WELDING INSPECTION REPORT****Resident Engineer:** Casey, William**Address:** 333 Burma Road**City:** Oakland, CA 94607**Report No:** WIR-029147**Date Inspected:** 13-Feb-2013**Project Name:** SAS Superstructure**OSM Arrival Time:** 700**Prime Contractor:** American Bridge/Fluor Enterprises, a JV**OSM Departure Time:** 1530**Contractor:** USA Hoist**Location:** USA Hoist, Crest Hill, IL

Bridge No: 34-0006**Component:** SAS Tower Elevator**Summary of Items Observed:**

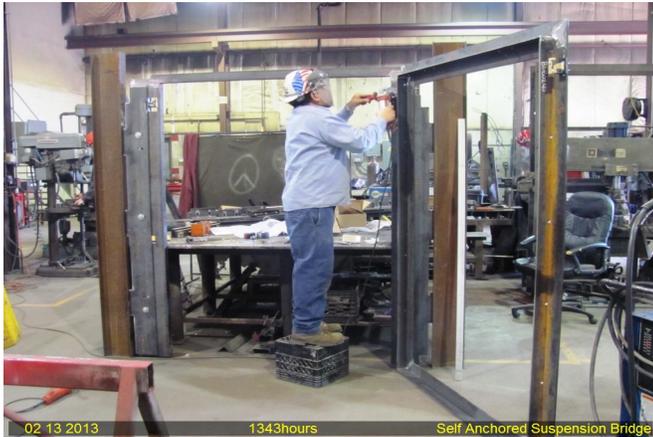
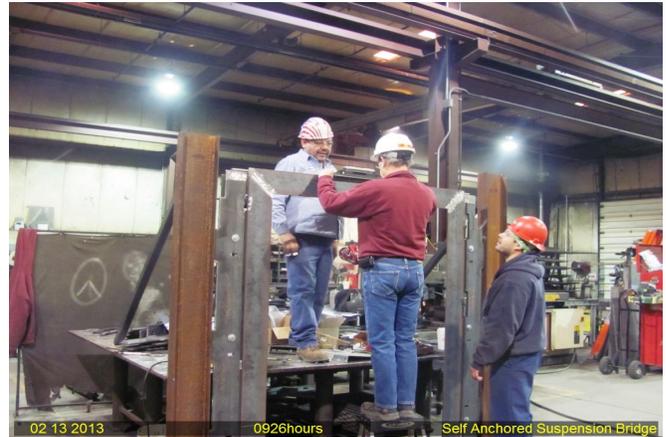
At USA Hoist fabrication shop, welding foreman Genaro Ulloa together with another welder Matt Wasaqi were noted continuing bolting and trial fitting the second door assembly for elevator door stops 1, 4 and 5. After bolting the enclosure frame to the temporary beam, another welder Manolo Luna performed the tack welding of the three (3) weld-on hinge to the enclosure frame. The welder was noted using the gas shielded Flux Cored Arc Welding (FCAW-G) during the tack welding. After tack welding the three weld-on hinges, Mr. Genaro took the measurements from the tack welded hinges and transferred them to the door frame. Welder Manolo Luna tack welded the other pairs of the hinge to the door frame. After the completion of the tack welding on the three pairs of hinges to the door enclosure and door frame, Mr. Genaro Ulloa started to put the assembly together and adjusted the position of the door frame/enclosure where required until they were satisfied with the clearances on all sides of the door. USA Hoist personnel were noted tack welding the 120mm long mild steel weld-on hinge per shop drawing number 914932.

During the trial fit up of the second elevator door assembly mentioned above, Mr. Genaro Ulloa called Mr. Bob Overbeek and showed him the position or condition of the trial fit. Mr. Overbeek was noted using an 18" long Starrett Precision Machinist level to check the alignment of the door assembly. USA Hoist personnel made some more small adjustments here but Mr. Overbeek was not satisfied with the trial fit assembly and told them to make more adjustments. Mr. Overbeek also informed Mr. Genaro Ulloa to find the suitable location for the Norton

Parallel Rigid Arm Door Closer since it is not detailed in the shop drawing. According to Mr. Overbeek, after finding the suitable location for the door closure, it will be added "As Built" to the approved shop drawing and then resubmit for Caltrans approval.

Since the exact location of the Norton Parallel Rigid Arm Door Closer was not detailed in the approved shop drawing, Mr. Overbeek informed this QA that after finding the suitable location for the door closure, it will be added "As Built" to the approved shop drawing and then resubmit for Caltrans approval.
