**DEPARTMENT OF TRANSPORTATION**

Contract #: 04-0120F4Cty: SF/ALA Rte: 80 PM: 13.2/13.9File #: 1.28**WELDING INSPECTION REPORT****Resident Engineer:** Casey, William**Address:** 333 Burma Road**City:** Oakland, CA 94607**Report No:** WIR-029183**Date Inspected:** 26-Mar-2013**Project Name:** SAS Superstructure**OSM Arrival Time:** 700**Prime Contractor:** American Bridge/Fluor Enterprises, a JV**OSM Departure Time:** 1730**Contractor:** American Bridge/Fluor Enterprises, a JV**Location:** Job Site**CWI Name:** As noted below**CWI Present:** Yes No**Inspected CWI report:** Yes No N/A**Rod Oven in Use:** Yes No N/A**Electrode to specification:** Yes No N/A**Weld Procedures Followed:** Yes No N/A**Qualified Welders:** Yes No N/A**Verified Joint Fit-up:** Yes No N/A**Approved Drawings:** Yes No N/A**Approved WPS:** Yes No N/A**Delayed / Cancelled:** Yes No N/A**Bridge No:** 34-0006**Component:** SAS OBG**Summary of Items Observed:**

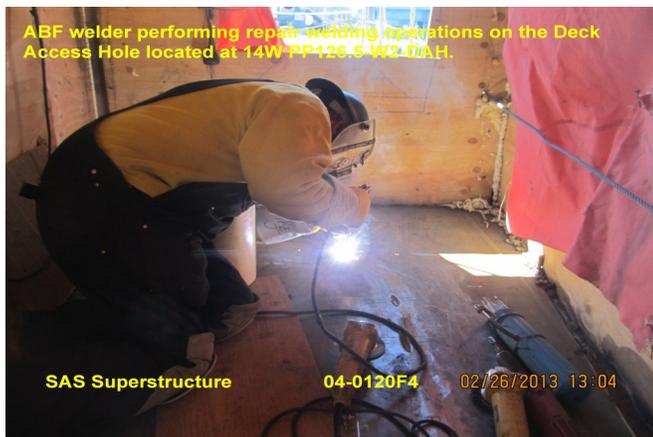
ABF welder Mike Jimenez #4671 was observed performing ongoing weld repairs on 14W PP129.5-W2-DAH. The dimension of the excavations were recorded as  $y=2930\text{mm}-100\text{L}/24\text{W}/16\text{D}$ , at  $y=3500\text{mm}$  the dimensions of the excavation was recorded as  $80\text{L}/20\text{W}/11\text{D}$ , at  $y=3790\text{mm}$  the dimensions of the excavation was recorded as  $70\text{L}/23\text{W}/11\text{D}$ , at  $y=4000\text{mm}$  the dimensions of the excavation were recorded as  $95\text{L}/20\text{W}/14\text{D}$ , at  $1890\text{mm}$  the dimensions of the excavation were recorded as  $95\text{L}/25\text{W}/14\text{D}$  and at  $y=940\text{mm}$  the dimensions were recorded as  $85\text{L}/25\text{W}/13\text{D}$ . The welder was observed utilizing WPS ABF-WPS-D15-1004-Repair-Revision 0 for SMAW. The welder was observed preheating the welds prior to Carbon Arc Gouging and welding. Other welding parameters as inspected by the QC Inspector appeared to be in compliance with the WPS noted above.
