Contract #: 04-0120F4Cty: SF/ALA Rte: 80 PM: 13.2/13.9File #: 1.28**WELDING INSPECTION REPORT**

Report No: WIR-029213
Date Inspected: 29-Jan-2013

Project Name: SAS Superstructure
Prime Contractor: American Bridge/Fluor Enterprises, a JV
Contractor: American Bridge/Fluor Enterprises, a JV

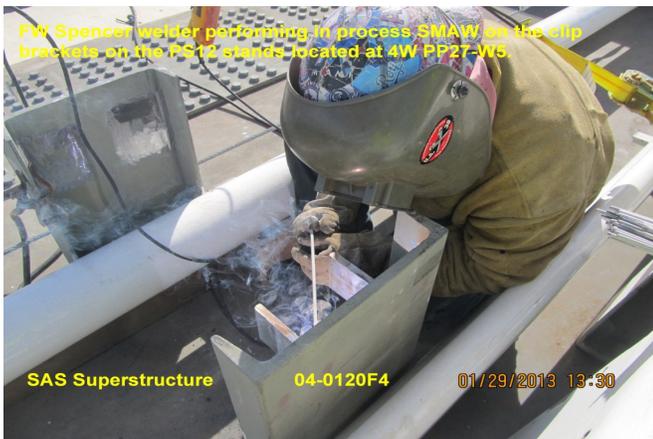
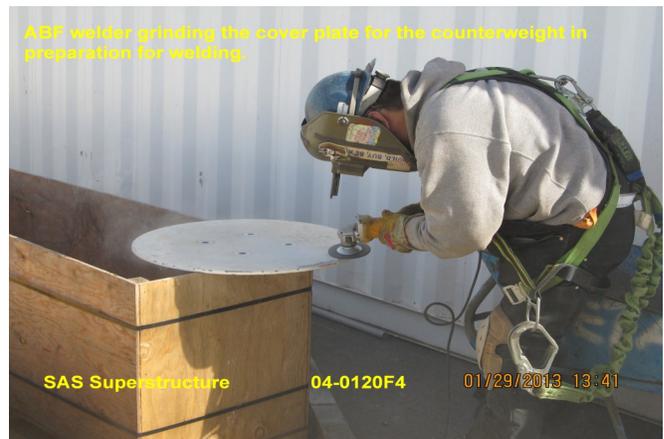
ABF welder Wai Kit Lai #2953 was observed performing SMAW welding on the Deck Access Hole at 14E PP126. 5-E2-DAH. The welder was observed utilizing WPS ABF-D1.5-1040C-CU for SMAW. The welder was observed preheating the welds prior to welding. Other welding parameters as inspected by the QC Inspector appeared to be in compliance with the WPS noted above. This QA Inspector made subsequent observations throughout the shift to monitor quality and noted that the work at this location is in progress and appeared to be in general conformance with the contract documents. The work is in progress.

FW Spencer welder Damien Llamas # 6645 was observed performing SMAW welding on pipe brackets to PS12 Channel at 4W PP27-W5 on the exterior of the OBG. Weld numbers have not been assigned due to the work is in progress. The welder was observed utilizing WPS FWS-Fillets Murex for SMAW. The welder was observed preheating the welds prior to welding. Other welding parameters as inspected by the QC Inspector appeared to be in compliance with the WPS noted above. RFI-003098R00 was referenced during observation.

ABF welder Mike Jimenez #4671 was observed performing FCAW seal welding on the 6mm x 75mm plates on the threaded holes of counterweight number 10 located at 1W PP8. The welder was observed utilizing WPS
