DEPARTMENT OF TRANSPORTATION

Quality Assurance and Source Inspection

WELDING INSPECTION REPORT

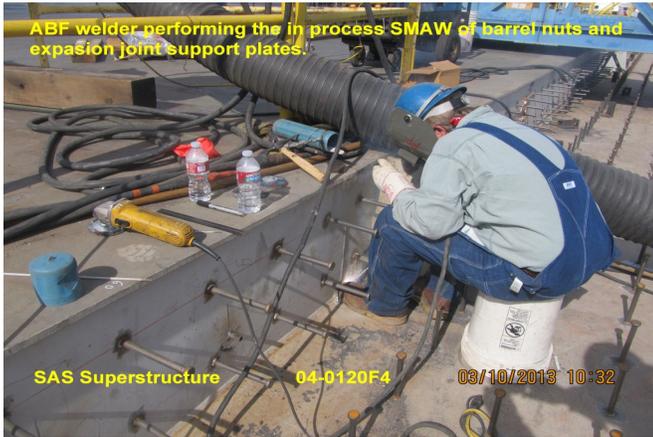
This QA Inspector randomly observed. ABF welder Terry McCormick #8494 performing Shielded Metal Arc Welding (SMAW) at the hinge “A” expansion joint east in the 2G horizontal positions on the expansion joint support plates [01] and typical barrel nuts in accordance with WPS ABF-WPS-D1.5-F1200A. The QC inspector monitored the welding and the parameters as they applied to the above mention WPS. This QA Inspector made subsequent observations to monitor quality and noted that the work at this location was in progress and appeared to be in general conformance with the contract documents.
