Contract #: 04-0120F4Cty: SF/ALA Rte: 80 PM: 13.2/13.9File #: 1.28**WELDING INSPECTION REPORT****Resident Engineer:** Casey, William**Address:** 333 Burma Road**City:** Oakland, CA 94607**Report No:** WIR-029351**Date Inspected:** 02-Apr-2013**Project Name:** SAS Superstructure**OSM Arrival Time:** 700**Prime Contractor:** American Bridge/Fluor Enterprises, a JV**OSM Departure Time:** 1730**Contractor:** American Bridge/Fluor Enterprises, a JV**Location:** Job Site**CWI Name:** See below.**CWI Present:** Yes No**Inspected CWI report:** Yes No N/A**Rod Oven in Use:** Yes No N/A**Electrode to specification:** Yes No N/A**Weld Procedures Followed:** Yes No N/A**Qualified Welders:** Yes No N/A**Verified Joint Fit-up:** Yes No N/A**Approved Drawings:** Yes No N/A**Approved WPS:** Yes No N/A**Delayed / Cancelled:** Yes No N/A**Bridge No:** 34-0006**Component:** OBG**Summary of Items Observed:**

WELDING INSPECTION REPORT

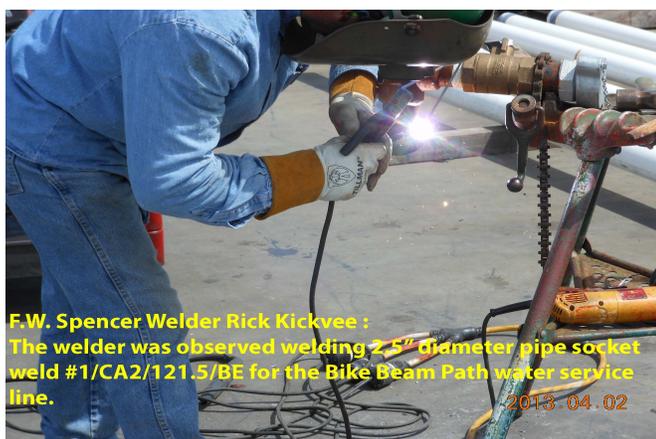
F.W. Spencer Welder Rick Kickvee :
The welder was observed welding 2.5" diameter pipe socket weld #1/CA2/121.5/BE for the Bike Beam Path water service line.

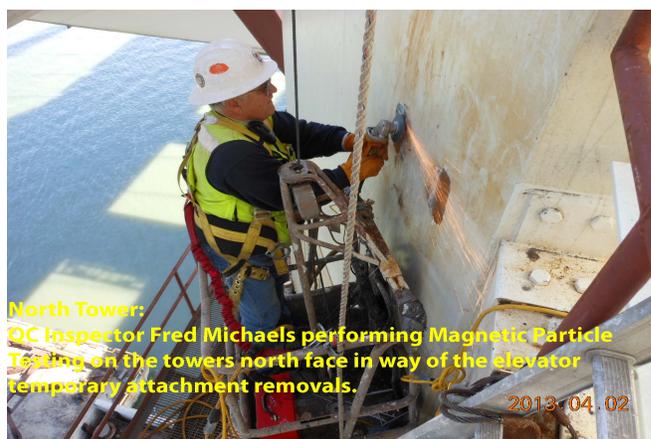
North Tower:
QC Inspector Fred Michaels performing Magnetic Particle Testing on the towers north face in way of the elevator temporary attachment removals.
