Contract #: 04-0120F4Cty: SF/ALA Rte: 80 PM: 13.2/13.9File #: 1.28**WELDING INSPECTION REPORT**

Report No: WIR-029368
Date Inspected: 01-Apr-2013

Project Name: SAS Superstructure
Prime Contractor: American Bridge/Fluor Enterprises, a JV
Contractor: American Bridge/Fluor Enterprises, a JV

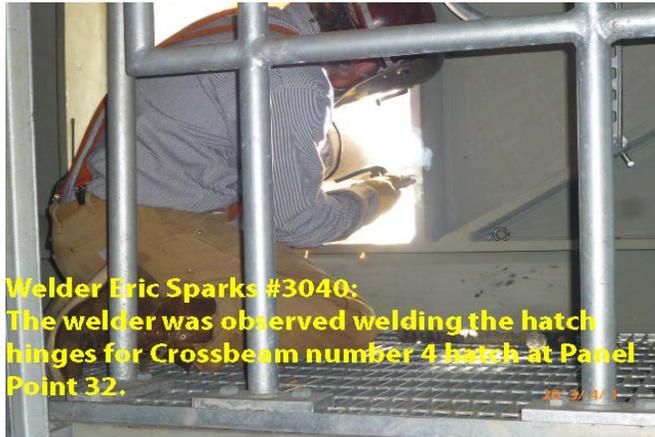
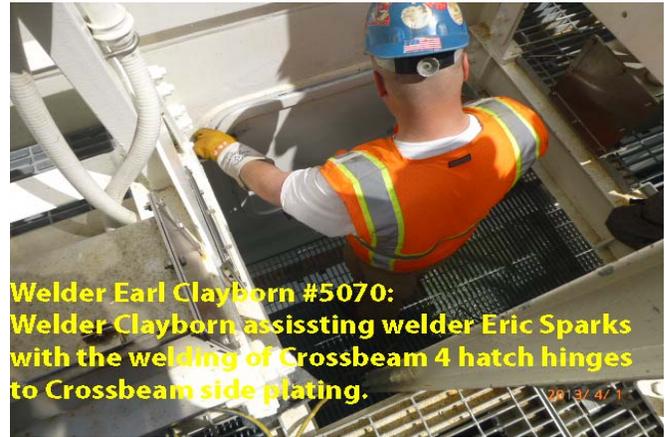
The welder was observed welding the hatch hinges for Crossbeam number 4 hatch at Panel Point 32 in way of the bridge centerline. The welder was observed welding utilizing the Welding Procedure Specification (WPS) ABF-WPS-D15-F1200A for Shield Metal Arc Welding (SMAW). The welding parameters were verified by QC Inspector Fred Michaels throughout the day and appeared to be in compliance with the WPS noted above. Welder Earl Clayborn #5070 was noted assisting welder Eric Sparks #3040 throughout the day.

- Skyway Lifting Lug Hole Welds #SLLH-2, #SLLH-9, #SLLH-10, #SLLH-11, #SLLH-12, #SLLH-13 & #SLLH-16.
