Contract #: 04-0120F4Cty: SF/ALA Rte: 80 PM: 13.2/13.9File #: 1.28**WELDING INSPECTION REPORT****Resident Engineer:** Casey, William**Address:** 333 Burma Road**City:** Oakland, CA 94607**Report No:** WIR-029422**Date Inspected:** 17-Apr-2013**Project Name:** SAS Superstructure**OSM Arrival Time:** 700**Prime Contractor:** American Bridge/Fluor Enterprises, a JV**OSM Departure Time:** 1730**Contractor:** American Bridge/Fluor Enterprises, a JV**Location:** Job Site**CWI Name:** See below.**CWI Present:** Yes No**Inspected CWI report:** Yes No N/A**Rod Oven in Use:** Yes No N/A**Electrode to specification:** Yes No N/A**Weld Procedures Followed:** Yes No N/A**Qualified Welders:** Yes No N/A**Verified Joint Fit-up:** Yes No N/A**Approved Drawings:** Yes No N/A**Approved WPS:** Yes No N/A**Delayed / Cancelled:** Yes No N/A**Bridge No:** 34-0006**Component:** OBG**Summary of Items Observed:**

# WELDING INSPECTION REPORT

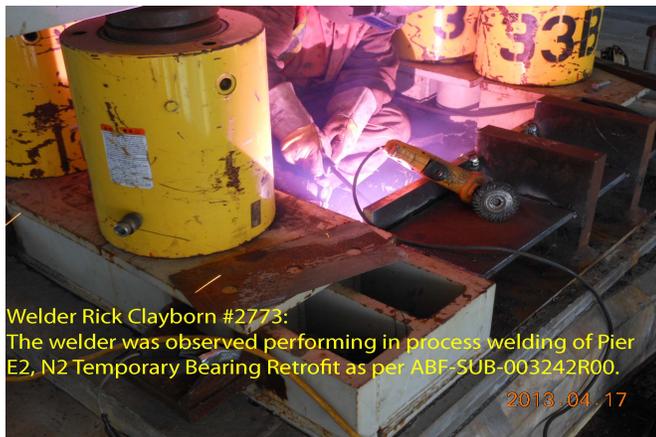
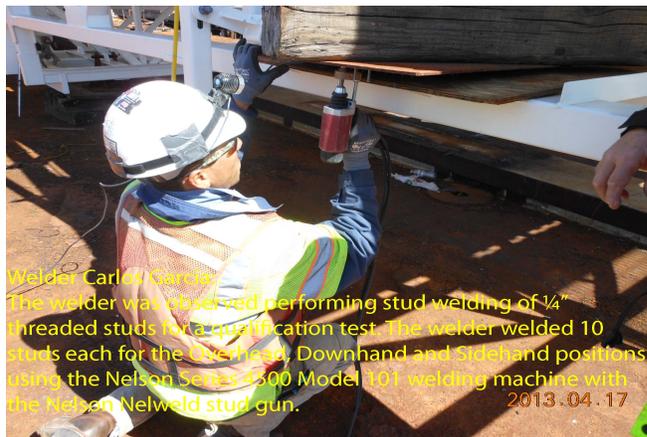
The welder was observed performing stud welding of 1/4" threaded studs for a qualification test. The welder welded 10 studs each for the Overhead, Downhand and Sidehand positions using the Nelson Series 4500 Model 101 welding machine with the Nelson Nelweld stud gun. The current was set at 350 Amps with weld time at .17 seconds to produce a 0.215" weld base diameter. Each of the 30 welded studs were then torque tested to 5ft-lbs as per Figure 7.3 of AWS D1.5 2002 and all passed. This test also satisfied the pre production requirements of Section 7.7.1.1 and the welder then commenced welding the studs on Traveler E2/E3 EB as required supported by PQR S003 with QC Inspector Fred Michaels overseeing and inspecting stud welding operations. Welding parameters appeared to be in compliance with the PQR noted above.

The welder was observed performing in process welding of Pier E2, N2 Temporary Bearing Retrofit as per ABF-SUB-003242R00 as a means of restricting the movement of the temporary bearing to the east. The welder was observed utilizing the Welding Procedure Specification (WPS) ABF-WPS-D15-F2200-1, F2200-3, 2160-1 and 2160-3 for Flux Core Arc Welding (FCAW). The welding parameters were verified by QC Inspector William Sherwood throughout the day and appeared to be in compliance with the WPS noted above.
