**DEPARTMENT OF TRANSPORTATION**

Contract #: 04-0120F4Cty: SF/ALA Rte: 80 PM: 13.2/13.9File #: 1.28**WELDING INSPECTION REPORT****Resident Engineer:** Casey, William**Address:** 333 Burma Road**City:** Oakland, CA 94607**Report No:** WIR-029428**Date Inspected:** 19-Apr-2013**Project Name:** SAS Superstructure**OSM Arrival Time:** 700**Prime Contractor:** American Bridge/Fluor Enterprises, a JV**OSM Departure Time:** 1730**Contractor:** American Bridge/Fluor Enterprises, a JV**Location:** Job Site**CWI Name:** As noted below**CWI Present:** Yes No**Inspected CWI report:** Yes No N/A**Rod Oven in Use:** Yes No N/A**Electrode to specification:** Yes No N/A**Weld Procedures Followed:** Yes No N/A**Qualified Welders:** Yes No N/A**Verified Joint Fit-up:** Yes No N/A**Approved Drawings:** Yes No N/A**Approved WPS:** Yes No N/A**Delayed / Cancelled:** Yes No N/A**Bridge No:** 34-0006**Component:** SAS OBG**Summary of Items Observed:**

# WELDING INSPECTION REPORT

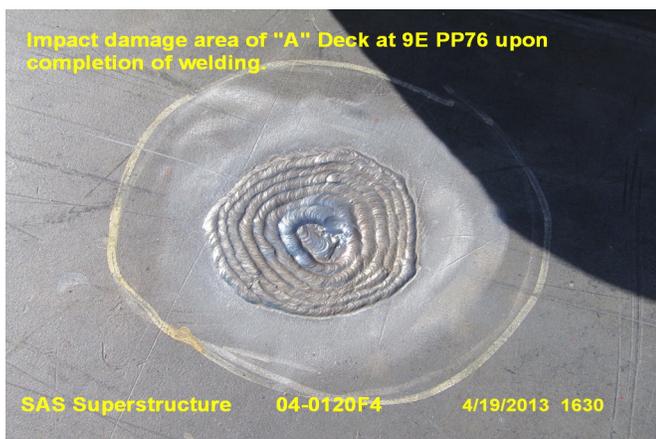
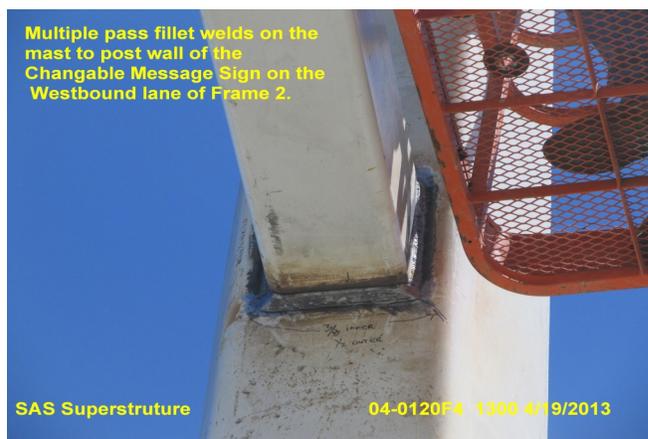
This QA Inspector randomly observed ABF welder Lin E Yun #9344 performing SMAW on the impact damaged area of "A" deck located at 9E PP76. The welder was instructed by ABF personnel to perform the work and was

performed in the absence of approval from engineering staff. The interpass temperatures were monitored and recorded at below 450°F between passes. This QA Inspector noted that the welder completed the work on this date and a TL-15 was generated.

This QA Inspector contacted ASMR Parinaz Aghili concerning the weld repair prior to engineer approval and generated a TL-15.
