Contract #: 04-0120F4Cty: SF/ALA Rte: 80 PM: 13.2/13.9File #: 1.28**WELDING INSPECTION REPORT****Resident Engineer:** Casey, William**Address:** 333 Burma Road**City:** Oakland, CA 94607**Report No:** WIR-029438**Date Inspected:** 02-Apr-2013**Project Name:** SAS Superstructure**OSM Arrival Time:** 700**Prime Contractor:** American Bridge/Fluor Enterprises, a JV**OSM Departure Time:** 1730**Contractor:** American Bridge/Fluor Enterprises, a JV**Location:** S.A.S. Job site**CWI Name:** Jim Bowers**CWI Present:** Yes No**Inspected CWI report:** Yes No N/A**Rod Oven in Use:** Yes No N/A**Electrode to specification:** Yes No N/A**Weld Procedures Followed:** Yes No N/A**Qualified Welders:** Yes No N/A**Verified Joint Fit-up:** Yes No N/A**Approved Drawings:** Yes No N/A**Approved WPS:** Yes No N/A**Delayed / Cancelled:** Yes No N/A**Bridge No:** 34-0006**Component:** S.A.S. Structure**Summary of Items Observed:**

WELDING INSPECTION REPORT

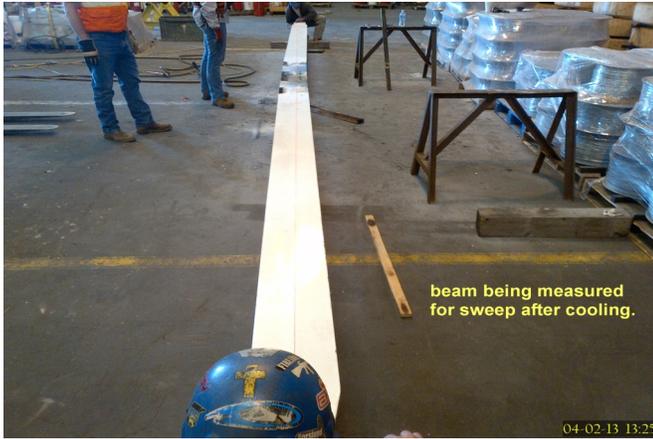
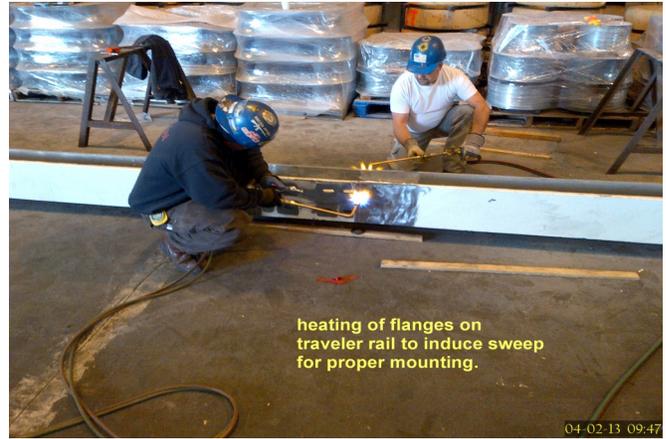
The QAI witnessed ABF personnel using oxy-fuel torches to induce sweep into a traveler rail that didn't align properly to its mounting location between panel point 110 and 112 West. The QAI was informed that this work was apparently not performed at the fabricator and will be done at pier 7. The QAI noted that the work is outlined in Request for Information (RFI) 3233. The QAI and ABF Welding Quality Control Manager (WQCM) Jim Bowers observed 4 heating / cooling cycles across the flanges of the traveler rail. The process was monitored using 1100° and 1200° temperature indicating crayons. After the beam was cooled to ambient temperature after the last application of heat, the sweep was measured and the QAI was informed that the galvanizing and paint will be repaired. See the attached photos.
