**DEPARTMENT OF TRANSPORTATION**

Contract #: 04-0120F4Cty: SF/ALA Rte: 80 PM: 13.2/13.9File #: 1.28**WELDING INSPECTION REPORT****Resident Engineer:** Casey, William**Address:** 333 Burma Road**City:** Oakland, CA 94607**Report No:** WIR-029503**Date Inspected:** 01-May-2013**Project Name:** SAS Superstructure**OSM Arrival Time:** 700**Prime Contractor:** American Bridge/Fluor Enterprises, a JV**OSM Departure Time:** 1730**Contractor:** American Bridge/Fluor Enterprises, a JV**Location:** Job Site**CWI Name:** Bernie Docena**CWI Present:** Yes No**Inspected CWI report:** Yes No N/A**Rod Oven in Use:** Yes No N/A**Electrode to specification:** Yes No N/A**Weld Procedures Followed:** Yes No N/A**Qualified Welders:** Yes No N/A**Verified Joint Fit-up:** Yes No N/A**Approved Drawings:** Yes No N/A**Approved WPS:** Yes No N/A**Delayed / Cancelled:** Yes No N/A**Bridge No:** 34-0006**Component:** SAS Tower**Summary of Items Observed:**

# WELDING INSPECTION REPORT

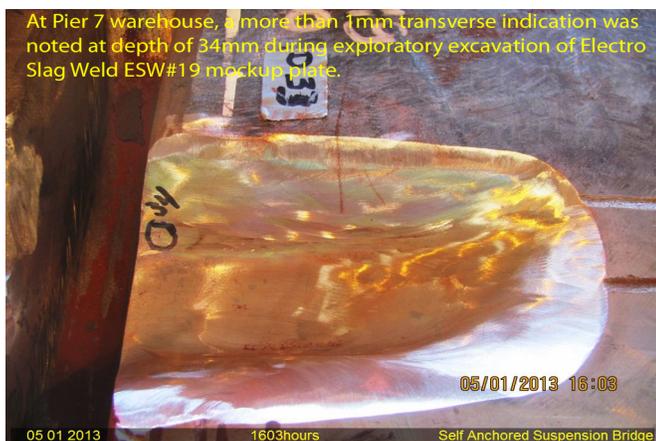
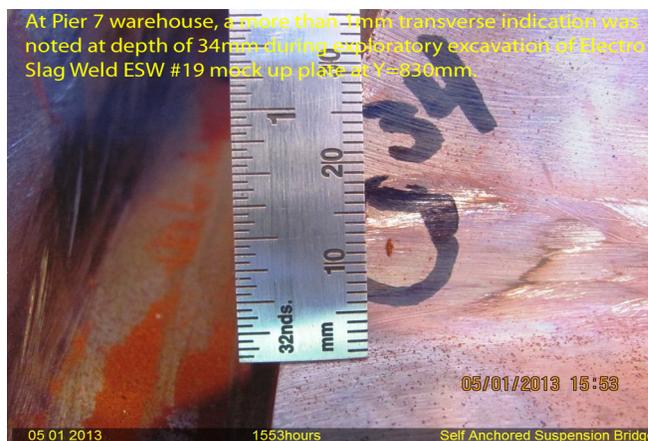
At Pier 7 warehouse, this QA together with ABF QC Bernie Docena have observed the exploratory excavation of Ultrasonic Testing (UT) detected defect on welded mock up plate ESW #19 Electro Slag Weld (ESW). ABF personnel was observed continuing to perform exploratory excavation on welded ESW at location Y=830mm. The ABF personnel have resumed the exploratory excavation from 12mm deep with 3mm increments. The personnel were noted using only the disc grinder in every 3mm increments of excavation up to 25mm and 1mm increments after 25mm up to the transverse indication. ABF QC Bernie Docena was observed performing Magnetic Particle Testing (MT) on every depth of excavation with no significant indication noted so far. This QA also performed the same test at every depth and noted same result. During the shift, the ABF personnel continued the excavation in 3mm increments using the same method of test and verification up to 25mm and then 1mm increments after 25mm until 34mm where 1.5mm long transverse indication was noted at this depth. After finding the transverse indication, SMR Aaron Prlich was called to see the indication. The shift was completed up to this depth of excavation and an ABF personnel was advised to excavate the side where the indication was located.

3. 21mm in depth – no significant indication noted.
4. 24mm in depth – no significant indication noted.
5. 25mm in depth – no significant indication noted.
6. 26mm in depth – no significant indication noted.
7. 27mm in depth – no significant indication noted.
8. 28mm in depth – no significant indication noted.
9. 29mm in depth – no significant indication noted.
10. 30mm in depth – no significant indication noted.
11. 31mm in depth – no significant indication noted.
12. 32mm in depth – no significant indication noted.
13. 33mm in depth – no significant indication noted.
14. 34mm in depth – 1.5mm transverse indication noted.
