**DEPARTMENT OF TRANSPORTATION**

Contract #: 04-0120F4Cty: SF/ALA Rte: 80 PM: 13.2/13.9File #: 1.28**WELDING INSPECTION REPORT****Resident Engineer:** Casey, William**Address:** 333 Burma Road**City:** Oakland, CA 94607**Report No:** WIR-029551**Date Inspected:** 11-May-2013**Project Name:** SAS Superstructure**OSM Arrival Time:** 700**Prime Contractor:** American Bridge/Fluor Enterprises, a JV**OSM Departure Time:** 1730**Contractor:** American Bridge/Fluor Enterprises, a JV**Location:** Job Site**CWI Name:** See below.**CWI Present:** Yes No**Inspected CWI report:** Yes No N/A**Rod Oven in Use:** Yes No N/A**Electrode to specification:** Yes No N/A**Weld Procedures Followed:** Yes No N/A**Qualified Welders:** Yes No N/A**Verified Joint Fit-up:** Yes No N/A**Approved Drawings:** Yes No N/A**Approved WPS:** Yes No N/A**Delayed / Cancelled:** Yes No N/A**Bridge No:** 34-0006**Component:** Tower ESW Welds**Summary of Items Observed:**

# WELDING INSPECTION REPORT

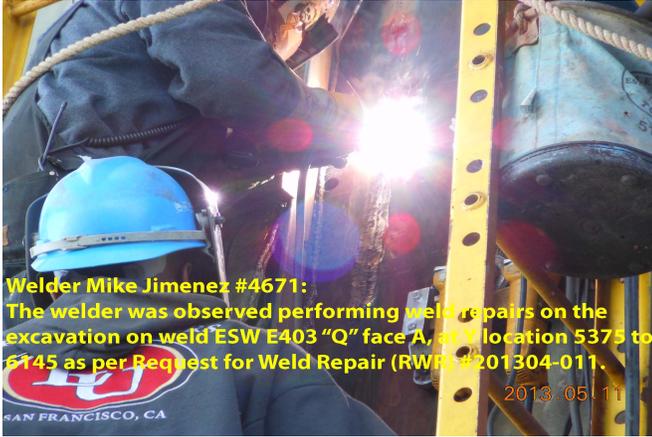
The welder was observed performing weld repairs on the excavation on weld ESW E403 "Q" face A, at Y location 5375 to 6145 as per Request for Weld Repair (RWR) #201304-011. The excavation is in way of Ultrasonic Testing Shear Wave (UTSW) rejected indications. The welder was observed preheating the weld to 300 degrees Fahrenheit prior to welding using the Miller ProHeat 35 with heat induction blankets. The welder utilized the Welding Procedure Specification (WPS) ABF-WPS-D15-1000-Repair Rev.3 for Shield Metal Arc Welding (SMAW) using an E7018 H4R with a 5/32" diameter rod with current measured at 166 amps. The welding parameters were verified by QC Inspector Bernard Docena throughout the day and appeared to be in compliance with the WPS noted above.
