Contract #: 04-0120F4Cty: SF/ALA Rte: 80 PM: 13.2/13.9File #: 99.28**WELDING INSPECTION REPORT****Resident Engineer:** Casey, William**Address:** 333 Burma Road**City:** Oakland, CA 94607**Report No:** WIR-029563**Date Inspected:** 03-May-2013**Project Name:** SAS Superstructure**OSM Arrival Time:** 700**Prime Contractor:** American Bridge/Fluor Enterprises, a JV**OSM Departure Time:** 1530**Contractor:** USA Hoist**Location:** USA Hoist, Crest Hill, IL**CWI Name:** See below**CWI Present:** Yes No**Inspected CWI report:** Yes No N/A**Rod Oven in Use:** Yes No N/A**Electrode to specification:** Yes No N/A**Weld Procedures Followed:** Yes No N/A**Qualified Welders:** Yes No N/A**Verified Joint Fit-up:** Yes No N/A**Approved Drawings:** Yes No N/A**Approved WPS:** Yes No N/A**Delayed / Cancelled:** Yes No N/A**Bridge No:** 34-0006**Component:** Elevator Cab frame assembly**Summary of Items Observed:**

WELDING INSPECTION REPORT

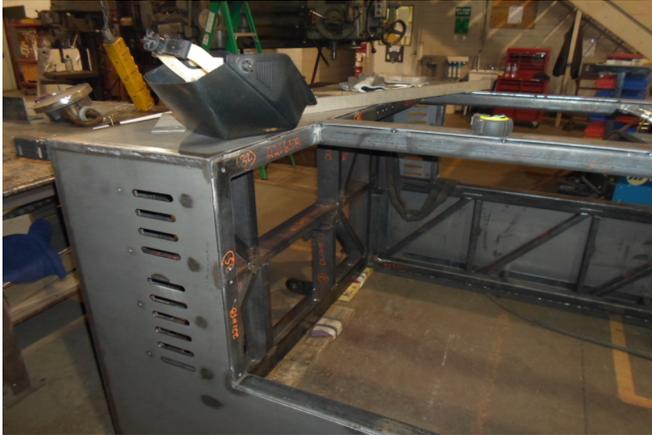
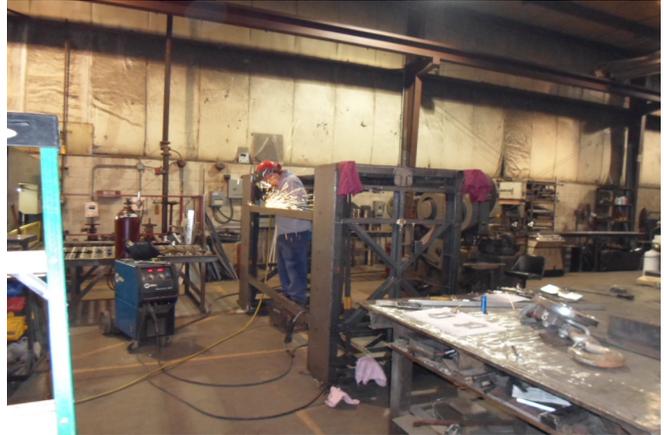
This QAI observed the fit-up/tacking and welding in-progress of the sheetmetal skin strips (2 total) item #3 to outer-face side of the composite boxed-shape member formed from bent-plate channel members #27 and #58 assembled in a toe-to-toe configuration. These areas of welding were not completed this day, with approximately 75% having been performed. The WPS FCAW-3139 was utilized for this welding.

This QAI observed the welding performed and completed of the top of plates #13 (2 total) to C4x5.4 channels #25, #51, and #2 (2 total). This QAI also witnessed the welding performed and completed of the bottom side of plates #13 (2 total) to C4x5.4 channels #2 (2 total). This QAI monitored the parameters of the welding performed, verifying adherence to the approved WPS. The welding was observed and verified by this QAI and appeared to be in compliance with the contract documents.
