Contract #: 04-0120F4Cty: SF/ALA Rte: 80 PM: 13.2/13.9File #: 99.28**WELDING INSPECTION REPORT****Resident Engineer:** Casey, William**Address:** 333 Burma Road**City:** Oakland, CA 94607**Report No:** WIR-029681**Date Inspected:** 13-Jun-2013**Project Name:** SAS Superstructure**OSM Arrival Time:** 700**Prime Contractor:** American Bridge/Fluor Enterprises, a JV**OSM Departure Time:** 1530**Contractor:** USA Hoist**Location:** Crest Hill, IL

Bridge No: 34-0006**Component:** SAS Tower Elevator**Summary of Items Observed:**

WELDING INSPECTION REPORT

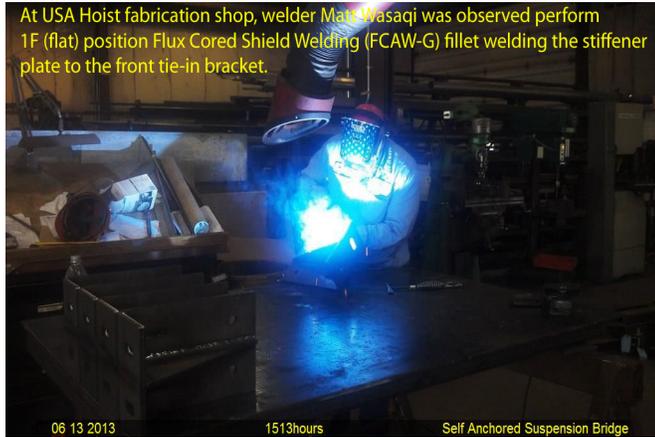
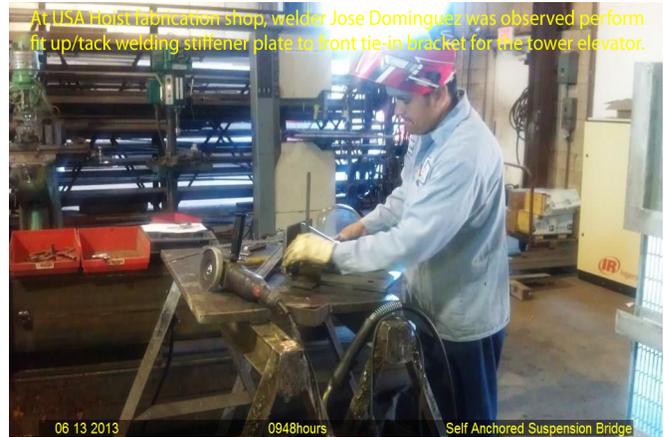
Today at USA Hoist assembly shop, around 60 pieces out of 146 pieces of front tie-in brackets have returned from the shop where they were bent. This QA randomly observed USA Hoist qualified welder Jose Dominguez perform fit up and tack welding the 13 1/2" long x 5 1/2" wide x 3/8" thick stiffener plate to 14" x 6" x 1/2" thick bent plate front tie-in bracket per USA Hoist shop drawing #914204-14. The welder was noted tack welding the stiffener plate using gas shielded FCAW-G with 1.1mm E71T-1C Familiarc DW-50 wire electrode implementing USA Hoist Welding Procedure Specification FCAW 3210. The shielding gas being used was noted a combination of 75% Argon and 25% CO2 with flow rate of 35 CFH. During the shift, fit up/tack welding of the above mentioned bracket was still continuing and should remain tomorrow.

At the same assembly shop, another USA Hoist qualified welder Matt Wasiqi was observed fillet welding the same front tie-in brackets for the tower elevator as the other welder was performing fit up and tack welding. The welder was noted using the same process and implementing the same welding procedure specification. The welder was noted using gas shielded FCAW-G with 1.1mm E71T-1C Familiarc DW-50 wire electrode implementing USA Hoist Welding Procedure Specification FCAW 3210. The shielding gas being used was noted a combination of 75% Argon and 25% CO2 with flow rate of 38 CFH. During the shift, the working welding parameters were measured 29 volts and 230 amperes which deemed in compliance to the project requirements. This QA randomly checked the workmanship and measured the required 1/4" fillet on all sides of the stiffener which it was found in

compliance to the requirement. As of today, the welder has finished fillet welding 10 brackets out of the 146 pieces required.
