**DEPARTMENT OF TRANSPORTATION**

Contract #: 04-0120F4Cty: SF/ALA Rte: 80 PM: 13.2/13.9File #: 1.28**WELDING INSPECTION REPORT****Resident Engineer:** Casey, William**Address:** 333 Burma Road**City:** Oakland, CA 94607**Report No:** WIR-029731**Date Inspected:** 12-Jun-2013**Project Name:** SAS Superstructure**OSM Arrival Time:** 700**Prime Contractor:** American Bridge/Fluor Enterprises, a JV**OSM Departure Time:** 1730**Contractor:** American Bridge/Fluor Enterprises, a JV**Location:** Jobsite**CWI Name:** See below**CWI Present:** Yes No**Inspected CWI report:** Yes No N/A**Rod Oven in Use:** Yes No N/A**Electrode to specification:** Yes No N/A**Weld Procedures Followed:** Yes No N/A**Qualified Welders:** Yes No N/A**Verified Joint Fit-up:** Yes No N/A**Approved Drawings:** Yes No N/A**Approved WPS:** Yes No N/A**Delayed / Cancelled:** Yes No N/A**Bridge No:** 34-0006**Component:** Eastbound cable shroud; Crossbeam CB19**Summary of Items Observed:**

# WELDING INSPECTION REPORT

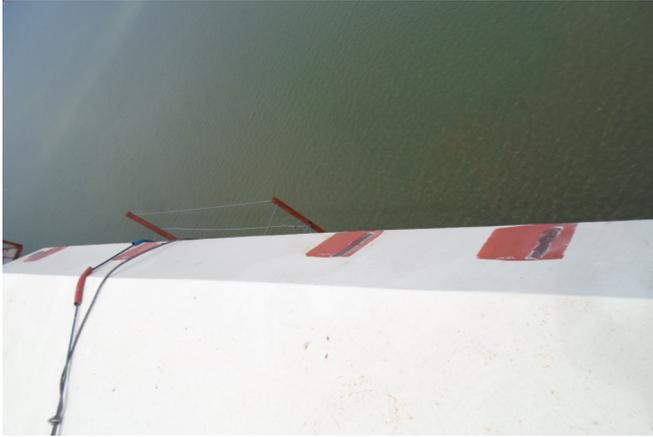
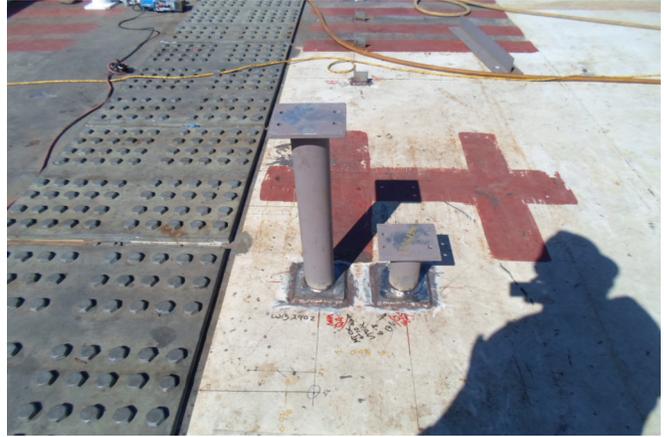
This QAI visually inspected the completed welds (4 total) of baseplates for subsequent mounting of 4" diameter piping supports to Westbound cable shroud at the following locations: PP118.5, PP118 (+120), PP119 (-420), PP119.5 (-600). All of these welds appeared to meet the requirements of the contract documents.

This QAI performed the Visual and Magnetic Particle Testing (MPT) inspections of fillet welds of attachments to top of Crossbeam CB19 for subsequent mounting of piping supports at the following locations: PP126(-2700)/W5(-282), PP126(-1250)/W5(-5248), PP126(+2827)/W5(-3005), PP126(+3796)/W5(-752). There were no indications noted at this time. See attached TL6028 Magnetic Particle Testing report for details. All welds at these locations appear to meet the requirements of the contract documents.

The welding of pipe support W-Tees (2 total) and Posts (2 total) to Crossbeam CB19 Deck top attachment members was performed this day by F.W. Spencer welder Barry Mullaney #6520 utilizing E7018 electrodes as per WPS #FWS Fillets Murex SFOBB Rev.1. The locations performed are as follows: PP126(-2700)/W5(-282), PP126(-1586)/W5(-5248), PP126(-600)/E5(-2902), and PP126(-600)/E5(-3152).
