DEPARTMENT OF TRANSPORTATION

Quality Assurance and Source Inspection

Contract #: 04-0120F4Cty: SF/ALA Rte: 80 PM: 13.2/13.9File #: 1.28**WELDING INSPECTION REPORT****Resident Engineer:** Casey, William**Address:** 333 Burma Road**City:** Oakland, CA 94607**Report No:** WIR-029733**Date Inspected:** 14-Jun-2013**Project Name:** SAS Superstructure**OSM Arrival Time:** 700**Prime Contractor:** American Bridge/Fluor Enterprises, a JV**OSM Departure Time:** 1730**Contractor:** American Bridge/Fluor Enterprises, a JV**Location:** Jobsite**CWI Name:** See below**CWI Present:** Yes No**Inspected CWI report:** Yes No N/A**Rod Oven in Use:** Yes No N/A**Electrode to specification:** Yes No N/A**Weld Procedures Followed:** Yes No N/A**Qualified Welders:** Yes No N/A**Verified Joint Fit-up:** Yes No N/A**Approved Drawings:** Yes No N/A**Approved WPS:** Yes No N/A**Delayed / Cancelled:** Yes No N/A**Bridge No:** 34-0006**Component:** Eastbound OBG top deck surface; Crossbeam**Summary of Items Observed:**

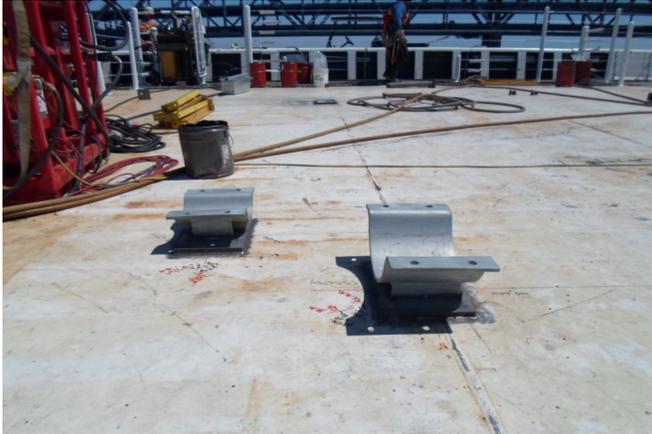
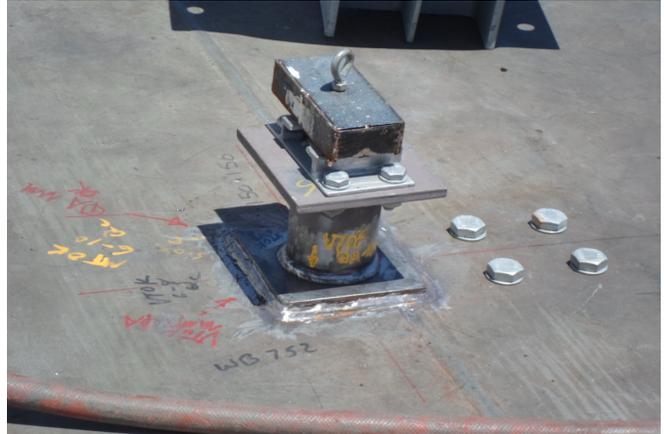
This QAI observed and identified arc-strike and gouged areas of the Deck top surface of Eastbound OBG together with AB/F Quality Control (QC) inspector William Sherwood. The arc-strike areas were 'flap-wheel' sanded down to sound metal and inspected by Magnetic Particle Testing (MPT) by QC for the following locations: PP40(+1470)/E4(+3630), PP41(-230)/E4(+6700), PP30(+470)/E5(-2560), PP70(+1500)/E5(-3700). The gouged areas were 'flap-wheel' sanded to blend in with the surrounding metal surface. This QAI performed the MPT verification inspections of the arc-strike removal areas. There were no indications noted at this time. See the TL6028 Magnetic Particle Testing report for details. All of the reworked arc-strike and gouge areas were brought into conformance with the requirements of the contract documents.

At Crossbeam CB19 welding was observed by this QAI of pipe supports to deck top attachments at the following locations: PP126(+1130)/W5(-6010), PP126(+1836)/W5(-6510), PP126(-1250)/W5(-752), and PP126(+1027)/W5(-3005). The welding was performed by F.W.Spencer welder Barry Mullaney #6520 utilizing E7018 electrodes as per WPS #FWS Fillets Murex SFOBB Rev.1. Quality Control (QC) inspector Fred Michels was present, monitoring the WPS parameters of the welding in process. All of these above-mentioned welds

appeared to be in compliance with the requirements of the contract documents.
