Quality Assurance and Source Inspection

Contract #: 04-0120F4Cty: SF/ALA Rte: 80 PM: 13.2/13.9File #: 1.28**WELDING INSPECTION REPORT****Resident Engineer:** Casey, William**Address:** 333 Burma Road**City:** Oakland, CA 94607**Report No:** WIR-029843**Date Inspected:** 09-Jul-2013**Project Name:** SAS Superstructure**OSM Arrival Time:** 800**Prime Contractor:** American Bridge/Fluor Enterprises, a JV**OSM Departure Time:** 1300**Contractor:** USA Hoist**Location:** Crest Hill, IL.**CWI Name:** None present**CWI Present:** Yes No**Inspected CWI report:** Yes No N/A**Rod Oven in Use:** Yes No N/A**Electrode to specification:** Yes No N/A**Weld Procedures Followed:** Yes No N/A**Qualified Welders:** Yes No N/A**Verified Joint Fit-up:** Yes No N/A**Approved Drawings:** Yes No N/A**Approved WPS:** Yes No N/A**Delayed / Cancelled:** Yes No N/A**Bridge No:** 34-0006**Component:** Tower Elevator items**Summary of Items Observed:**

WELDING INSPECTION REPORT

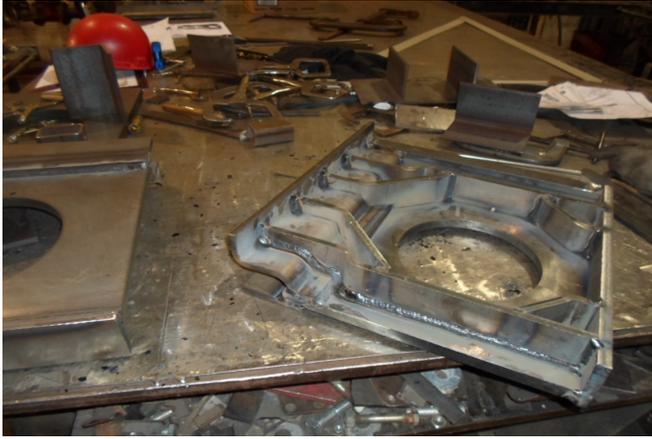
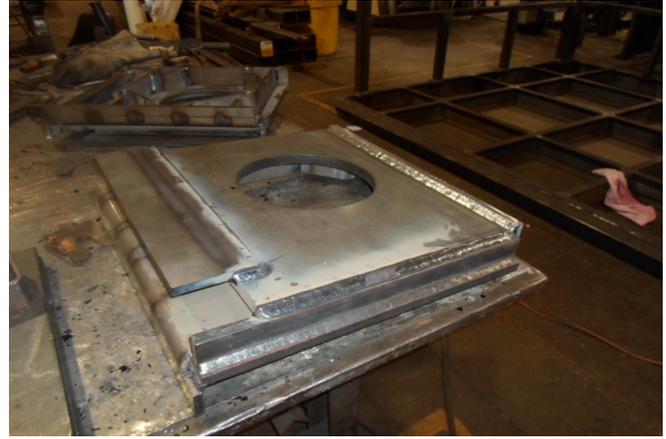
Welding is in-progress, but not completed, of Right-Hand and Left-Hand Bearing & Roller Mounting assemblies shown on Drawings #914233-20 and 914232-20, respectively. The welding was performed by Manola Lunas #B utilizing E71T-1 .045" diameter FCAW-G electrode as per AWS A5.20 and the approved WPS# FCAW3210. The shielding gas used was mix of Argon@75%/CO2@25% with a flow rate of 37CFH. No QC was present this day. The welds that have been so far performed of these members exhibit a very good appearance.
