DEPARTMENT OF TRANSPORTATION

Contract #: 04-0120F4Cty: SF/ALA Rte: 80 PM: 13.2/13.9File #: 1.28**WELDING INSPECTION REPORT****Resident Engineer:** Casey, William**Address:** 333 Burma Road**City:** Oakland, CA 94607**Report No:** WIR-029857**Date Inspected:** 27-Jun-2013**Project Name:** SAS Superstructure**OSM Arrival Time:** 930**Prime Contractor:** American Bridge/Fluor Enterprises, a JV**OSM Departure Time:** 1800**Contractor:** XKT/Nesco**Location:** XKT Engineering, Vallejo**CWI Name:** Wayne Van de Wark**CWI Present:** Yes No**Inspected CWI report:** Yes No N/A**Rod Oven in Use:** Yes No N/A**Electrode to specification:** Yes No N/A**Weld Procedures Followed:** Yes No N/A**Qualified Welders:** Yes No N/A**Verified Joint Fit-up:** Yes No N/A**Approved Drawings:** Yes No N/A**Approved WPS:** Yes No N/A**Delayed / Cancelled:** Yes No N/A**Bridge No:** 34-0006**Component:** E2 Retrofit Side Plates**Summary of Items Observed:**

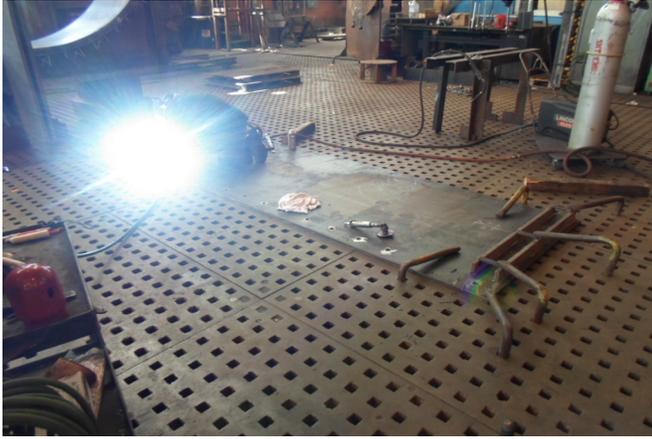
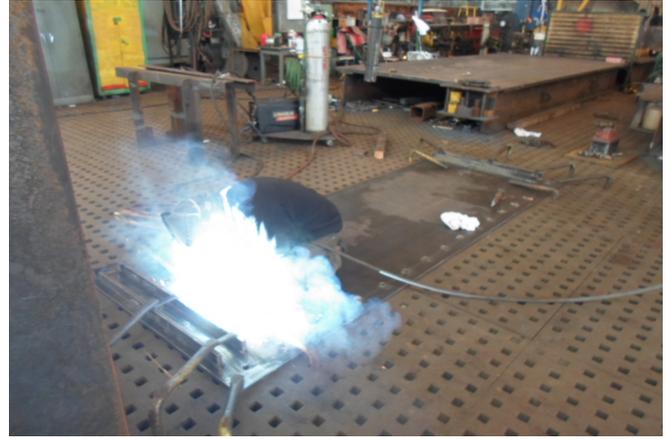
This QA inspector observed the fillet welding of the plate stiffeners to the Side Plate identified as item number 103A. The welding was performed by the welder Nestor Rojas, ID number AF, utilizing the E71T-1 1/16" diameter Lincoln Electric UltraCore FCAW-G electrodes as per the Welding Procedure Specification (WPS) identified as XKTD15-00. For fabrication purposes the drawing identified as 7861-103, Revision 1 was referenced.
