Contract #: 04-0120F4Cty: SF/ALA Rte: 80 PM: 13.2/13.9File #: 1.28**WELDING INSPECTION REPORT**

Report No: WIR-029861
Date Inspected: 12-Jul-2013

Project Name: SAS Superstructure **OSM Arrival Time:** 700
Prime Contractor: American Bridge/Fluor Enterprises, a JV **OSM Departure Time:** 1730
Contractor: American Bridge/Fluor Enterprises, a JV **Location:** Job Site

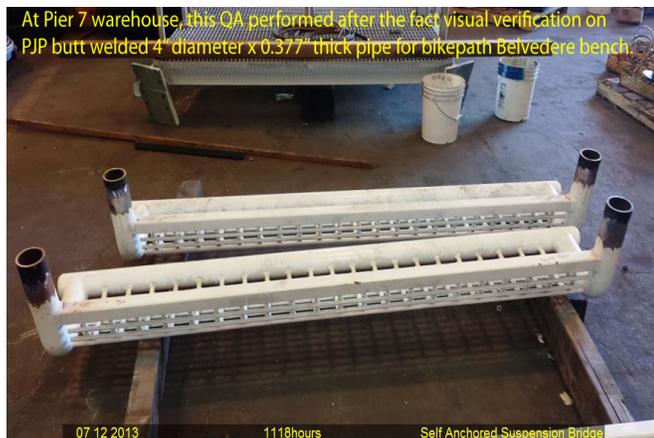
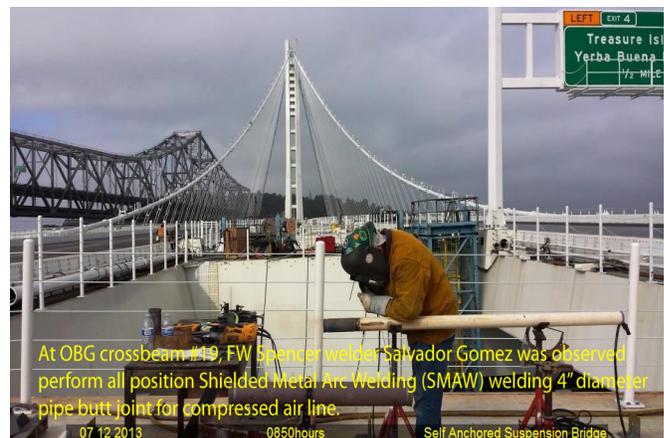
At location bikepath E panel point PP77 and Northeast PP126, this QA randomly observed FW Spencer qualified welders Tim Esquivel, Barry Mullaney and a new welder Salvador Gomez continuing to perform Complete Joint Penetration (CJP) 6G (all position) Shielded Metal Arc Welding (SMAW) welding root pass to cover pass on 2.5" diameter domestic water line and 4" diameter compressed air field butt joints. The welders were noted welding the root pass with 3/32" diameter E6010 electrode and followed by fill pass to cover pass using 3/32" diameter E7018H4R electrode implementing Caltrans procedure FW Spencer WPS 1-12-1. The welders were noted preheating and removing the moisture of the joint using a portable propylene gas torch prior welding. During welding, ABF QC Fred Michels was noted monitoring the parameters of the welders. At the end of the FW Spencer shift, CJP welding on 2.5" and 4.0" diameter pipe joints at various locations were completed;
