Contract #: 04-0120F4Cty: SF/ALA Rte: 80 PM: 13.2/13.9File #: 1.28**WELDING INSPECTION REPORT**

Report No: WIR-029866
Date Inspected: 10-Jul-2013

Project Name: SAS Superstructure
Prime Contractor: American Bridge/Fluor Enterprises, a JV
Contractor: American Bridge/Fluor Enterprises, a JV

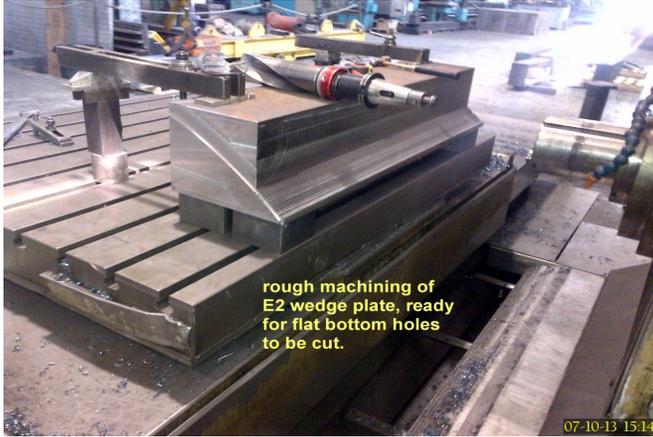
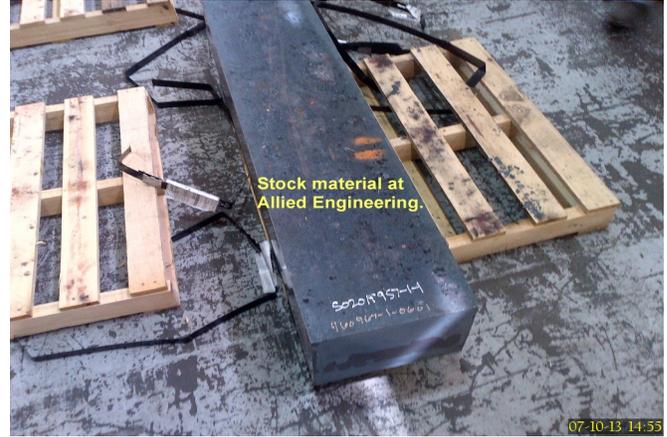
The QAI traveled to Allied Engineering in Alameda, CA and observed the machining of components for the E2 Shear Key modifications. The QAI spoke with shop personnel and observed that the stock materials are being squared and 1 part is beginning to be milled to final shape. The QAI reviewed the drawings and informed the Structural Materials Representative of the observations made. The QAI also relayed that there will be dimensional variations in part lengths because the steel supplied to the shop by ABF is cut to the final dimensions prior to machining. The QAI relayed that the parts may be up to 100mm shorter than detailed. See the attached photos.
