Contract #: 04-0120F4Cty: SF/ALA Rte: 80 PM: 13.2/13.9File #: 1.28**WELDING INSPECTION REPORT****Resident Engineer:** Casey, William**Address:** 333 Burma Road**City:** Oakland, CA 94607**Report No:** WIR-029942**Date Inspected:** 19-Aug-2013**Project Name:** SAS Superstructure**OSM Arrival Time:** 700**Prime Contractor:** American Bridge/Fluor Enterprises, a JV**OSM Departure Time:** 1730**Contractor:** American Bridge/Fluor Enterprises, a JV**Location:** Job Site**CWI Name:** Fred Michels**CWI Present:** Yes No**Inspected CWI report:** Yes No N/A**Rod Oven in Use:** Yes No N/A**Electrode to specification:** Yes No N/A**Weld Procedures Followed:** Yes No N/A**Qualified Welders:** Yes No N/A**Verified Joint Fit-up:** Yes No N/A**Approved Drawings:** Yes No N/A**Approved WPS:** Yes No N/A**Delayed / Cancelled:** Yes No N/A**Bridge No:** 34-0006**Component:** SAS Bikepath**Summary of Items Observed:**

WELDING INSPECTION REPORT

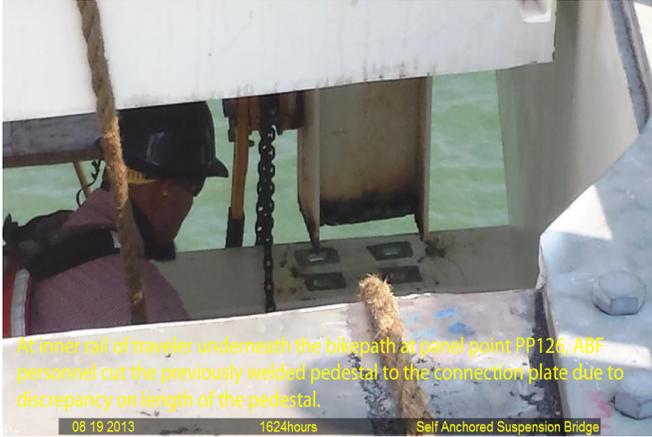
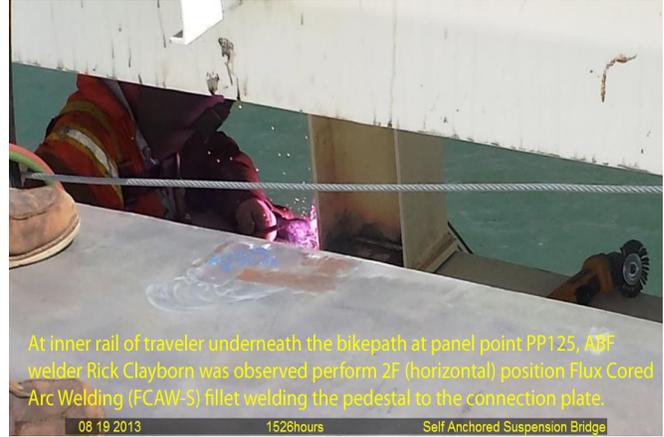
Underneath the bike path at panel points PP124 and PP125, this QA randomly observed ABF/JV the welder Rick Clayborn continue to perform the 8mm fillet welding of the flange and the 5mm fillet welding of the web of the W10 x 8 to ¾" thick connection plate inner rail hanger as required. The welder was observed welding in the 2F (horizontal) position utilizing self shielded Flux Cored Arc Welding (SMAW) process using the 0.072" diameter wire electrode as per the welding procedure ABF-WPS-D15-F2200. During the shift, ABF QC Fred Michels was noted monitoring the workmanship and the parameters. At the end of the shift, 2F SMAW fillet welding was completed at two locations mentioned above.

The ¾" thick connection plate was cut removed due to discrepancy in length and this was done without approval from the Engineer. When ABF QC was asked about the necessary supporting documents about the task being undertaken, Fred Michels informed this QA that ABF has submitted the Request for Information (RFI) but awaiting response from Caltrans.
