DEPARTMENT OF TRANSPORTATION

Quality Assurance and Source Inspection

Contract #: 04-0120F4Cty: SF/ALA Rte: 80 PM: 13.2/13.9File #: 1.28**WELDING INSPECTION REPORT****Resident Engineer:** Casey, William**Address:** 333 Burma Road**City:** Oakland, CA 94607**Report No:** WIR-029945**Date Inspected:** 22-Aug-2013**Project Name:** SAS Superstructure**OSM Arrival Time:** 700**Prime Contractor:** American Bridge/Fluor Enterprises, a JV**OSM Departure Time:** 1730**Contractor:** American Bridge/Fluor Enterprises, a JV**Location:** Job Site**CWI Name:** Fred Michels**CWI Present:** Yes No**Inspected CWI report:** Yes No N/A**Rod Oven in Use:** Yes No N/A**Electrode to specification:** Yes No N/A**Weld Procedures Followed:** Yes No N/A**Qualified Welders:** Yes No N/A**Verified Joint Fit-up:** Yes No N/A**Approved Drawings:** Yes No N/A**Approved WPS:** Yes No N/A**Delayed / Cancelled:** Yes No N/A**Bridge No:** 34-0006**Component:** SAS OBG & Bikepath**Summary of Items Observed:**

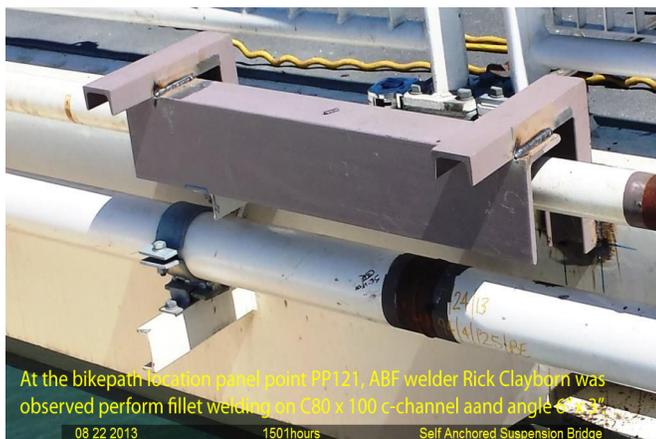
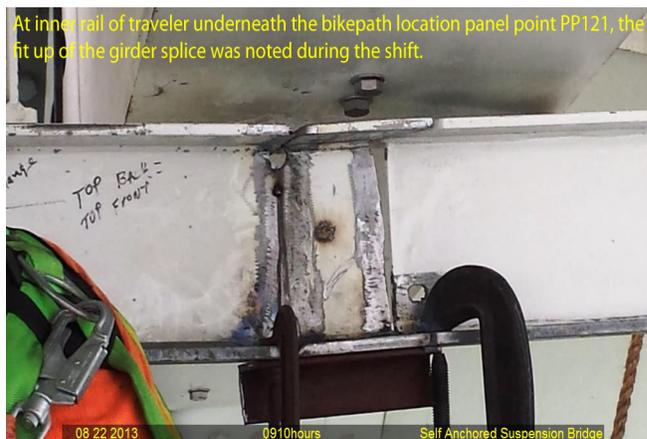
At the bike path at panel point PP123.25, this QA randomly observed ABF/JV the welder Rick Clayborn continuing to perform the fillet welding on the C80 x 100 channel to the side of the bike path for electrical support pull box as per the approved drawing ES-6/detail PB-1E. The welder was observed welding in the 2F/3F (horizontal/vertical) position utilizing the self shielded Flux Cored Arc Welding (SMAW) process using the .072" diameter wire electrode as per the welding procedure ABF-WPS-D15-F2200. After the welding of the C-channel to the side of the bike path, a 6" x 4" angle was also welded on top of the C-channel. During the shift, ABF QC

Fred Michels was noted monitoring the welding, workmanship and parameters. During the shift, fillet welding was completed at panel point PP123.25.

After the completion of the fillet welding mentioned above, another ABF welder Erick Sparks also performed the same 7mm all around fillet welding of the C80 x 100 to the side of the bikepath at the panel point PP125. During welding, the welder was noted utilizing Shielded Metal Arc Welding (SMAW) process using the 1/8" diameter E7018H4R electrode as per the welding procedure ABF-WPS-D15-F2200. After the welding of the C-channel to the side of the bikepath, a 6" x 4" angle was also welded on top of the C-channel. Fillet welding at this location was also completed during this shift. This QA performed random verification on the fillet welding of the C-channel and found deemed acceptable to the contract requirements.
