Contract #: 04-0120F4Cty: SF/ALA Rte: 80 PM: 13.2/13.9File #: 1.28**WELDING INSPECTION REPORT****Resident Engineer:** Casey, William**Address:** 333 Burma Road**City:** Oakland, CA 94607**Report No:** WIR-029947**Date Inspected:** 24-Aug-2013**Project Name:** SAS Superstructure**OSM Arrival Time:** 700**Prime Contractor:** American Bridge/Fluor Enterprises, a JV**OSM Departure Time:** 1530**Contractor:** American Bridge/Fluor Enterprises, a JV**Location:** Job Site**CWI Name:** Fred Michels**CWI Present:** Yes No**Inspected CWI report:** Yes No N/A**Rod Oven in Use:** Yes No N/A**Electrode to specification:** Yes No N/A**Weld Procedures Followed:** Yes No N/A**Qualified Welders:** Yes No N/A**Verified Joint Fit-up:** Yes No N/A**Approved Drawings:** Yes No N/A**Approved WPS:** Yes No N/A**Delayed / Cancelled:** Yes No N/A**Bridge No:** 34-0006**Component:** SAS Crossbeam**Summary of Items Observed:**

WELDING INSPECTION REPORT

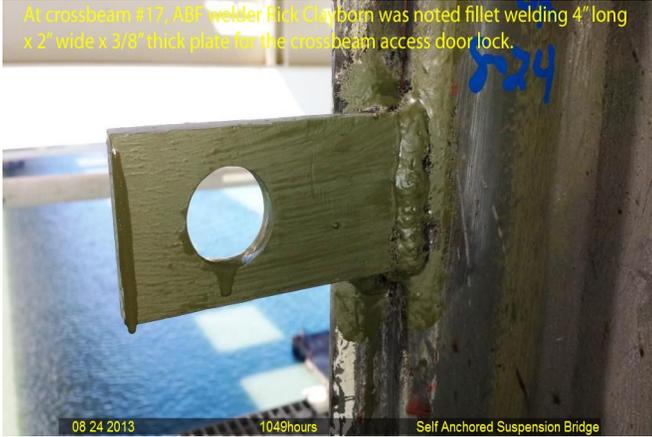
At crossbeam #17, ABF welder Rich Clayborn was noted fillet welding 4" long x 2" wide x 3/8" thick plate for the crossbeam access door lock.
