DEPARTMENT OF TRANSPORTATION

Contract #: 04-0120F4Cty: SF/ALA Rte: 80 PM: 13.2/13.9File #: 1.28**WELDING INSPECTION REPORT****Resident Engineer:** Casey, William**Address:** 333 Burma Road**City:** Oakland, CA 94607**Report No:** WIR-029955**Date Inspected:** 27-Aug-2013**Project Name:** SAS Superstructure**OSM Arrival Time:** 700**Prime Contractor:** American Bridge/Fluor Enterprises, a JV**OSM Departure Time:** 1730**Contractor:** American Bridge/Fluor Enterprises, a JV**Location:** Job Site

ESW Repair excavation

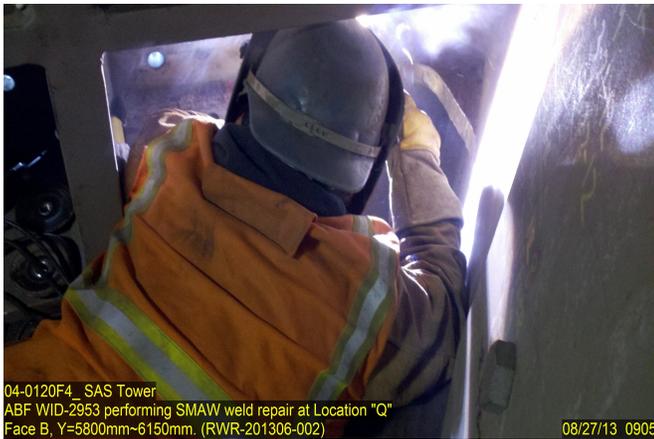
The QA Inspector was present to observe ABF welder Wai Kit Lai (WID-2953) performing Shield Metal Arc Welding (SMAW) on the repair excavation on Electroslag Weld (ESW) "Q", at face B. The locations and repair information are listed in Request for Weld Repair (RWR) 201306-002 from Ultrasonic Testing & Magnetic particle testing indications designated for repair. The repair locations were noted as:

Prior to welding, Mr. Lai was observed preheating the weld to over 350° Fahrenheit prior to welding using the Miller ProHeat 35 with heat induction blankets. The welder was using 4.0mm diameter electrode (E7018-1 HR4) per ABF Welding Procedure Specification (WPS) ABF-WPS-D15-1000-Repair Rev.3. The welding parameters were verified by ABF QC Inspector Bernie Docena with a Fluke 337 current clampmeter and preheat was verified with temperature indicators. Mr. Docena performed welding parameters verifications at random intervals throughout the shift. The welding observed appeared to be in compliance with the WPS noted above.
