**DEPARTMENT OF TRANSPORTATION**

Contract #: 04-0120F4Cty: SF/ALA Rte: 80 PM: 13.2/13.9File #: 01.28**WELDING INSPECTION REPORT****Resident Engineer:** Casey, William**Address:** 333 Burma Road**City:** Oakland, CA 94607**Report No:** WIR-029962**Date Inspected:** 17-Aug-2013**Project Name:** SAS Superstructure**OSM Arrival Time:** 700**Prime Contractor:** American Bridge/Fluor Enterprises, a JV**OSM Departure Time:** 1530**Contractor:** American Bridge/Fluor Enterprises, a JV**Location:** Job Site

**Tower Skirt Ring Beam**

**ESW Weld Repair "Q"**

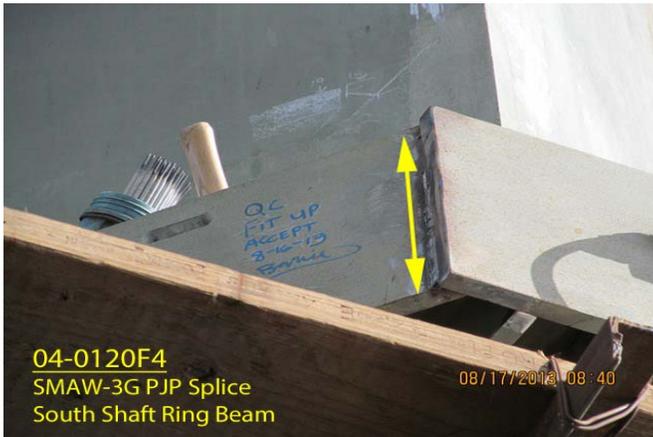
The QAI periodically observed ABF welding personnel Gao Wu Chin utilizing the Shielded Metal Arc Welding (SMAW) process in the vertical (3G) position with Atom Arc E7018-1 HR4, 1/8" diameter electrode to begin welding the various weld joints on the corner of the South shaft. The weld joints are identified as a Complete Joint Penetration (CJP) skewed tee joint, single bevel Partial Joint Penetration (PJP) skewed and vertical fillet welds (weld #167, #168, #169). The fit up was visually accepted by Bernie Docena and verified by the QAI Joe Adame on Friday (8/16/2013). As welding continued the QAI verified welding amperage at approximately 128 amperes. Several verifications of this reading were made throughout the day with similar readings. The Welding Procedure Specification (WPS) designated for this work is identified as ABF-WPS-D1.5-1020, Rev1, ABF-WPS-D1.5-F1201A and ABF-D1.5-1160. QC Inspector Bernie Docena was observed monitoring the work at this location on this date.

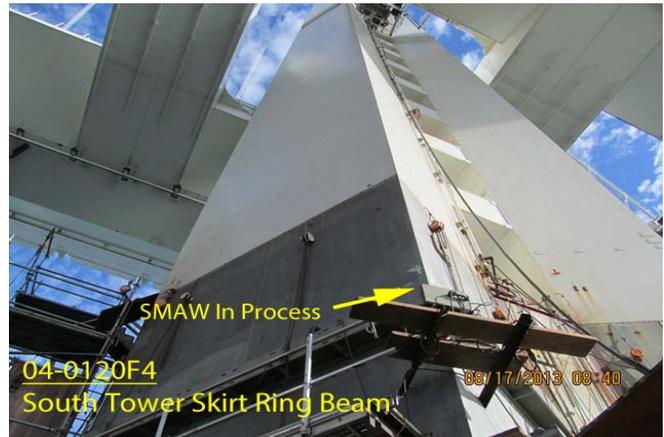
The QAI periodically observed ABF welding personnel Donald Plumb utilizing the Shielded Metal Arc Welding (SMAW) process in the vertical (3G) position with Atom Arc E7018-1 H4R, 5/32" diameter electrode to weld excavation for a weld repair. The welding is taking place on the exterior (east) side at joint Q, weld #E-043 on Face A side for a repair designated as 201308-003. Excavation dimensions are noted as Y=3390mm-3760mm,

Length=370mm, Width=70mm, Depth=55mm. The welder was observed applying filler passes on this date. The QAI observed the interpass temperature was maintained at approximately 410 degrees Fahrenheit with electric heating coil blankets through a heat induction system. As welding continued the QAI periodically verified welding amperage at approximately 130 amperes. Several verifications of this reading were made throughout the day with similar readings. The Welding Procedure Specification (WPS) designated for this repair was identified as ABF-WPS-D1.5-1000Repair, Rev.3. QC Inspector Bernie Docena was monitoring the progress of this repair on this date.
