DEPARTMENT OF TRANSPORTATION

Quality Assurance and Source Inspection

Contract #: 04-0120F4Cty: SF/ALA Rte: 80 PM: 13.2/13.9File #: 1.28**WELDING INSPECTION REPORT****Resident Engineer:** Casey, William**Address:** 333 Burma Road**City:** Oakland, CA 94607**Report No:** WIR-030061**Date Inspected:** 19-Sep-2013**Project Name:** SAS Superstructure**OSM Arrival Time:** 700**Prime Contractor:** American Bridge/Fluor Enterprises, a JV**OSM Departure Time:** 1530**Contractor:** American Bridge/Fluor Enterprises, a JV**Location:** Job Site**CWI Name:****CWI Present:** Yes No**Inspected CWI report:** Yes No N/A**Rod Oven in Use:** Yes No N/A**Electrode to specification:** Yes No N/A**Weld Procedures Followed:** Yes No N/A**Qualified Welders:** Yes No N/A**Verified Joint Fit-up:** Yes No N/A**Approved Drawings:** Yes No N/A**Approved WPS:** Yes No N/A**Delayed / Cancelled:** Yes No N/A**Bridge No:** 34-0006**Component:** SAS Tower Head**Summary of Items Observed:**

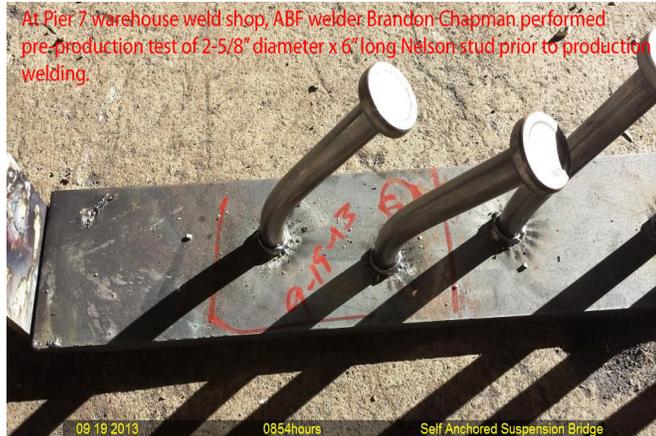
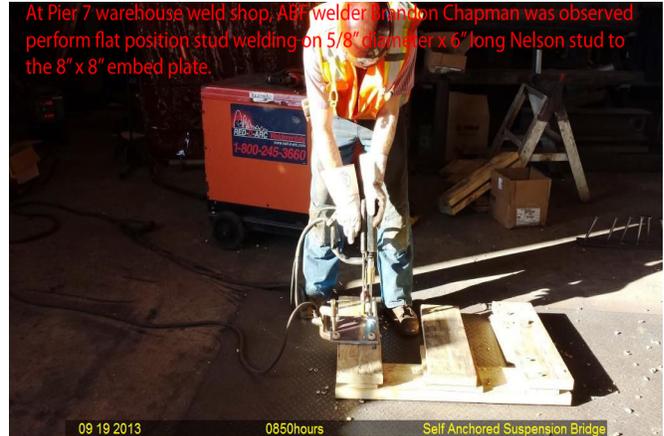
At Pier 7 warehouse weld shop, QA randomly observed ABF welder Brandon Chapman continuing to perform flat position stud welding on 5/8" diameter x 6" long stud to the top side of 8" x 8" x 1/2" thick embed plates per Contract Change Order #CCO 331 and ABF shop drawing #CCO331-X-01. The welder has stud welded two (2) pre-production welds then bent to 30 degrees. After welding, ABF QC Salvador Merino inspected the diameter of the welds for 360 degree all around flash. This QA also performed visual verification on the flash of the stud welds and noted same results. The welder then bent tested the test studs to 30 degree using a 10 pounds sledge hammer and noted acceptable results. The welder started the production stud welding as soon as the pre-production test was completed. During the shift, the welder has completed stud welding 4- 5/8" diameter x 6" long Nelson studs on each of the 32 embed plates.
