DEPARTMENT OF TRANSPORTATION

Contract #: 04-0120F4Cty: SF/ALA Rte: 80 PM: 13.2/13.9File #: 99.28**WELDING INSPECTION REPORT****Resident Engineer:** Casey, William**Address:** 333 Burma Road**City:** Oakland, CA 94607**Report No:** WIR-030070**Date Inspected:** 21-Sep-2013**Project Name:** SAS Superstructure**OSM Arrival Time:** 700**Prime Contractor:** American Bridge/Fluor Enterprises, a JV**OSM Departure Time:** 1730**Contractor:** American Bridge/Fluor Enterprises, a JV**Location:** Job Site**CWI Name:** Scott Kortum, Tony Sherwood**CWI Present:** Yes No**Inspected CWI report:** Yes No N/A**Rod Oven in Use:** Yes No N/A**Electrode to specification:** Yes No N/A**Weld Procedures Followed:** Yes No N/A**Qualified Welders:** Yes No N/A**Verified Joint Fit-up:** Yes No N/A**Approved Drawings:** Yes No N/A**Approved WPS:** Yes No N/A**Delayed / Cancelled:** Yes No N/A**Bridge No:** 34-0006**Component:** SAS Tower**Summary of Items Observed:**

Tower Skirt: In Process Welding, Skirt Plate #2, Welds At Jt's #154 North Shaft, #157 East Shaft

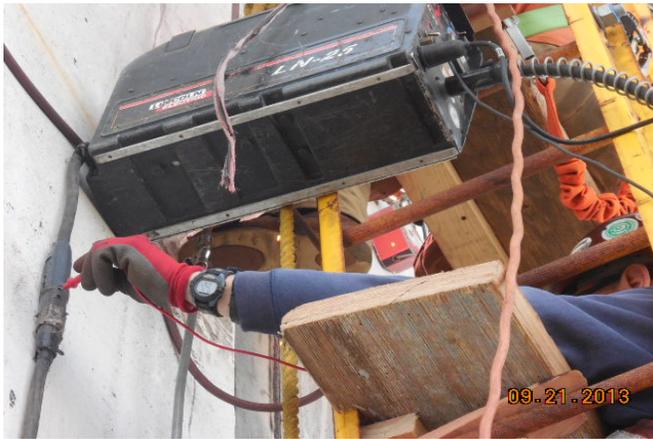
- The weld joint fit-up and alignment was checked with a straight edge and bridge cam gauge.
- Pre-heat was performed with a rosebud torch and verified by QC with temperature stick (200°F).
- Welding was performed by approved welders (Kit Li, Rick Clayborn).
- Electrical parameter check results for Kit Li (20.5 volts / 270 amps) and Rick Clayborn (20.0 volts / 270 amps).
- The weld procedure and joint details utilized (FWT21) are for a partial joint penetration (PJP) weld.
- Electrode utilized is FCAW NR-232, .072" diameter.
- Weld passes were de-slagged by grinder and wire wheel.

QC checking amps/volts of in process welding.

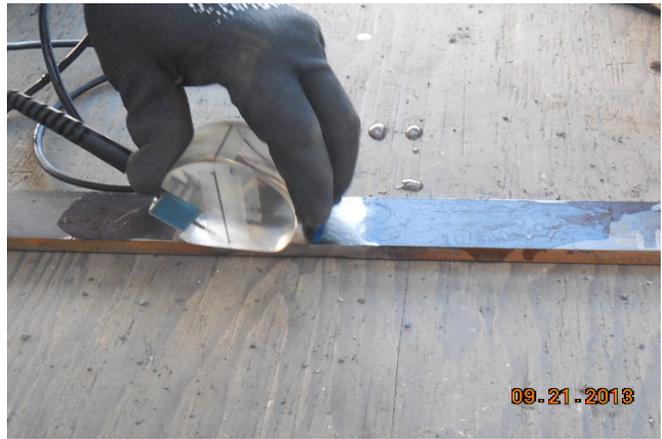
Prior to installation of backing bar at weld Jt #153 East Shaft. ABF personnel installed one CJP splice weld joining backing bar plate (9mm x 38mm), making the backing plate continuous. The CJP splice weld was back gouged and back welded. The front and back surfaces of weld were ground to flush and smooth contour. QA Inspector witnessed QC Inspector performed UT examination of backing bar splice weld. Test results are in general compliance.

QC UT of backing bar CJP splice.
