Contract #: 04-0120F4Cty: SF/ALA Rte: 80 PM: 13.2/13.9File #: 99.28**WELDING INSPECTION REPORT**

Report No: WIR-030080
Date Inspected: 27-Sep-2013

Project Name: SAS Superstructure **OSM Arrival Time:** 700
Prime Contractor: American Bridge/Fluor Enterprises, a JV **OSM Departure Time:** 1730
Contractor: American Bridge/Fluor Enterprises, a JV **Location:** Job Site

CWI Name:	Tony Sherwood, Bernie Docena			CWI Present:	Yes	No	
Inspected CWI report:	Yes	No	N/A	Rod Oven in Use:	Yes	No	N/A
Electrode to specification:	Yes	No	N/A	Weld Procedures Followed:	Yes	No	N/A
Qualified Welders:	Yes	No	N/A	Verified Joint Fit-up:	Yes	No	N/A
Approved Drawings:	Yes	No	N/A	Approved WPS:	Yes	No	N/A
				Delayed / Cancelled:	Yes	No	N/A
Bridge No:	34-0006			Component:	SAS Tower

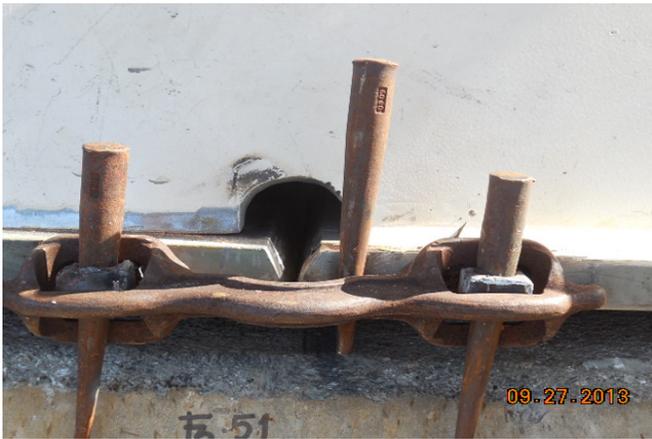
Tower Skirt: In Process Welds, Skirt Base Plate At Jt's #004 & #002, Skirt Plate #2 #156 S. Shaft
ABF personnel continued fit-up and welding of joints #002 CJP and #156 PJP splice weld noted above. Weld #004 was completed at 1000 hours. WPS #ABF-WPS-D15-2030-1 and ABF-D15-2140-3 for flux core arc welding (FCAW) was utilized by QC Inspectors. ABF personnel installed backing bar plate (9mm x 38mm) at base plate, and QC Inspector verified fit-up complied with specified tolerance. Approved welder installed stringer passes and operated welding equipment within WPS electrical parameters. Be advised that the backing bar for this joint will remain in place, in accordance with RFI# ABF-RFI-003417R00.

Dog & pin wedges utilized to fit-up skirt base pl.

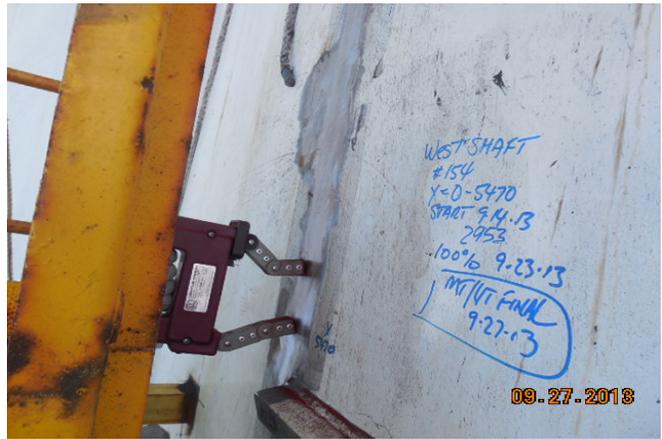
Weld crowns were ground to a flush smooth contour. After 24 hour hold period, QC Inspector performed VT and MT on approximately 25% of PJP exterior weld surface, QC test results are acceptable. QA Inspector witnessed QC Inspector magnetic particle testing (MT) the root pass of CJP weld #002 noted above. QA Inspector performed verification MT on 10% of QC inspected areas, QA test results comply with project specifications.

QA observation of QC 25% MT of 3G skirt splice.
