Contract #: 04-0120F4Cty: SF/ALA Rte: 80 PM: 13.2/13.9File #: 1.28**WELDING INSPECTION REPORT**

Report No: WIR-030105
Date Inspected: 04-Oct-2013

Project Name: SAS Superstructure
Prime Contractor: American Bridge/Fluor Enterprises, a JV
Contractor: American Bridge/Fluor Enterprises, a JV

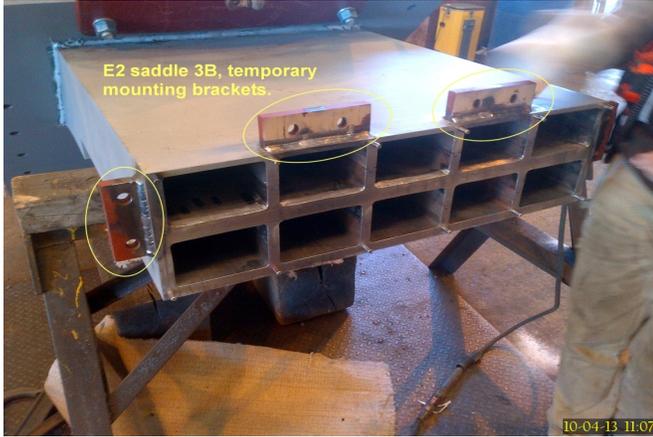
The QAI was informed by the Quality Control Inspector (QCI) Salvador Merino, that E2 retrofit saddle S3B is at the pier 7 warehouse. The QAI noted that the (4) temporary mounting brackets have been fillet welded and will be inspected. The QAI witnessed the QCI conducting Magnetic Particle Testing (MT) on the completed fillet welds. The QAI was informed that the welds were acceptable. The QAI conducted a visual examination of the welds and noted that they appeared to be conforming to the contract requirements. The QAI was informed that Richard Garcia had made the welds earlier today but this work was not witnessed or verified by the QAI, as there had been no notification that this work was being performed. See the attached photo.
