Analysis and Design of Wire Mesh/Cable Net Slope Protection

Final Report

Report No. CA05-0222

April 2005

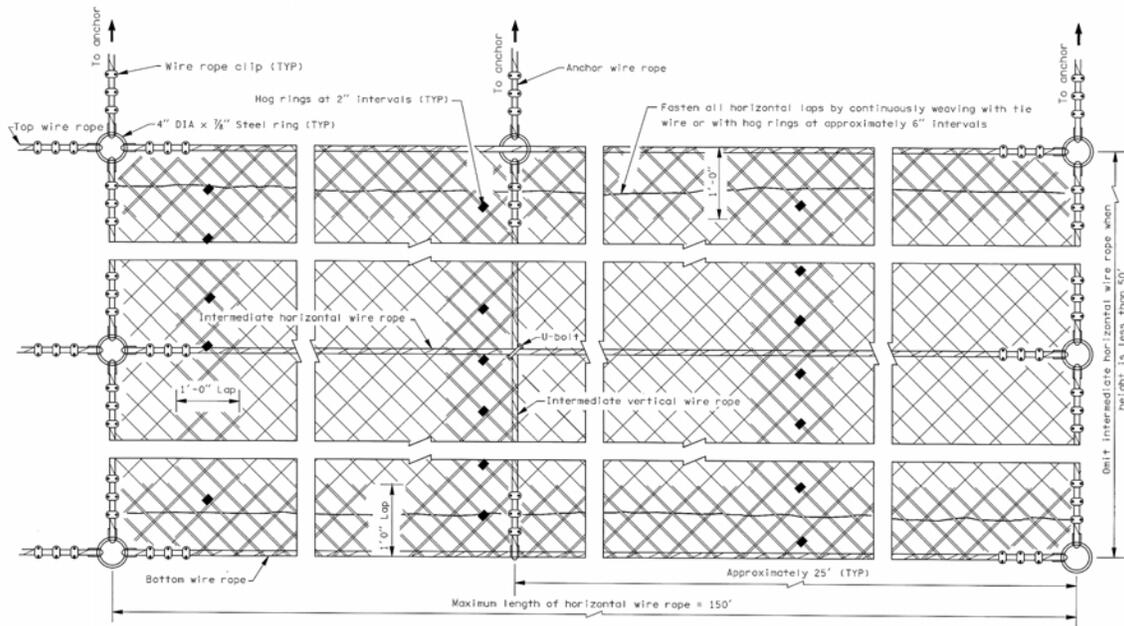
Figure 1-1. Schematic drawing shows basic elements of a drape mesh system.

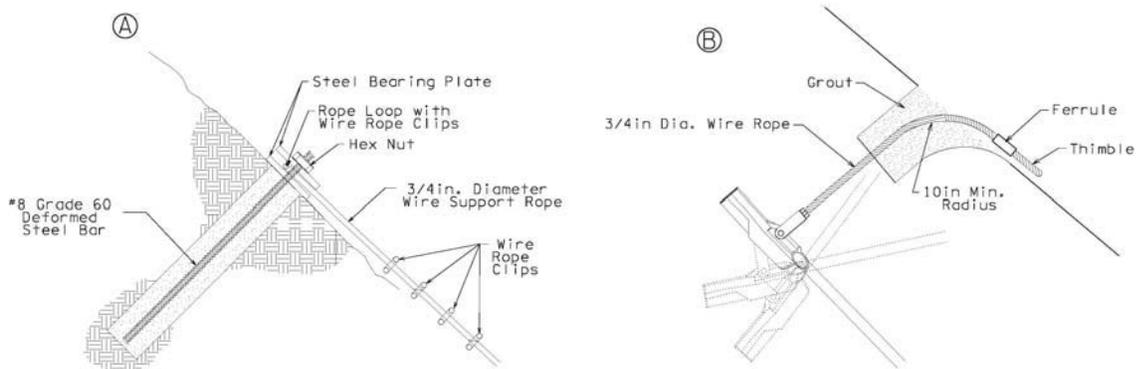
Figure 1-2. Typical rock anchors include (A) deformed steel threaded bar, and (B) a wire rope tendon.

Anchors can be grouped into those for intact rock or soil conditions. Rock anchors most commonly consist of a solid core, deformed steel, continuously threaded bar (Figure 1-2A) or, more recently, a wire rope tendon (Figure 1-2B) placed in a fully grouted hole. Some of the more common soil anchors include deadman-type, wire rope tendons, driven and/or grouted steel bars, hollow core drillable-groutable bars (Figure 1-3A), and MANTA RAY[®] (Figure 1-3B) anchors.

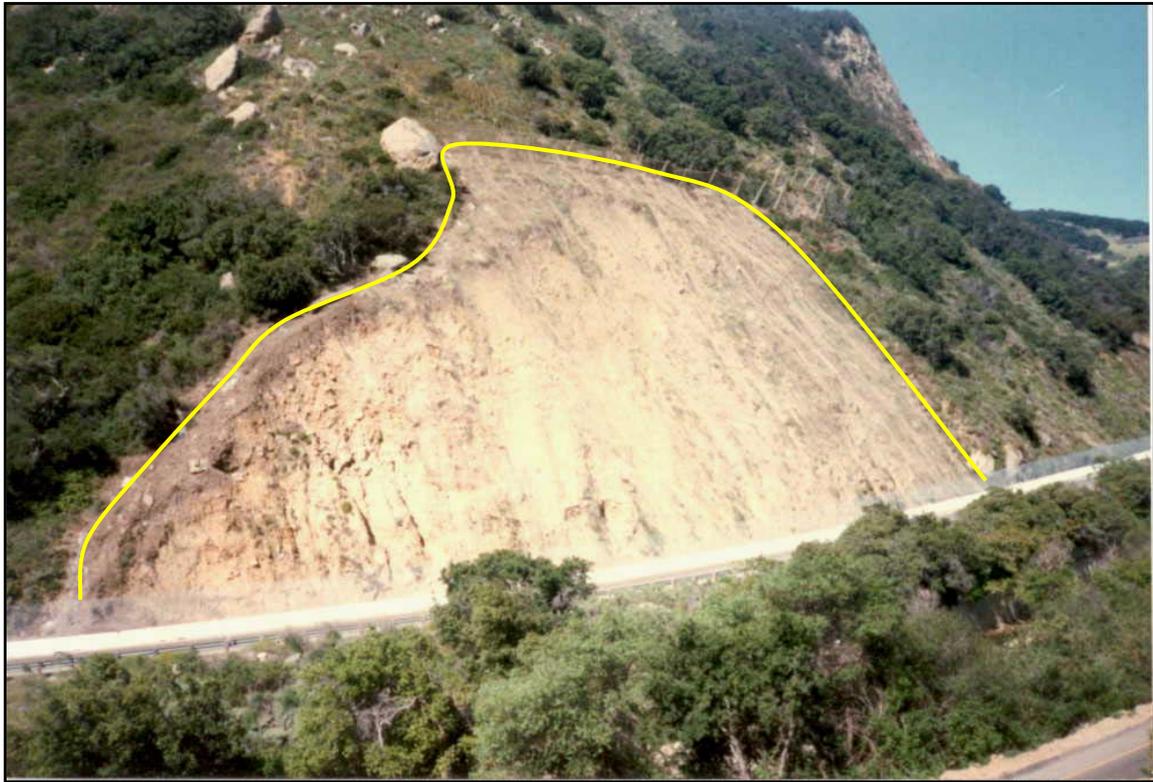
Figure 2-1. Slope condition before mesh installation; yellow line delineates coverage area

The Gaviota Pass site is located on California State Highway 101 between mileposts (MP) 46.80 and 47.90 in Santa Barbara County. Situated within the Santa Ynez Mountains, the Gaviota Pass is a steeply incised canyon of the Gaviota Creek drainage. The northbound and southbound lanes of Highway 101 are on opposite sides of the Gaviota Creek at an approximate elevation 200 feet. Steep slopes bound the roadway corridor, with the highest elevations above 3000 feet. Short duration, high intensity rains are common during the winter months, sometimes resulting in 3 to 5 inches per event, and high winds with gusts of up to 50 mph are common during the summer months. The rockfall that affects the highway primarily develops in the lower portion of the canyon, predominantly within the cut slopes (Figure 2-1). The cut slopes comprise Gaviota Sandstone, Holocene colluvium, and Quaternary landslide deposits. The cut slopes were designed with midslope benches and slope ratios from near vertical to 0.5H:1V. Rockfalls develop in the landslide and colluvial deposits as the result of differential erosion. Within the sandstone, rockfalls develop as planar and wedge rock block failures. In addition, the midslope benches gradually fail and fill with debris, creating rock-launching ramps. Small-scale rockslides, debris flows, and debris avalanches occur occasionally. Although some rockfall catchment area is available at the base of the slope, rockfalls 1 to 2 feet in dimension have reached the roadway.

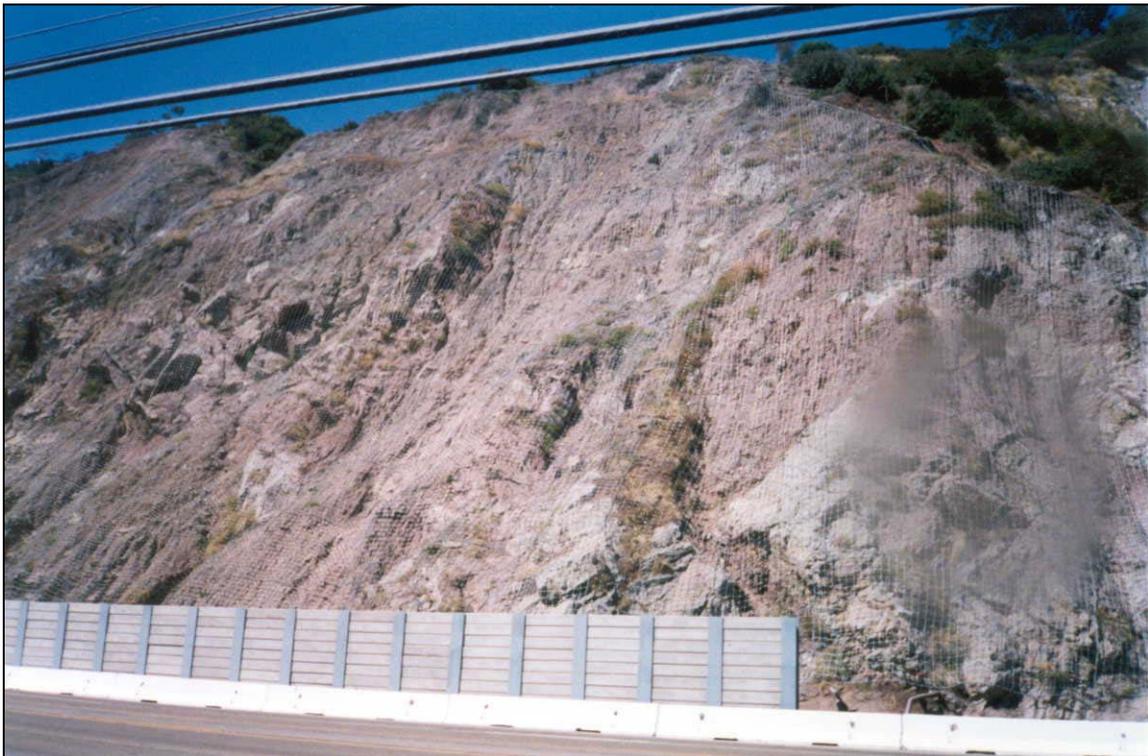
Figure 2-2. Slope condition after the slope was covered with a cable net.

small-scale slope instabilities such as rockslides, debris flows, and debris avalanches (Figure 2-2). The material consists of fractured sandstone overlain by Quaternary landslide deposits (angular fragments of sandstone, gravel, and silt). The slide is active and creeps during wet periods. The cut slopes have slope ratios of from near vertical to 1H:1V. Although some catchment area is available, rockfalls 3 to 6 feet in dimension, and small debris flows and rockslides 25 cubic yards in size have reached the roadway.

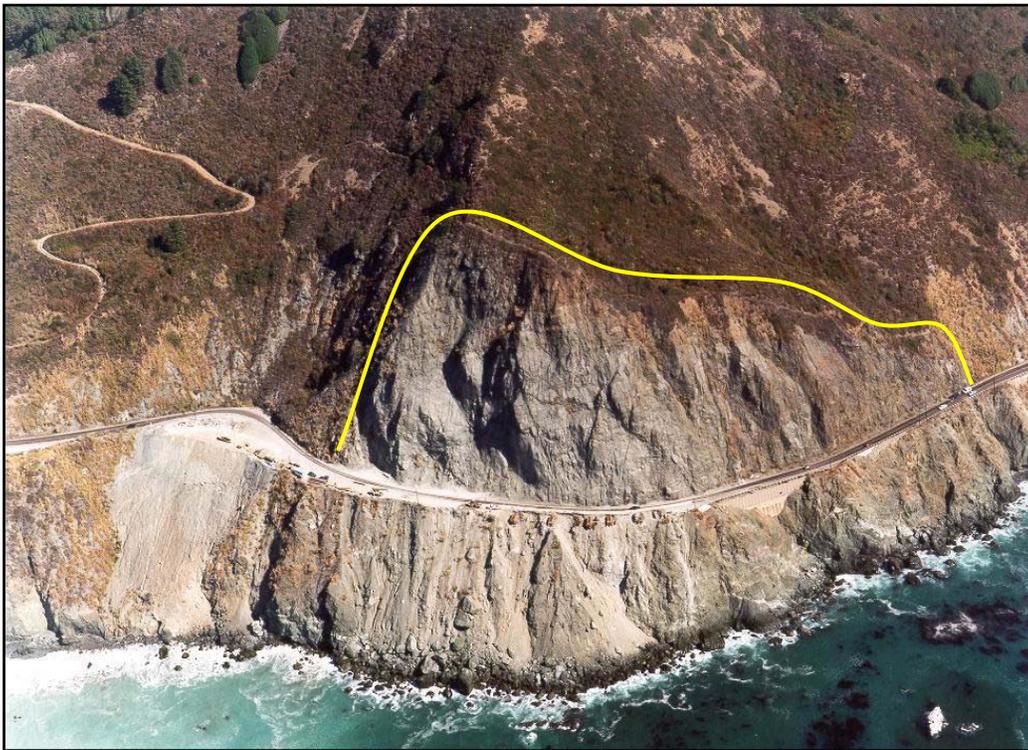
Figure 2-3. Slope condition after the mesh installation (yellow line) at Rain Rocks site.

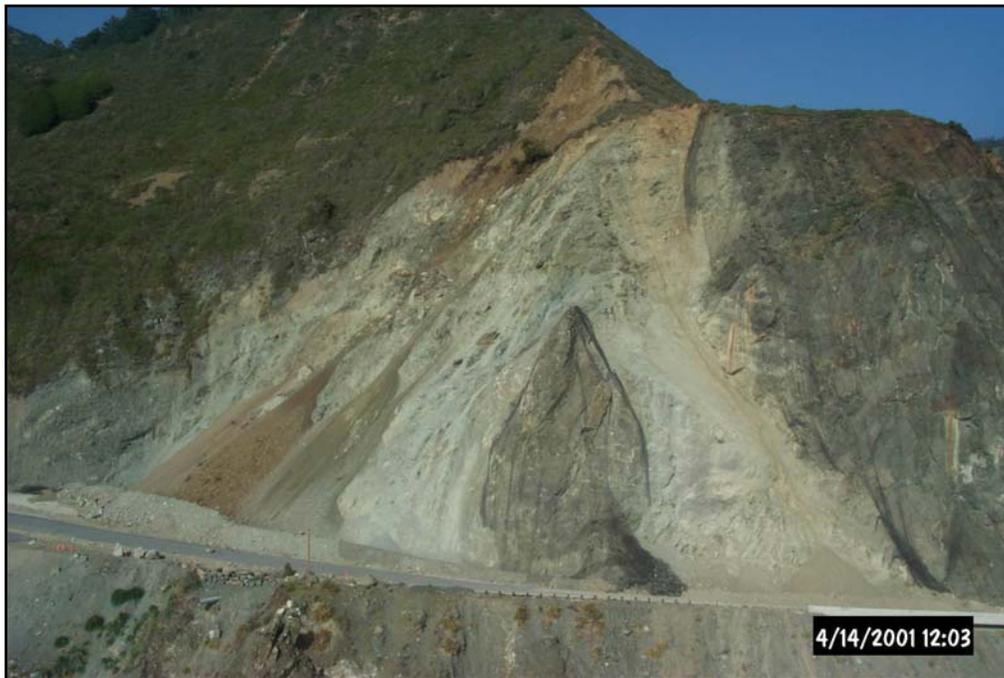
Figure 2-4. Slope condition after slope instabilities destroyed the hexagonal wire mesh installation at Pitkins Curve adjacent to Rain Rocks chute.

A small portion of the Pitkins Curve section extended into the original Rain Rocks installation. A small (500-cubic-yard) rockslide tore down the hexagonal wire mesh at the northern end, ripping the mesh from the infrastructure while the infrastructure stayed intact (Figure 2-4). Subsequent instabilities eventually undermined the infrastructure to failure. Again, the anchors and infrastructure were not damaged until the anchors were undermined. Within the slide scarp, a rock chute developed from which 3-foot-diameter rockfalls were regularly affecting the roadway. To mitigate this problem, the chute was covered with 7200 square feet of cable nets.

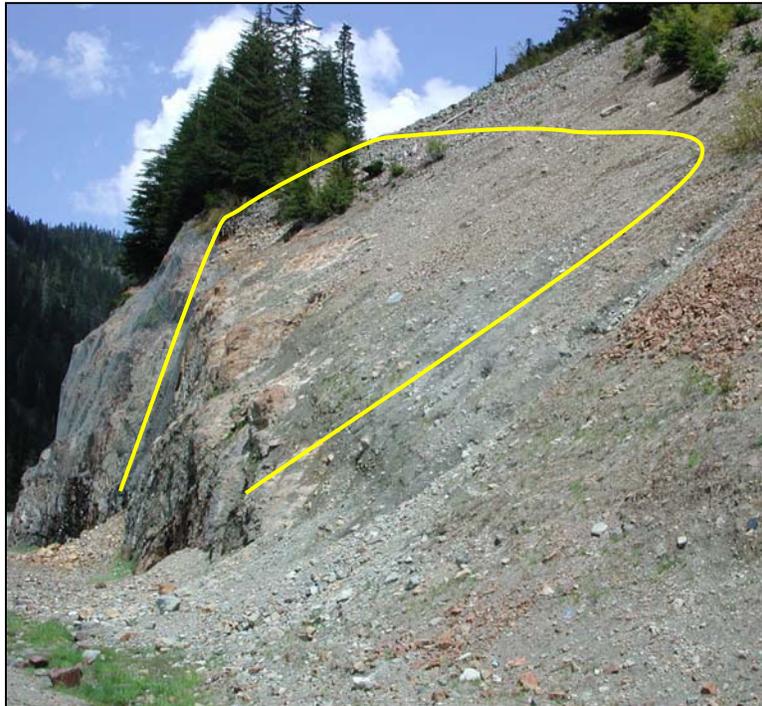
Figure 2-5. Slope configuration for the western portion of the 1998 cable net installation (yellow line). Extreme snow loads during the winter of 1998/99 caused most of the cable net anchors located along the top of the installation to fail.

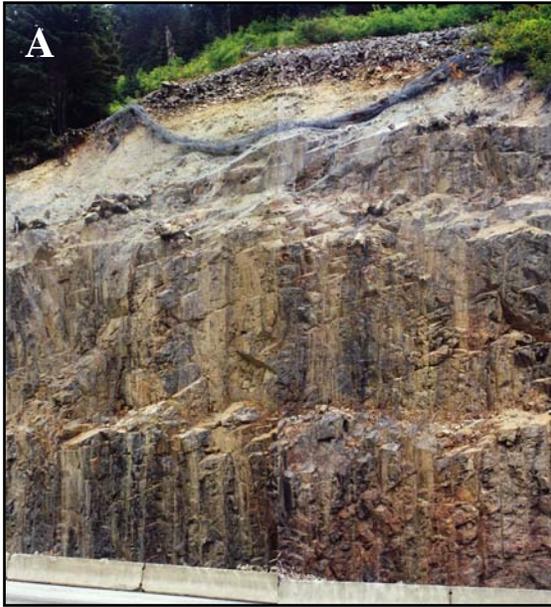
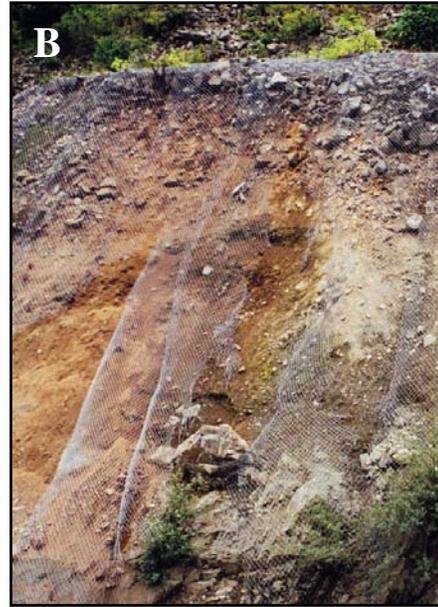
Figure 2-6A. Failure in the eastern portion of the 1982 chainlink installation. Active erosion undermined the top row of anchors. Pockets of debris accumulated along intermediate support ropes. Figure 2-6B shows localized rupture by a 3- to 4-foot-diameter boulder that initiated from the bouldery talus shown at the top of photograph.

By the mid-1990s, the eastern portion of the initial chainlink installation was in very poor condition (figures 2-6A and 2-6B). Erosion had exposed many midslope and top anchors. Debris accumulation behind the support ropes and large boulders had caused extensive punctures and ruptures of the system.

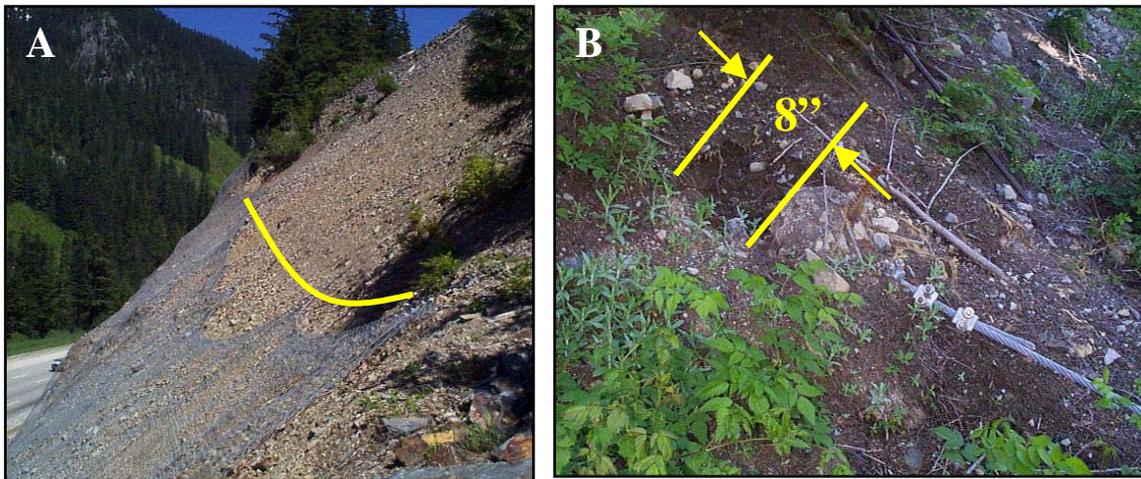
Figure 2-7A. Failure of the cable net system in the western portion of the site in July 1999. The yellow line is the approximate location of the top of the cable nets as installed in 1998. **Figure 2-7B** shows deformation of the ground where loads exceeded passive earth pressure, causing 8 inches of anchor deflection.

anchors, causing severe ground deformation (figures 2-7A and 2-7B). The ultimate capacity of the anchors in shear was around 35,000 lbs. Slightly lower-than-design grout strengths and difficulties with grouting in the cobbles and boulders often void of matrix may have contributed to the anchors failing in pullout. Some of the anchors where passive earth pressures were exceeded had been installed vertically, rather than normal to slope, resulting in diminished capacity.

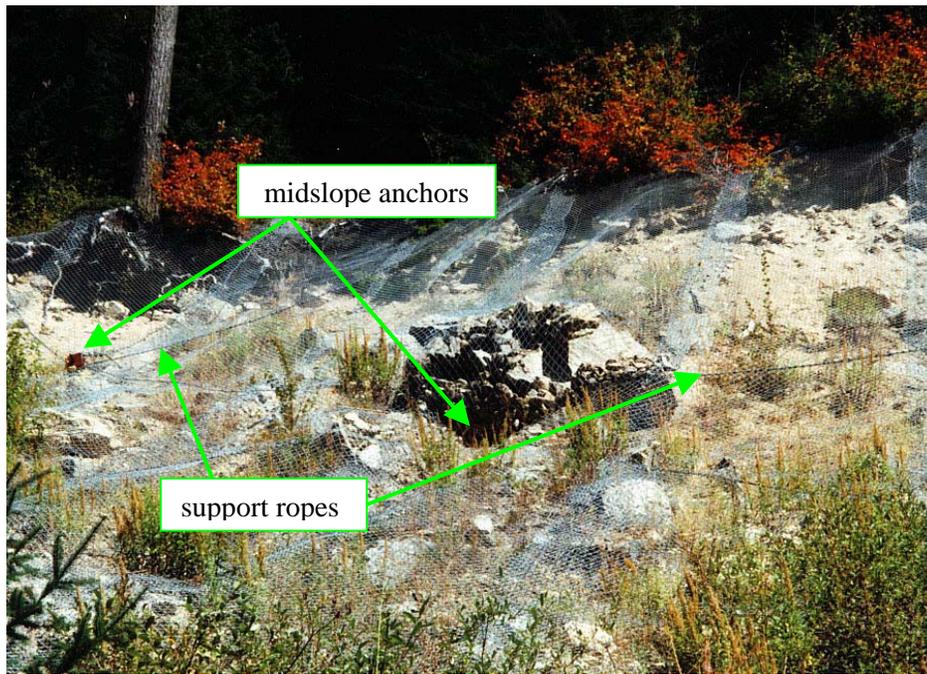
Figure 2-9. Note the large accumulation of debris at the juncture of the underlying support ropes and the midslope anchor.

After several decades of severe slope erosion and heavy snow loads, the eastern half of the first installation was badly damaged. Many seams in the chainlink had split, and localized rupture and puncture had occurred in numerous locations near the base of the installation. Support ropes also trapped large quantities of rock debris, imparting significant debris loading on the system (Figure 2-9).

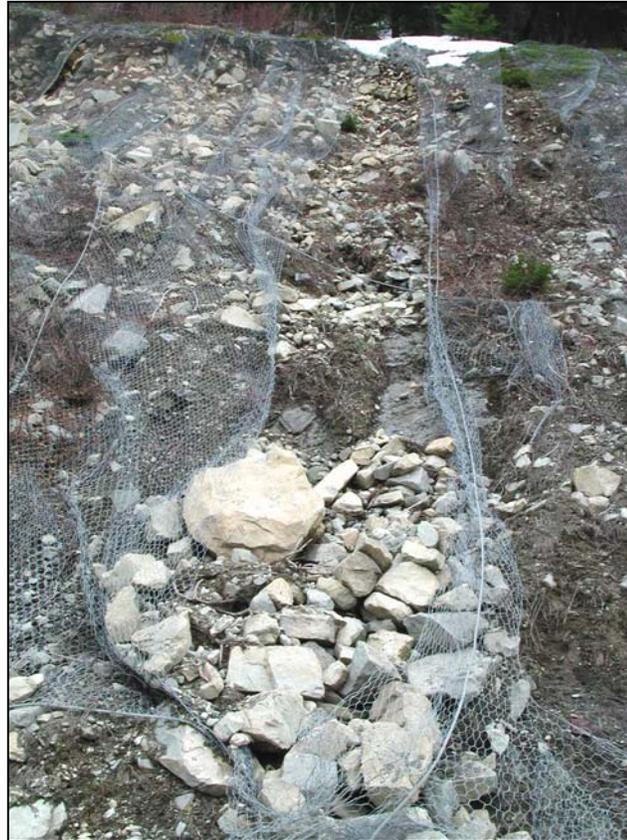
Figure 2-10. Rupture of the vertical seam and fabric; the midslope horizontal support cable was also damaged. The volume of debris associated with mesh failure is estimated to be 10 cubic yards, with block sizes of up to 3.5 feet in dimension.

Significant damage has occurred to the section that was replaced in 1998 with hexagonal wire mesh. While a different configuration of support ropes was placed on top of the mesh to better pass debris, a large quantity of debris has still accumulated beneath the lower half of the mesh (Figure 2-10).

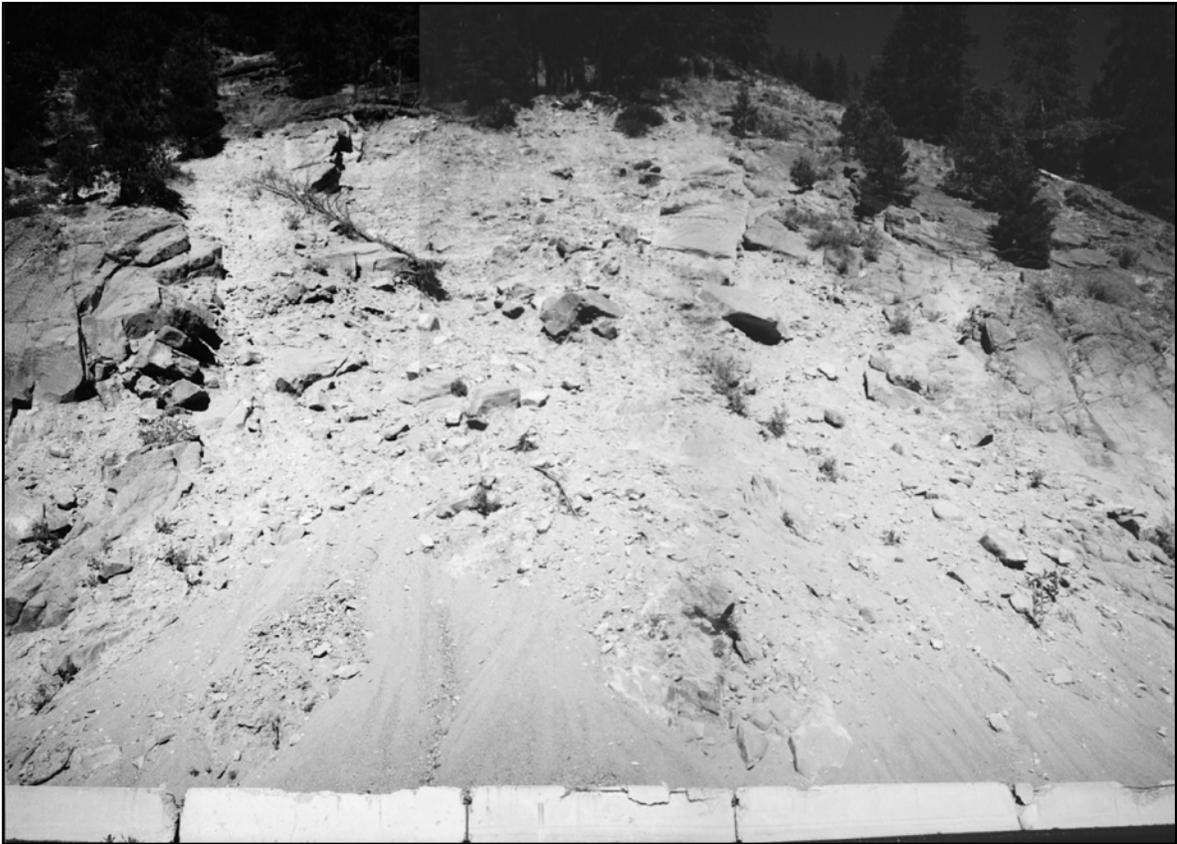
Figure 2-11. Slope condition before cable net installation; note the rockfall-related damage to the concrete barrier.

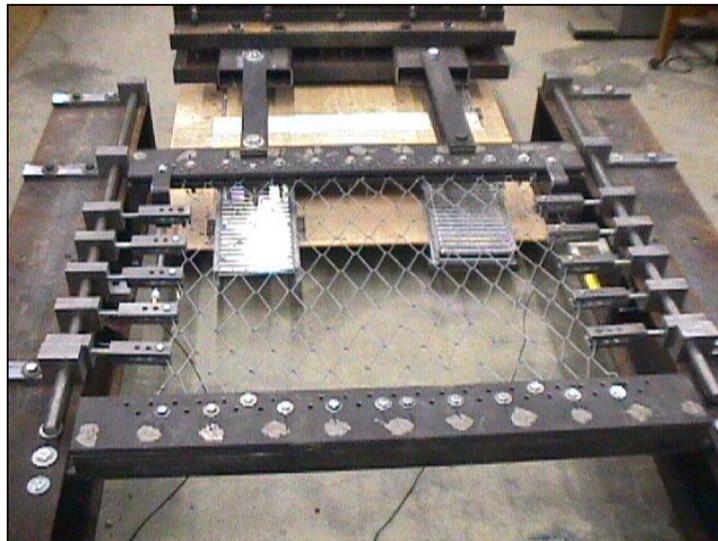
Figure 3.1. Testing apparatus with TECCO[®] mesh.

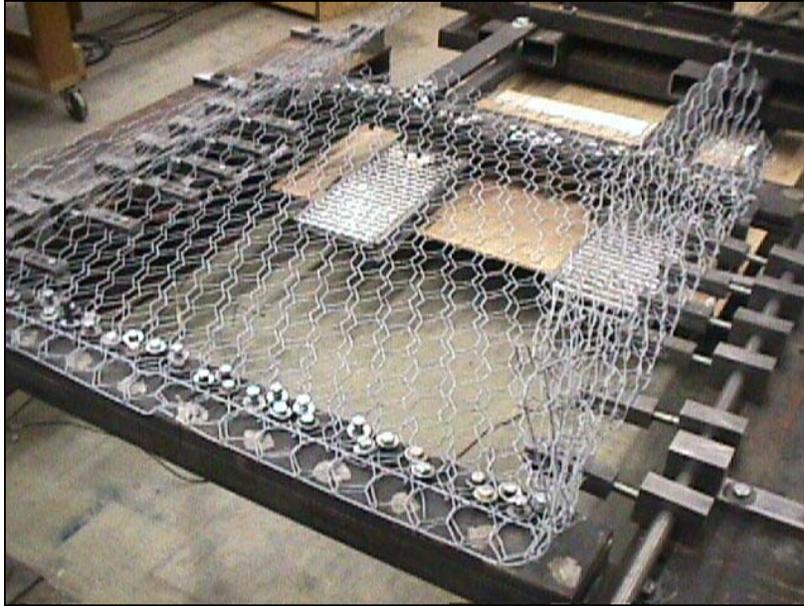
Figure 3-2. Setup for *Mac Double Galv1* mesh with bolts extended above the loading plates.

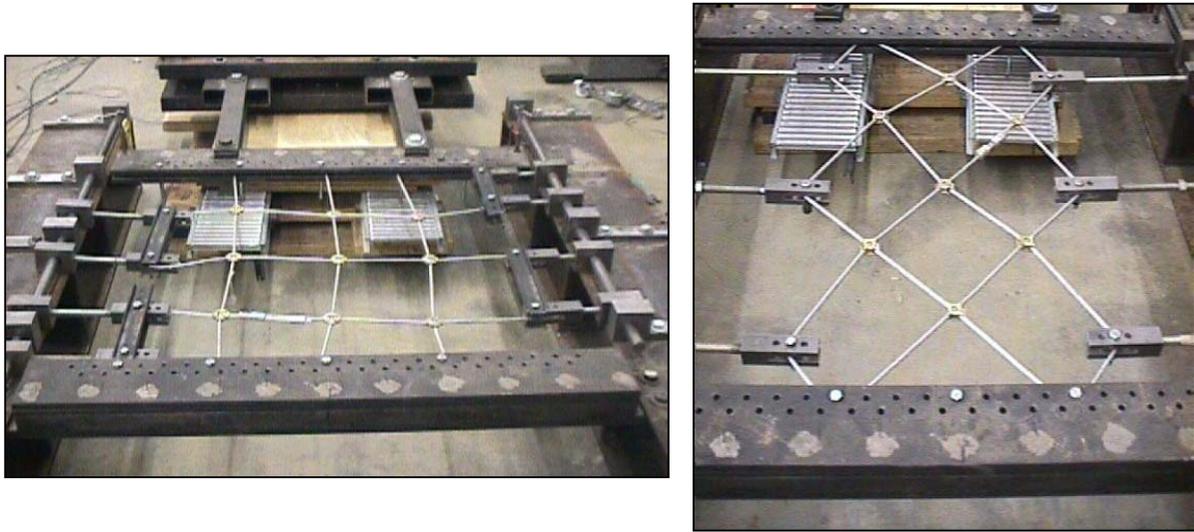
Figure 3-3. Setup for (A) Geobrug square grid cable net and (B) Geobrug diagonal grid cable net.

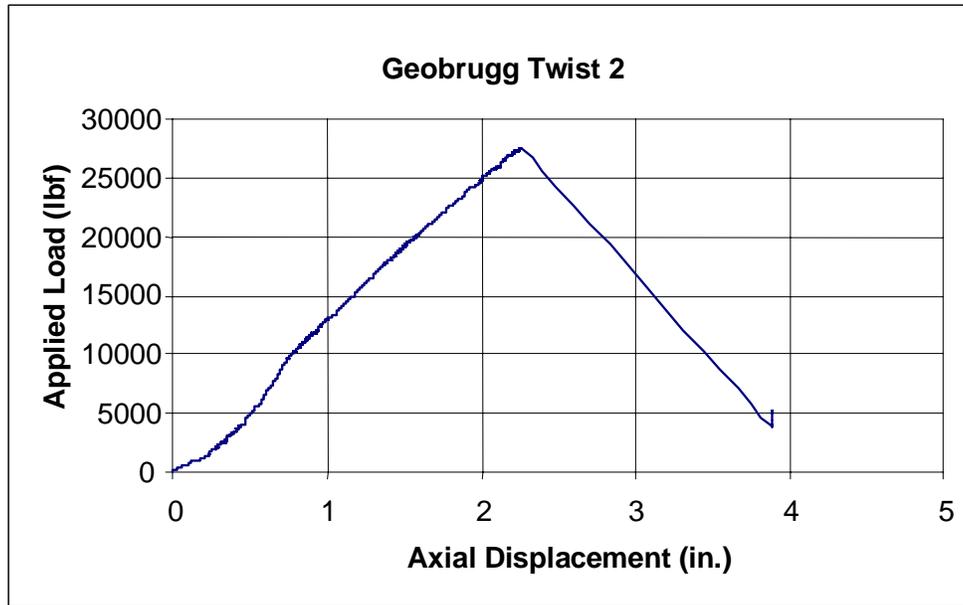
Figure 3-5. A load versus displacement graph for determining elastic modulus is shown for the TECCO® mesh.

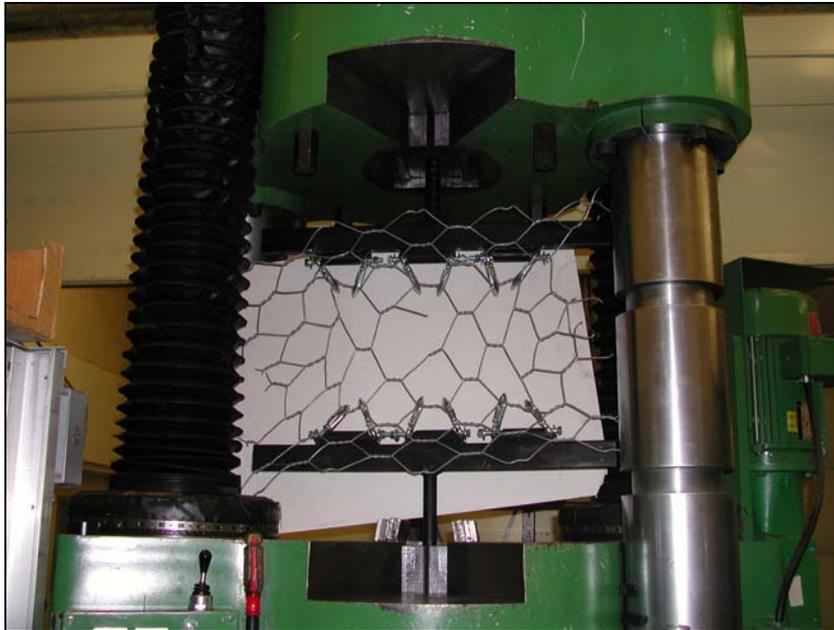
Figure 3-7. Testing/clamping apparatus and failed specimen of bulk material (no seam).

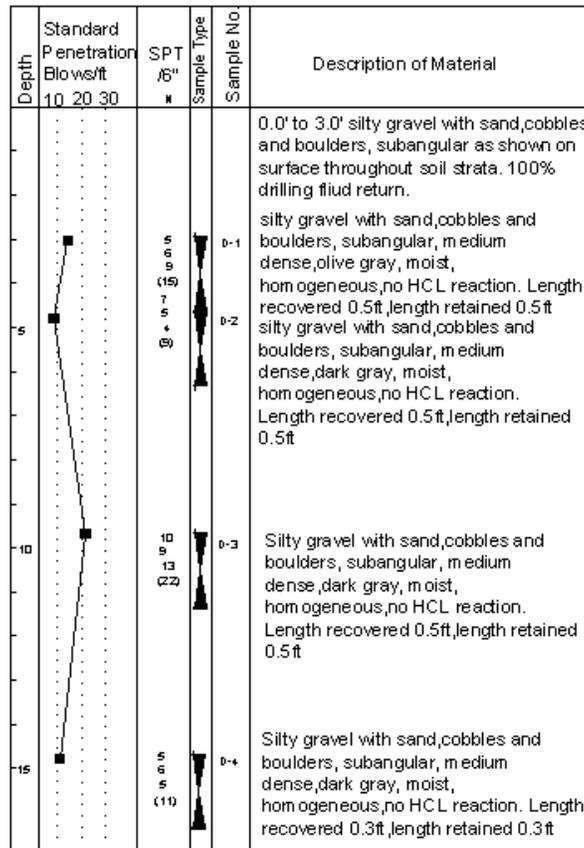
Figure 3-11. A boring log depicts the subsurface conditions in which the anchors were founded. The depths are recorded in feet.

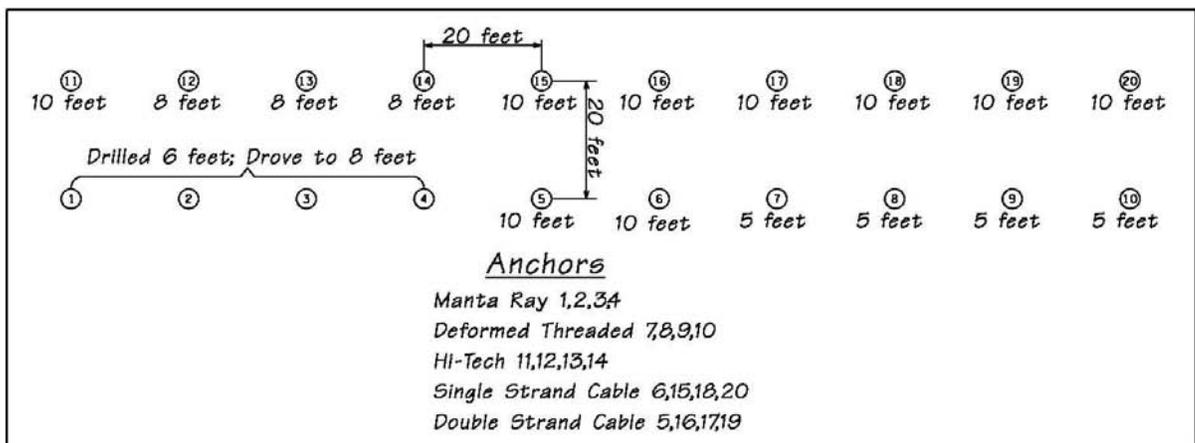
Figure 3-12. Layout of anchors and the depths to which they were installed.

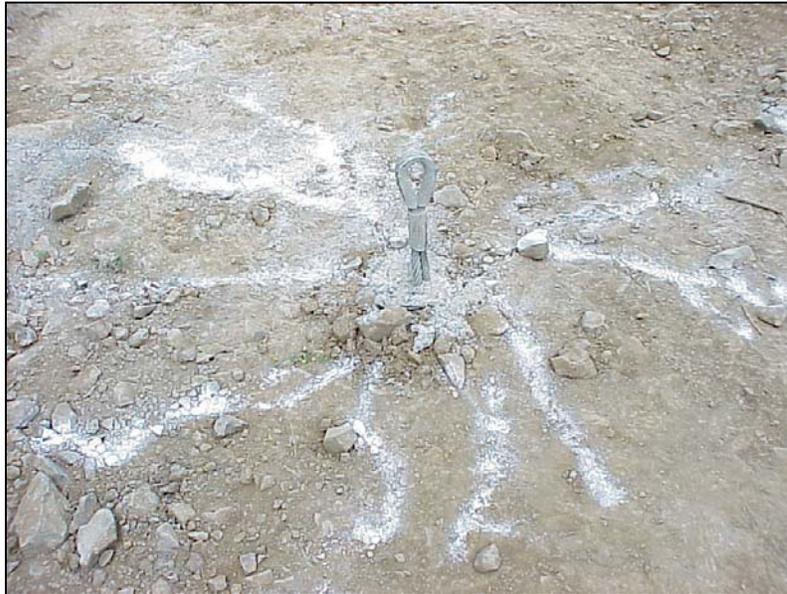
Figure 3-18. Ground cracking (white painted lines) that developed around Anchor 17 (double cable anchor) during vertical loading.

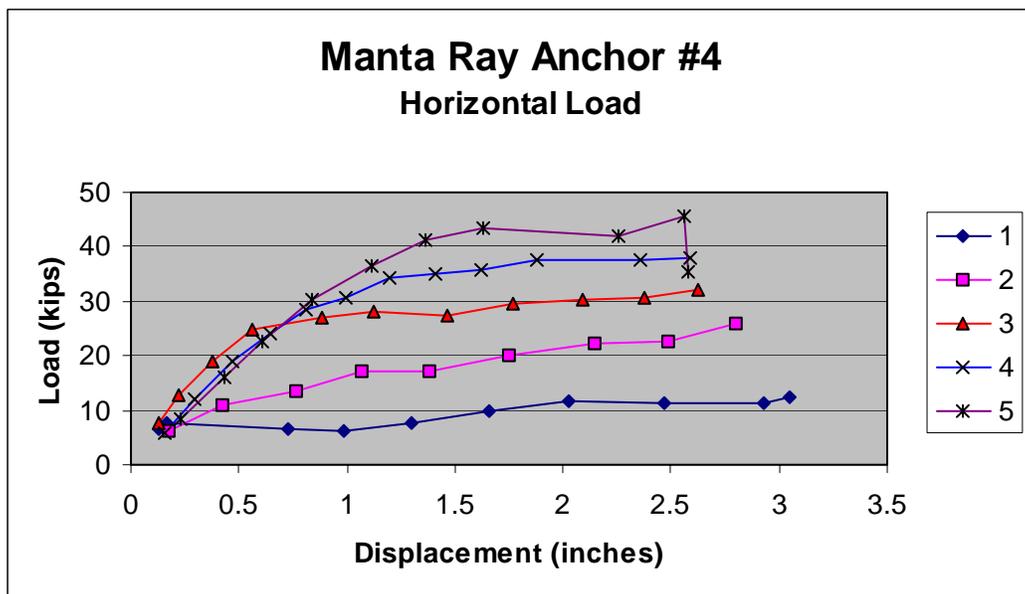
Figure 3-19. Load-displacement plot for horizontal test of a Manta Ray[®] anchor (#4).

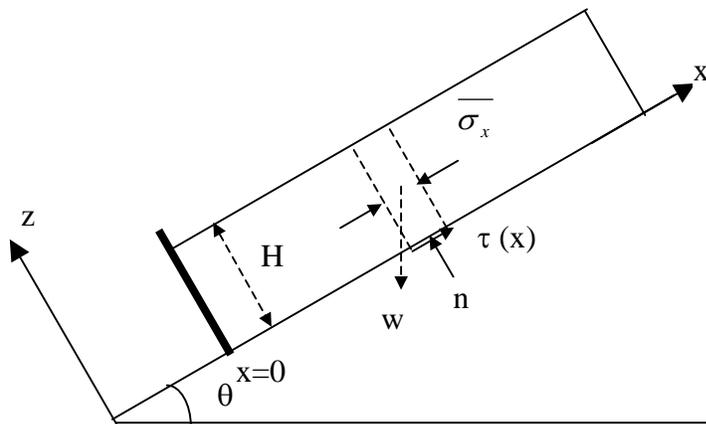
Figure 4-1. Stress components of snowpack upslope of an avalanche structure.

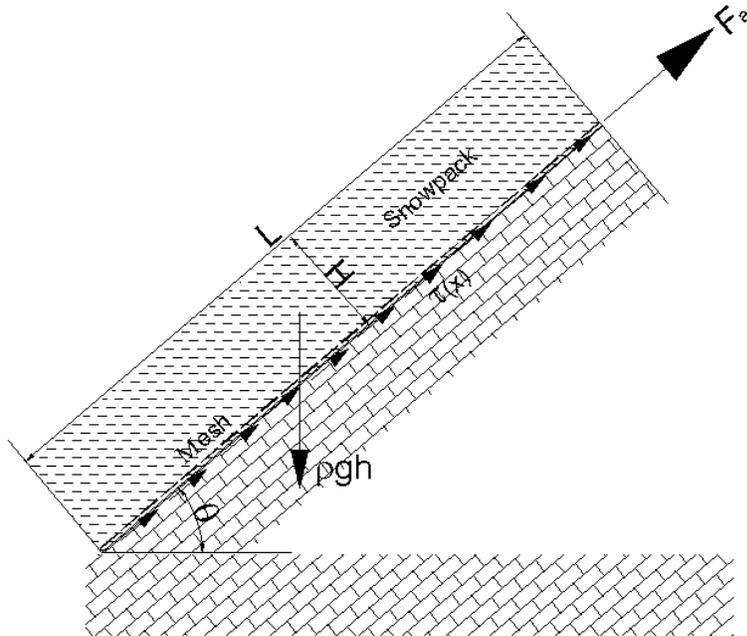
Figure 4-3: The force components of the mesh and snowpack when the snow is bonded to both to the mesh and ground. F_a is the drag force on the anchors for a section of mesh L in length.

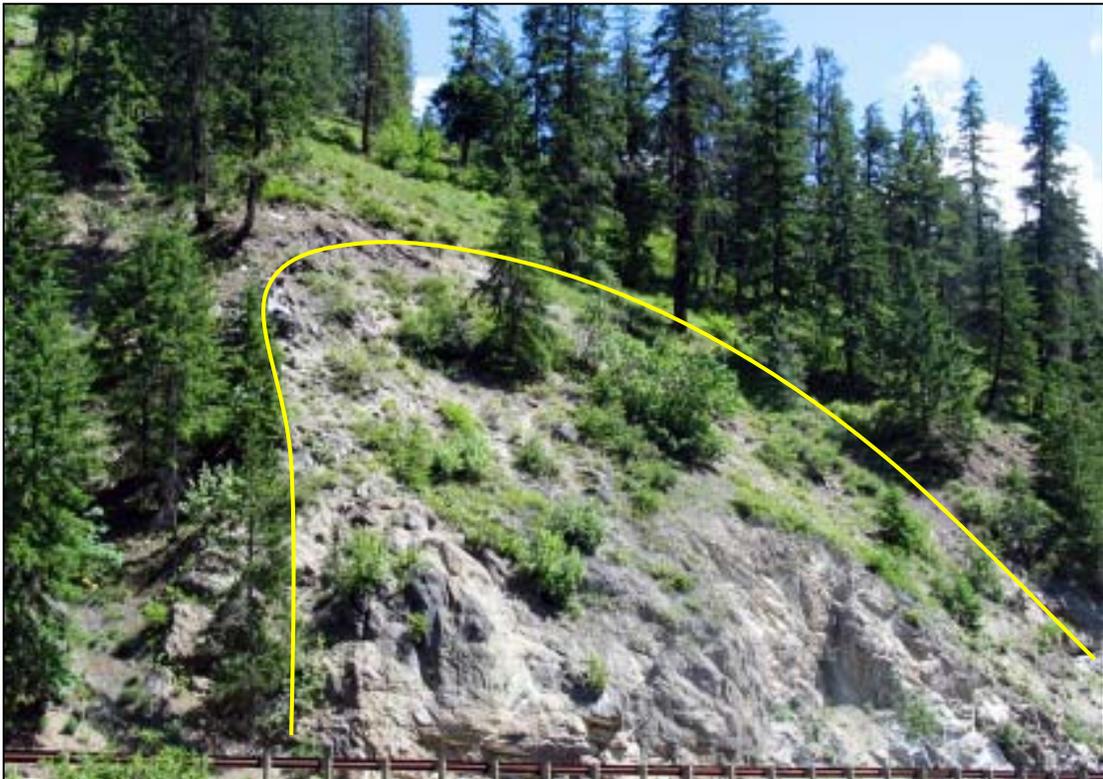
Figure 4-6: Mesh installation (yellow line) on a planar and relatively smooth slope segment upslope of the steep bedrock exposures at roadway level. Snow accumulates only on the upper slope segment.

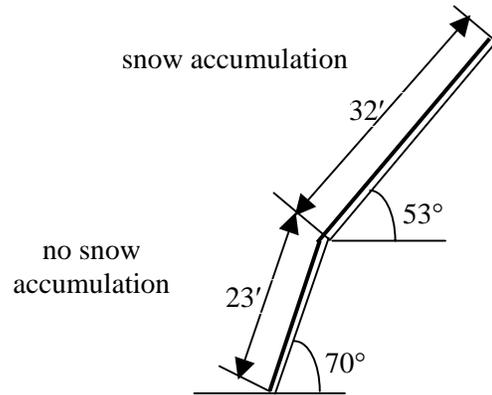
Figure 4-7: Cross-section of installation with slope configuration and area of snow accumulation.

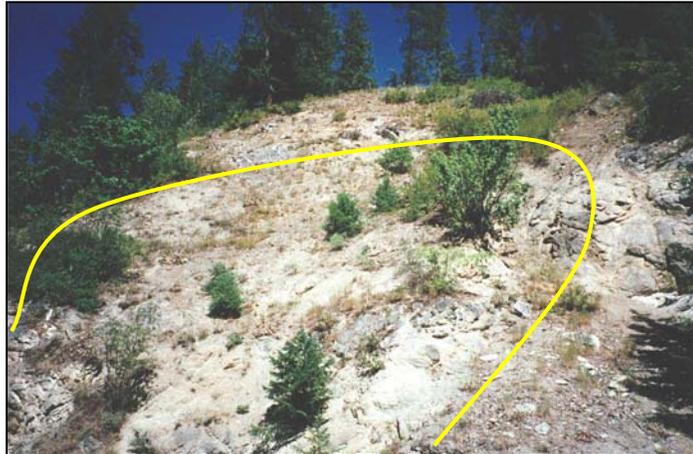
Figure 4-8. Upper slope area before 1997 installation and the area where snow accumulates. Yellow line delineates approximate coverage area of mesh. Note planar condition and absence of irregularities over much of the upper slope.

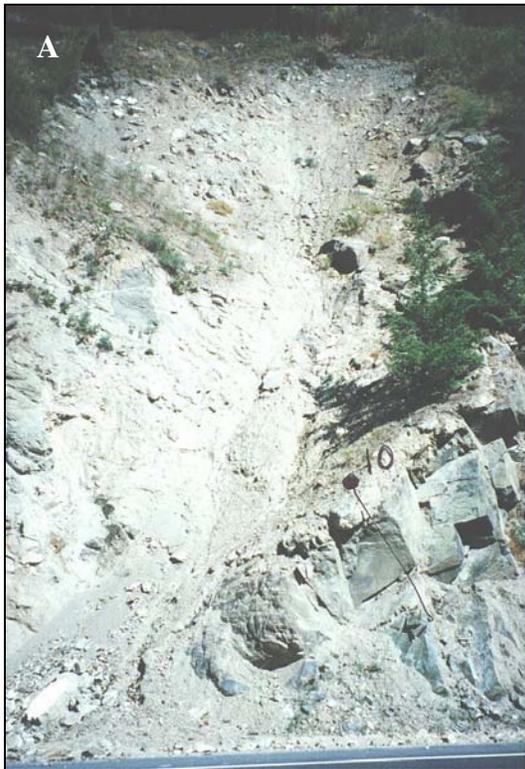
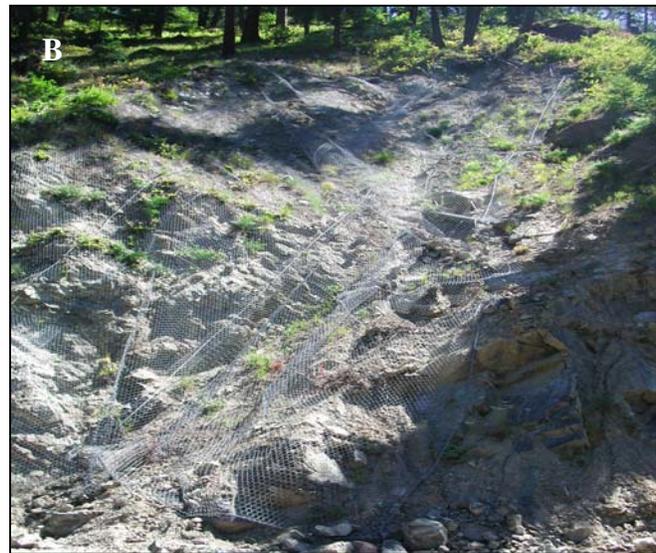
Figure 4-9. Slope area in (A) 1997 before and (B) 2002 five years after mesh installation and just after repair of the system.

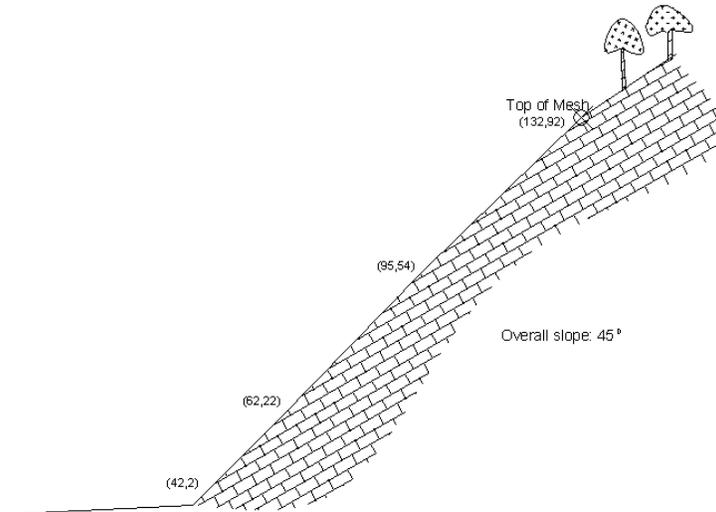
Figure 4-10. Cross-section of installation shows approximate slope configuration. Snow accumulates on the entire area of the installation.

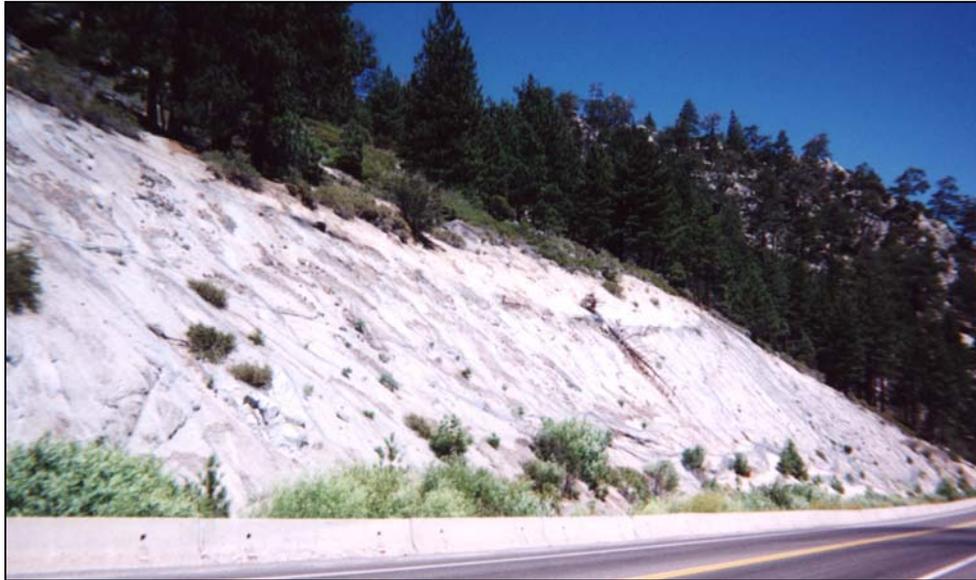
Figure 4-11. Eastern half of the damaged installation still partially suspended on the slope, held in place mostly through interface friction and the few remaining intact anchors.

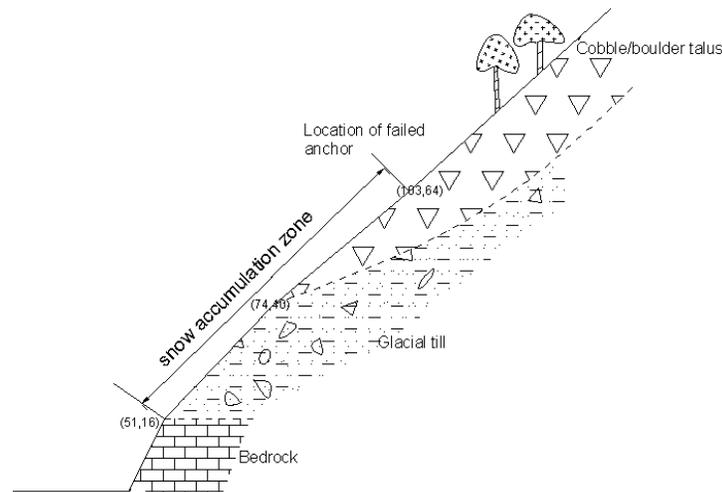
Figure 4-12. Cross-section through failed cable net shows the portion of the installation that accumulated snow. Snowpack also extended upslope of the installation. The entire slope above the bedrock portion is highly susceptible to snow avalanches.

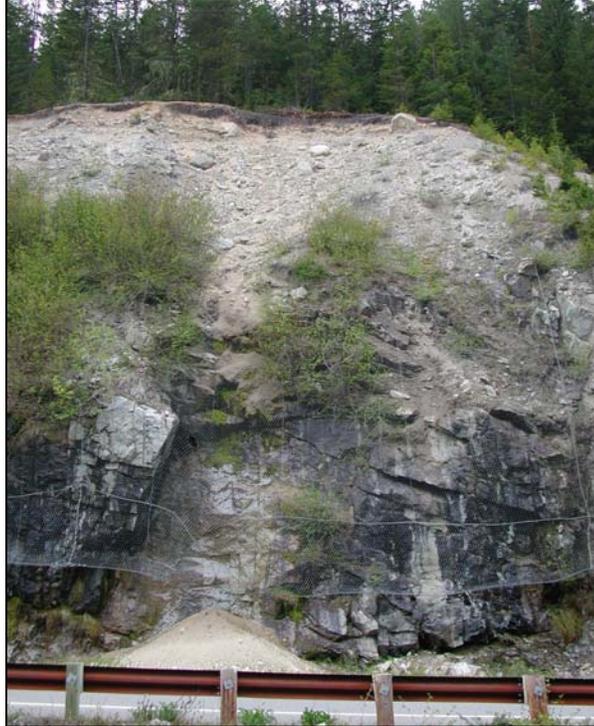
Figure 4-13. The slope conditions; snow accumulation occurs on the upper portion of the slope.

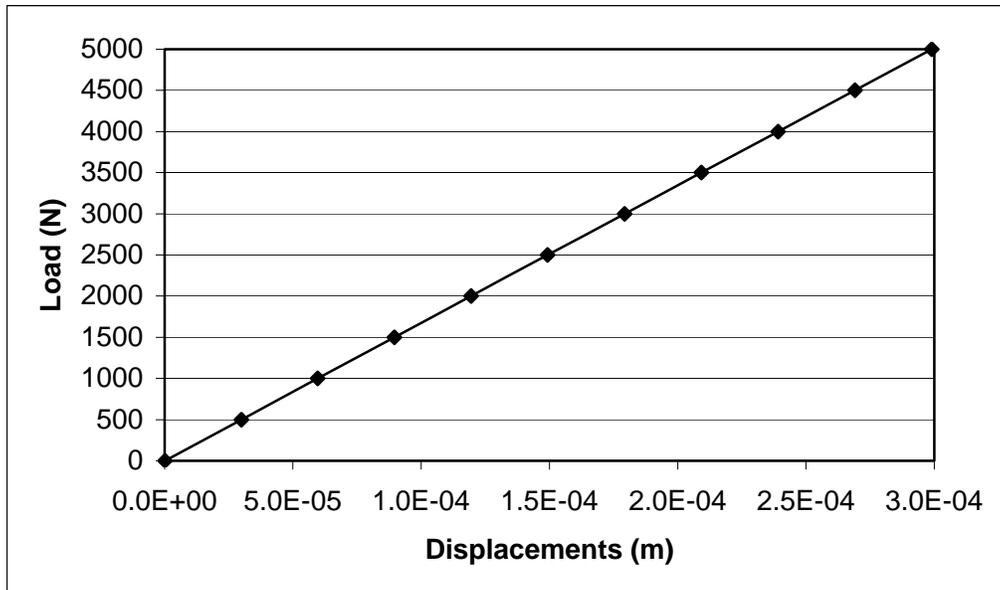
Figure 5-5. Applied load versus displacement of a cell assuming fixed sides.

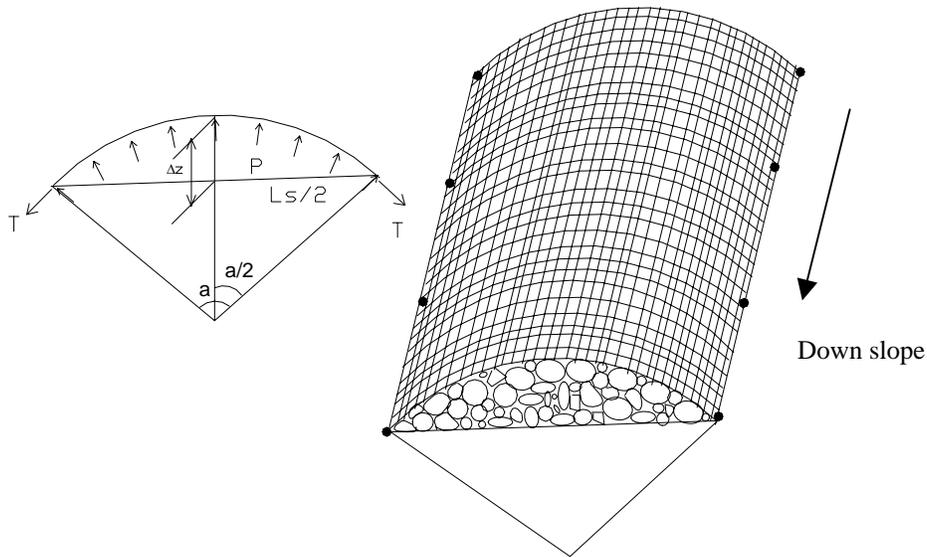
Figure 5-7. Assumed circular cross-sectional shape of the mesh and the conditions that would result in seam failure.

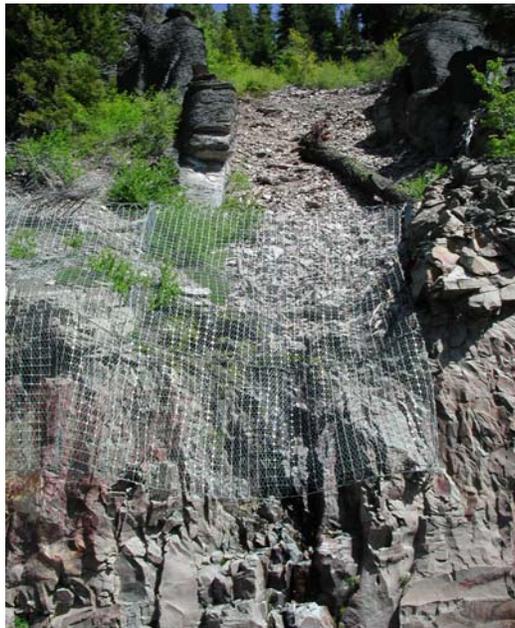
Figure 5-8. Modified cable net installation, upslope source of rockfall, and typical range of block sizes that impact the installation in a sub-perpendicular orientation.

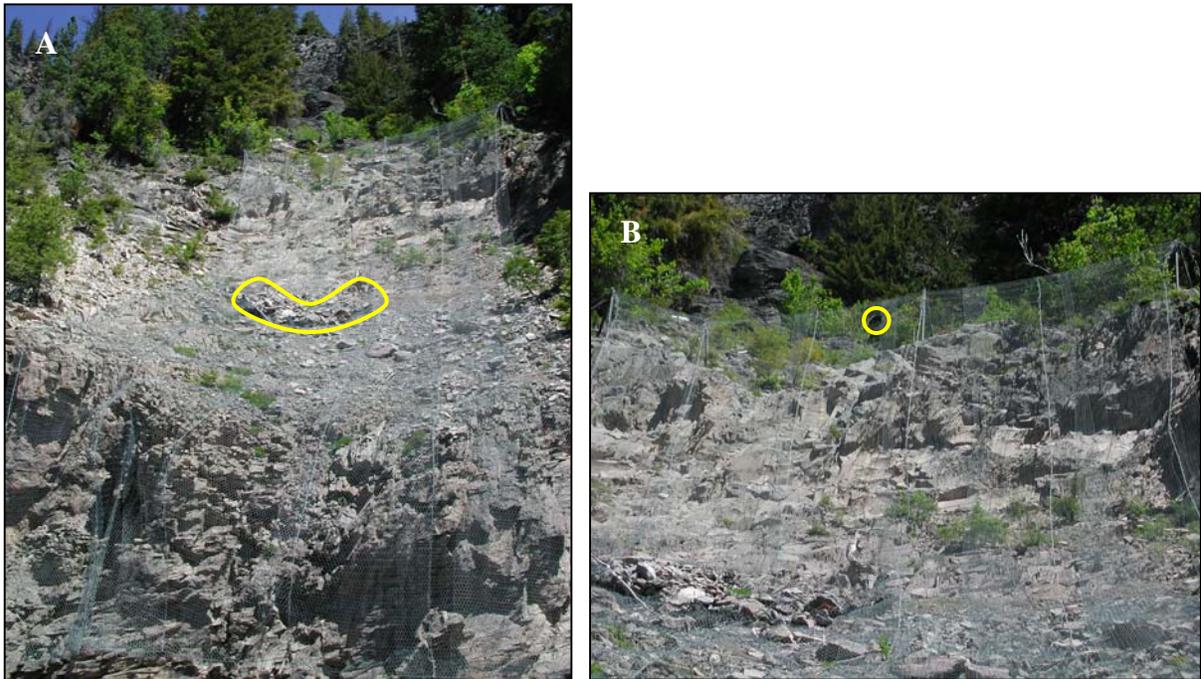
Figure 5-9. (A) Configuration of slope and installation. Yellow line outlines area of debris accumulation and rupture failure. (B) Enlarged view of top of mesh, downslope of chute. Yellow circle highlights 18-inch (450-mm) puncture of the mesh.

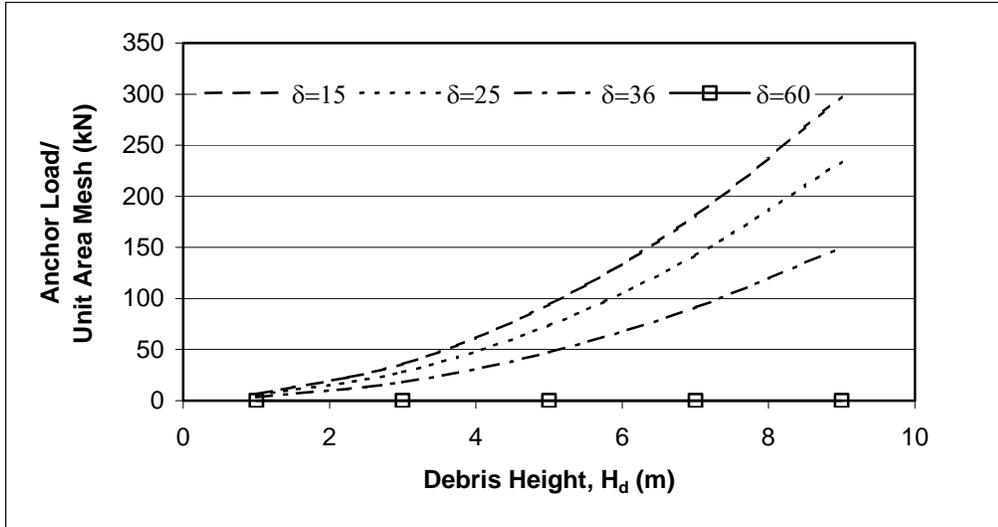
Figure 6-3. The effects of interface friction angle (δ) on anchor load for 30-m (100-ft) slope heights for a range of debris heights on a 50° slope.
