Analysis and Design of Wire Mesh/Cable Net Slope Protection

Final Report

Report No. CA05-0222

April 2005

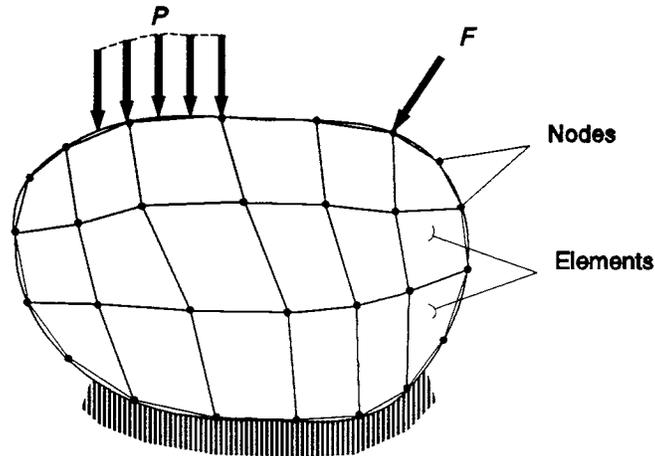
Figure 6-5. Finite element discretization shows loads (P) and forces (F) acting on mesh (Knight, 1997).

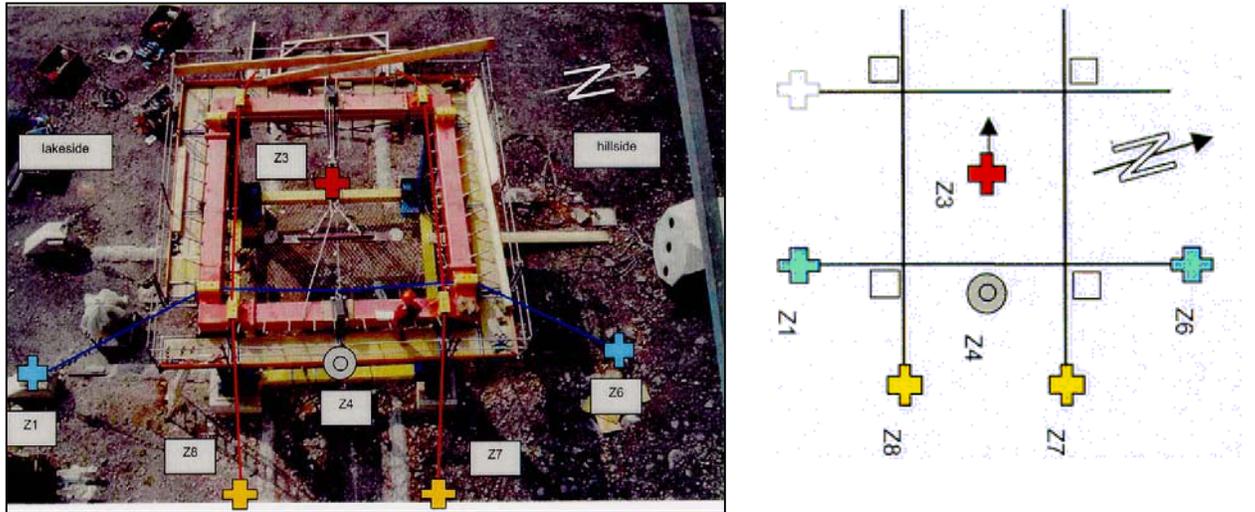
Figure 6-6. Test setup and locations of load cells. Z4 is the load cell used to measure the force at the stabilizing anchor. Z3 is the load cell used to measure the applied load. Load cells Z1, Z6, Z7, and Z8 measure force at the other supports.

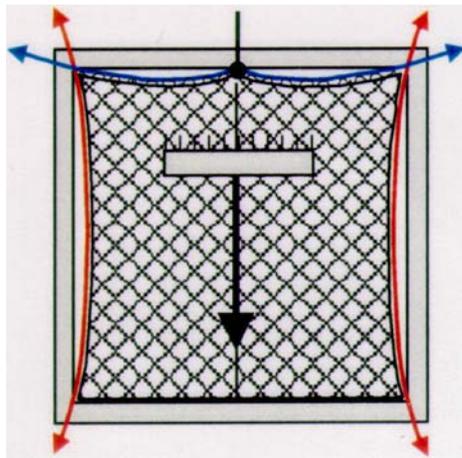
Figure 6-7. The direction of loading of the TECCO® mesh by the steel beam and the load transfer to perimeters (support ropes and anchors) of the mesh panel. The beam is fixed to a variable number of mesh cells referred to in Table 6-1. The unit of measure for the distance of the beam to the anchor is in the number of mesh cells.

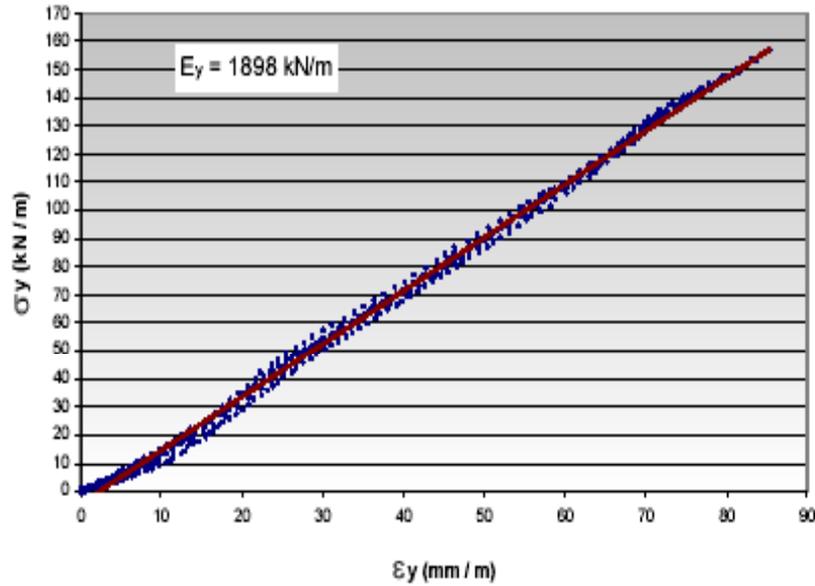
Figure 6-8. Stress- strain relationship for TECCO® G65 mesh.

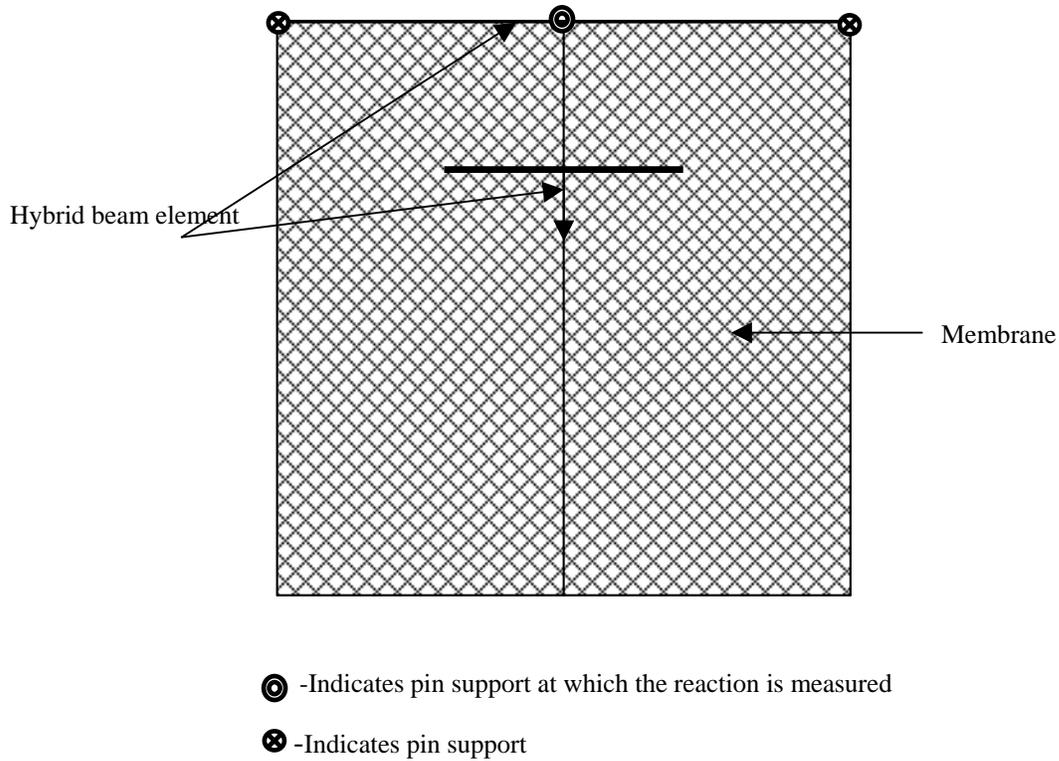
Figure 6-9. FE model setup shows locations of anchors and beam.

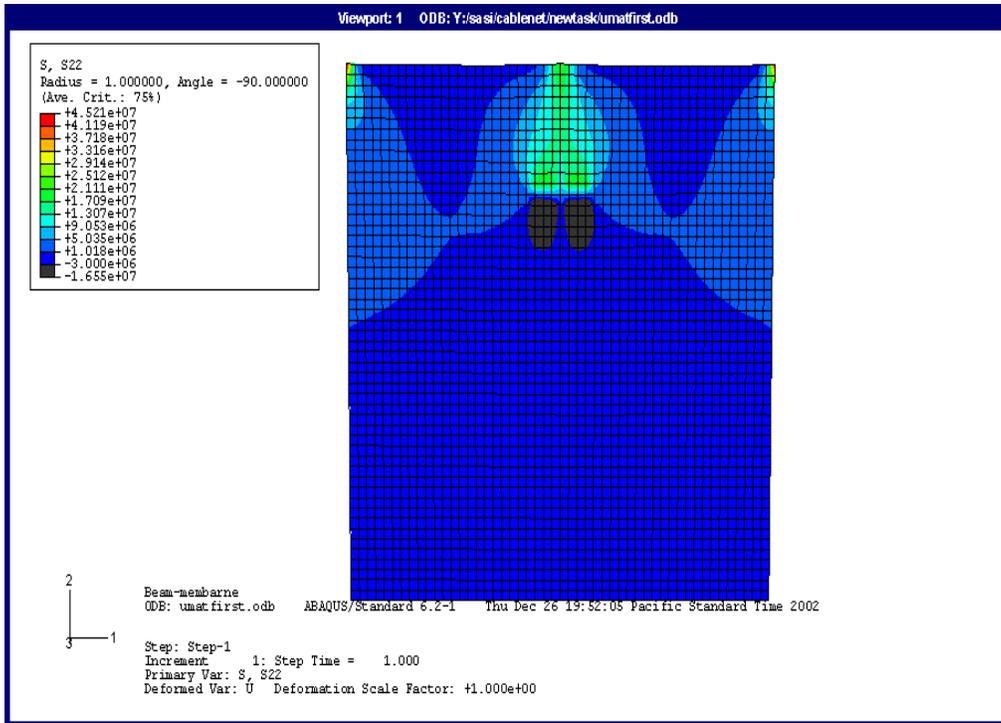
Figure 6-10. Stress contours for Test 1.

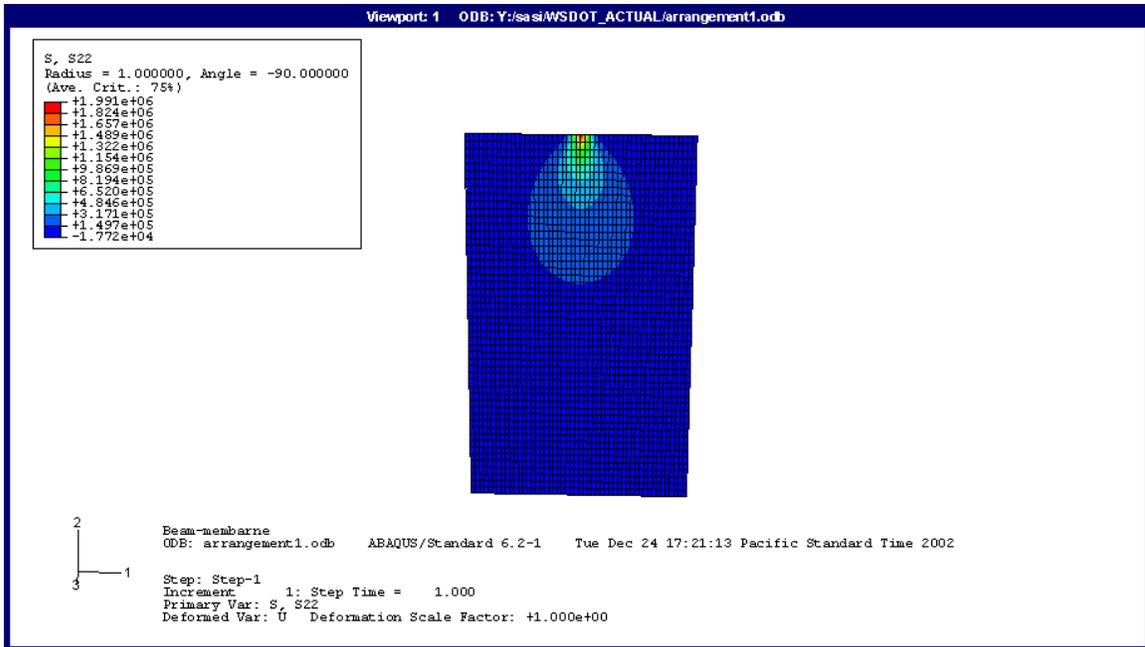
Figure 6-13. Stress contours for arrangement 1.

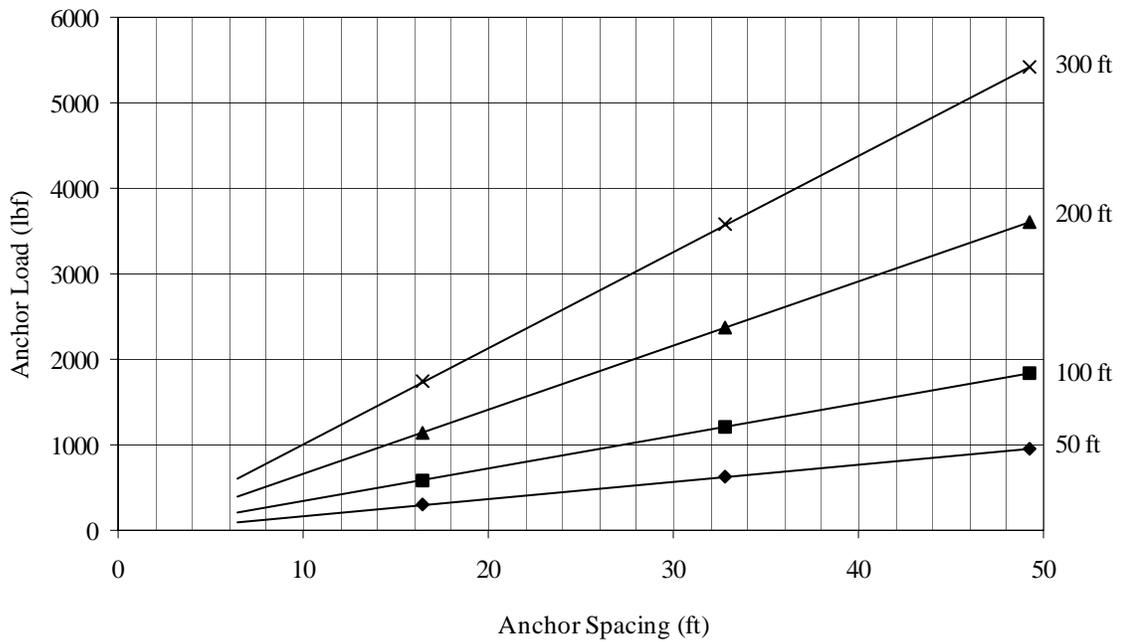
Figure 6-17. Anchor load *v.* spacing for double-twisted hexagonal wire mesh for a vertical slope (no interface friction) ranging in height from 50 to 300 ft (15 to 90 m).

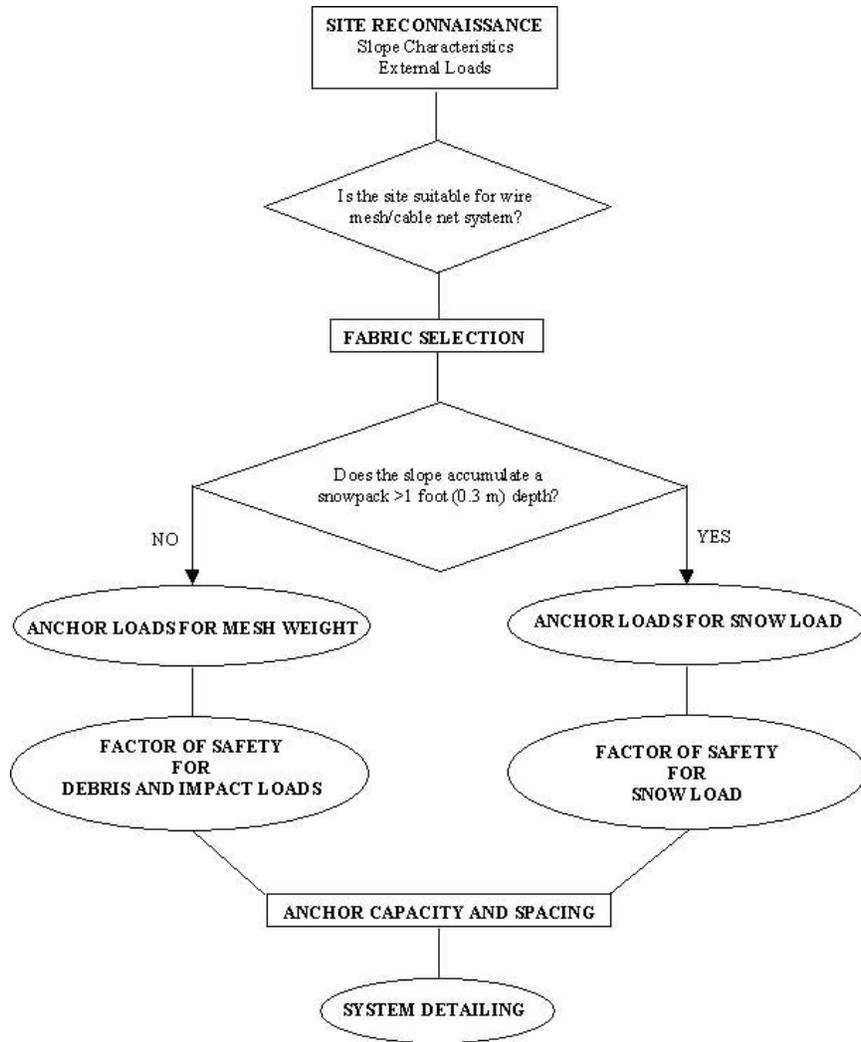
Figure 7-1. Recommended design approach for wire mesh/cable net systems.

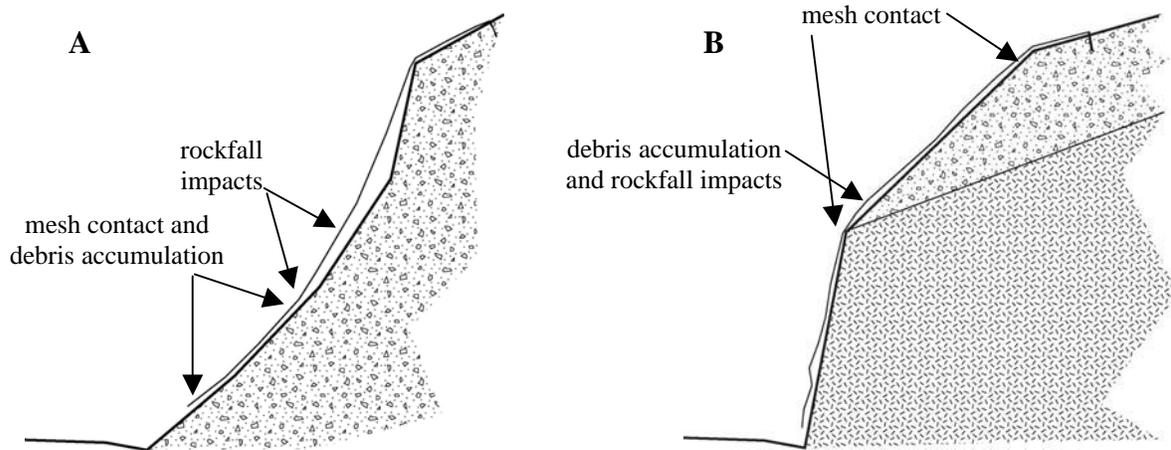
Figure 7-2. Cross-sections show typical (A) concave and (B) convex slopes and the areas of mesh contact, debris accumulation, and rockfall impacts.

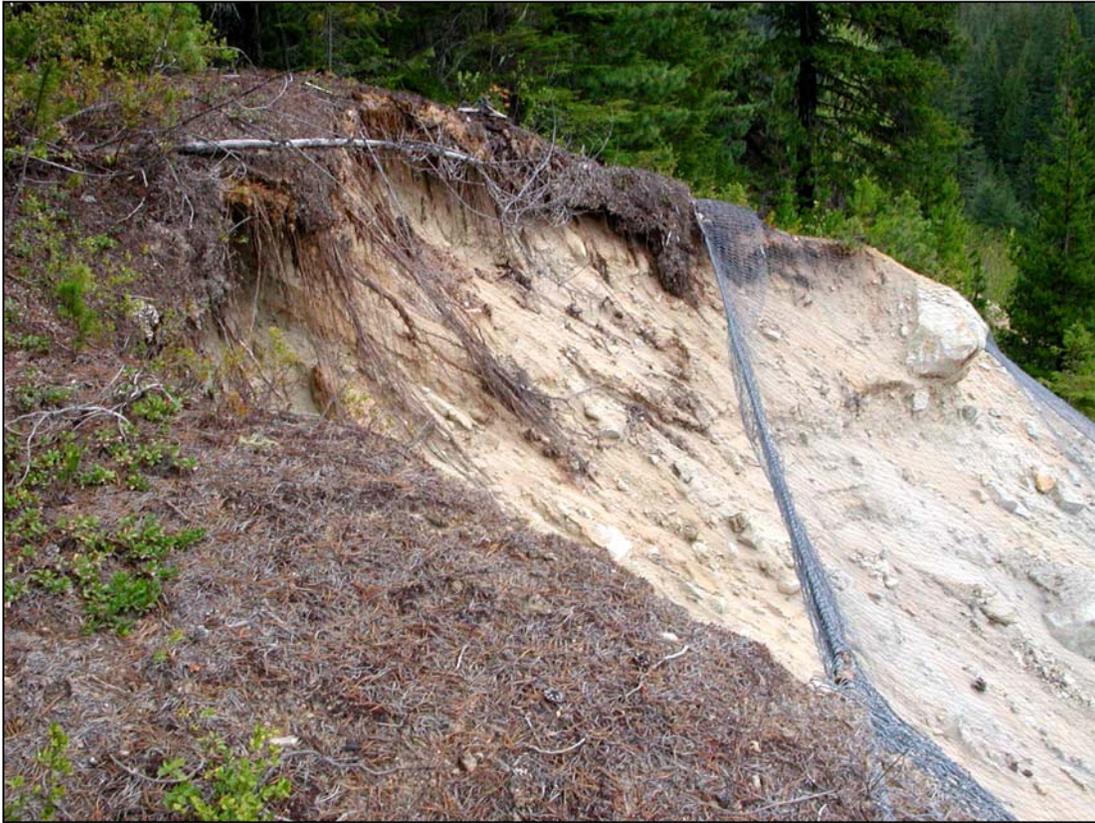
Figure 7-3. Ongoing erosion threatens a wire mesh system installed in the late 1980s in the North Cascades of Washington.

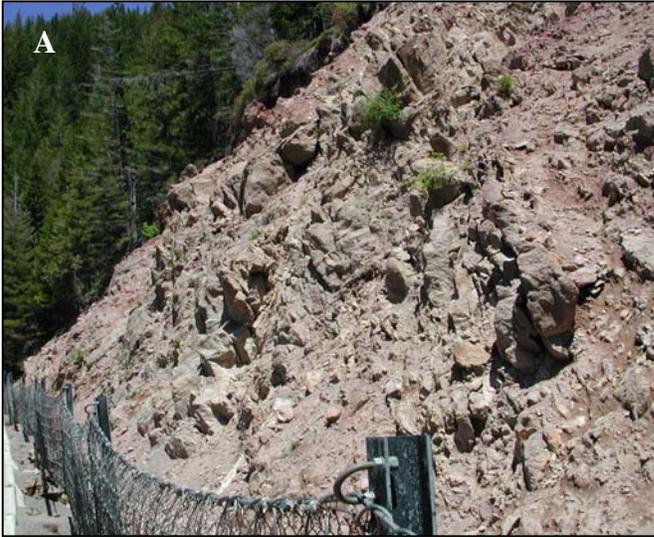
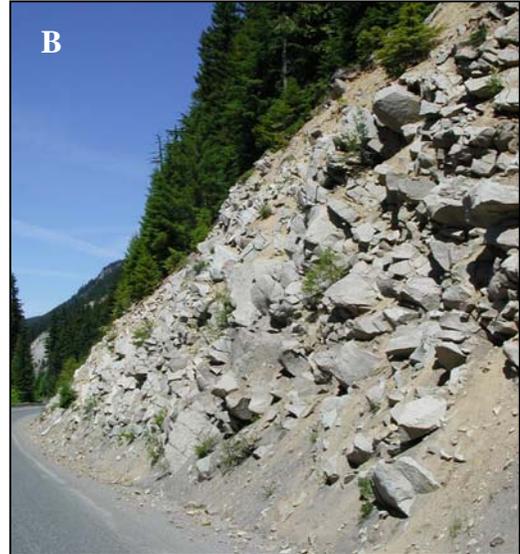
Figure 7-4. Rough slopes exhibit a high degree of surface roughness with planar, uniform profiles.

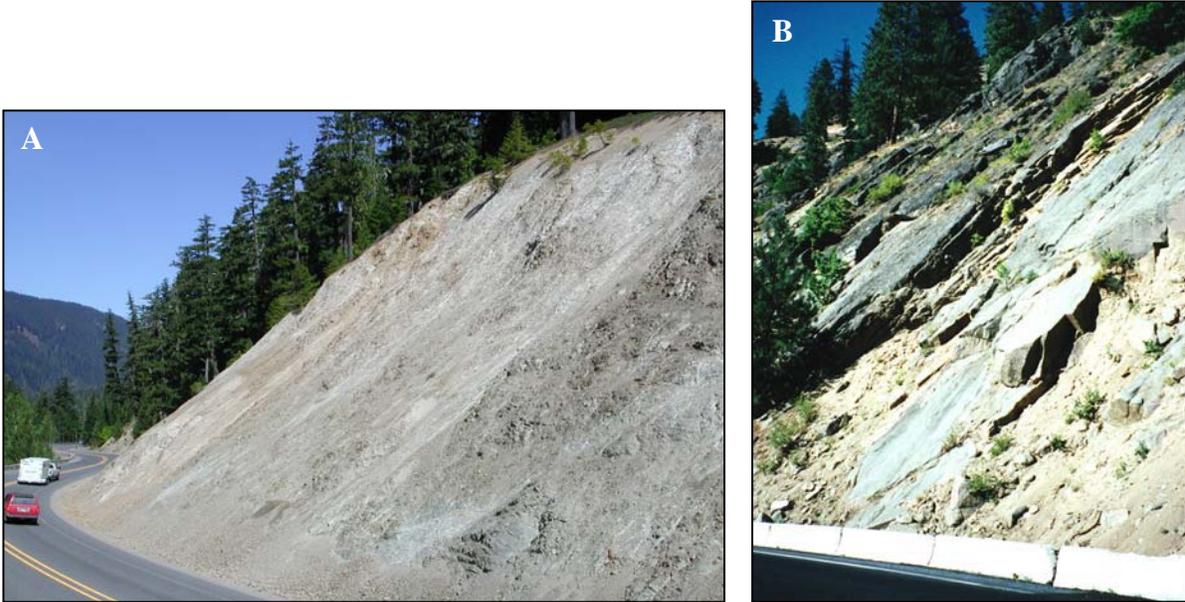
Figure 7-6. These planar slopes exhibit little surface roughness or slope irregularity. In the case of (A), the slope profile is controlled by the very highly fractured condition of the rockmass. The slope profile in (B) is the result of a highly persistent set of discontinuities that dips coincident with the slope.

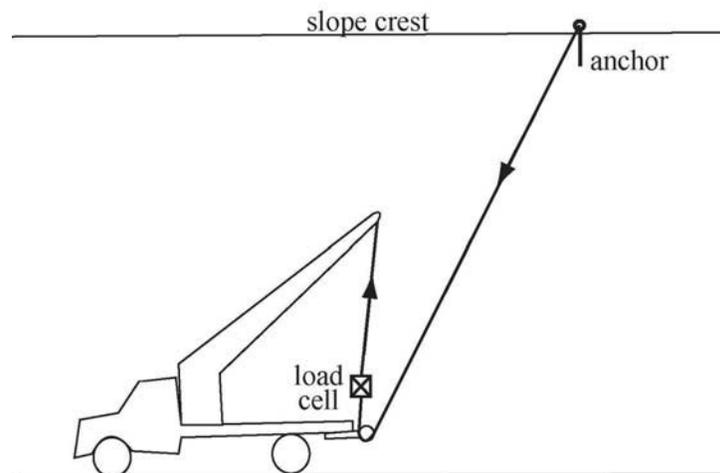
Figure 7-8. Testing setup of anchors in a sub-horizontal direction.

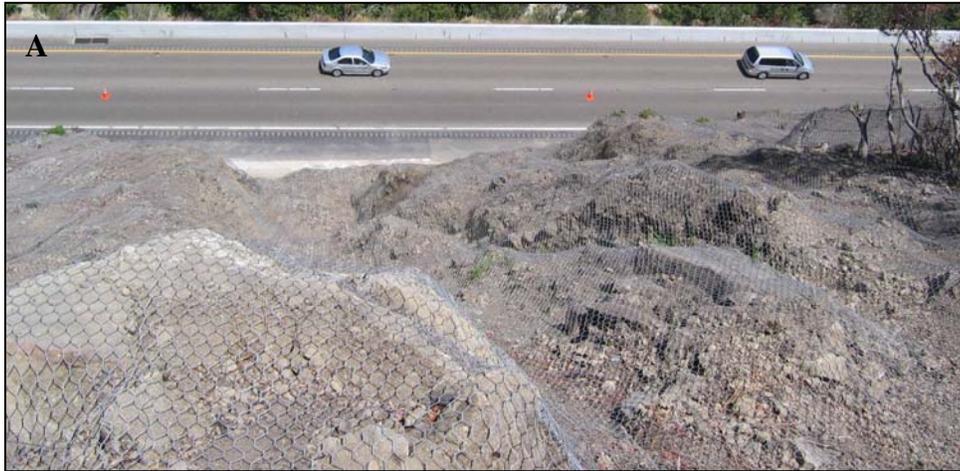
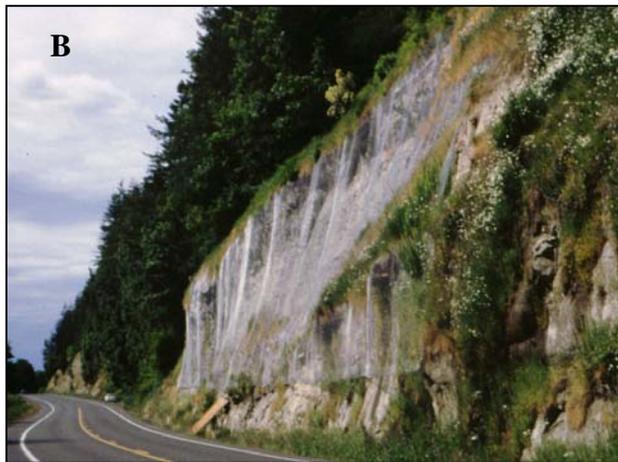
Figure 7-9. (A) The mesh was carefully installed to closely conform to this moderately inclined slope. (B) On a steep to overhanging slope where mesh conformance is generally more difficult to achieve, the mesh can become more visually apparent.

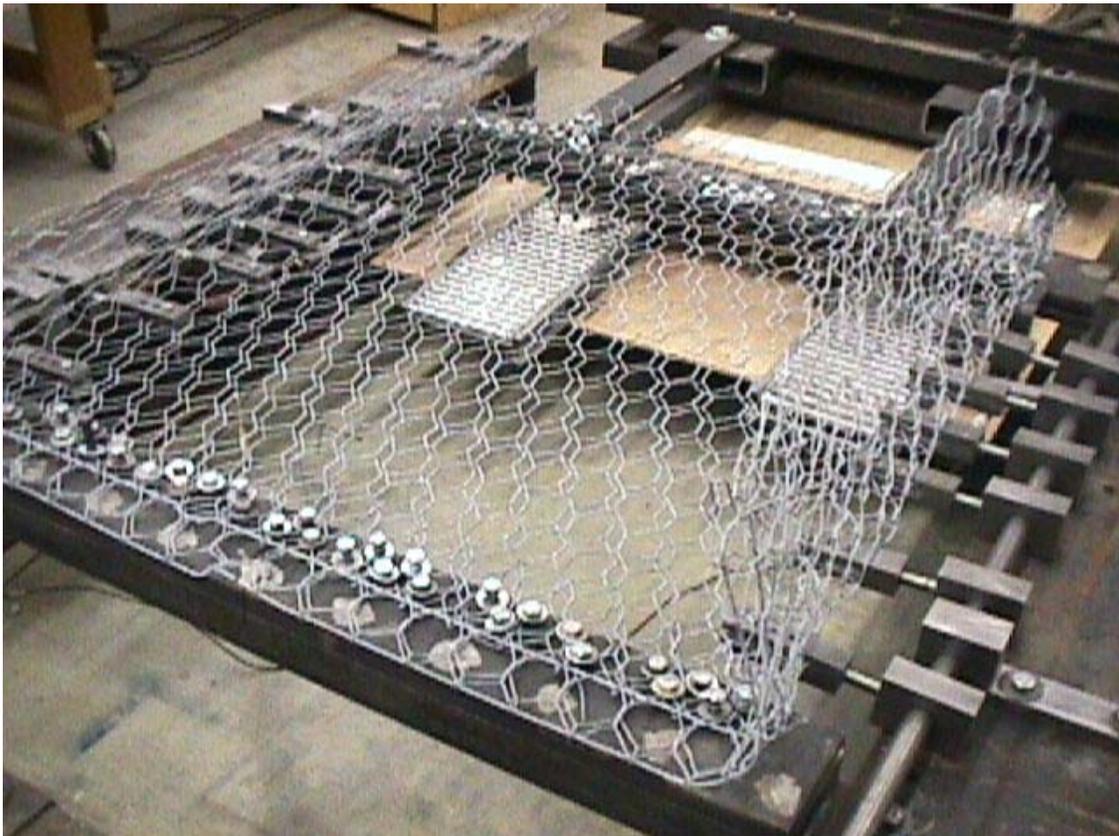
Figure 2. Testing Setup for Twisted Wire Mesh with Bolts Extended Above the Loading Plates

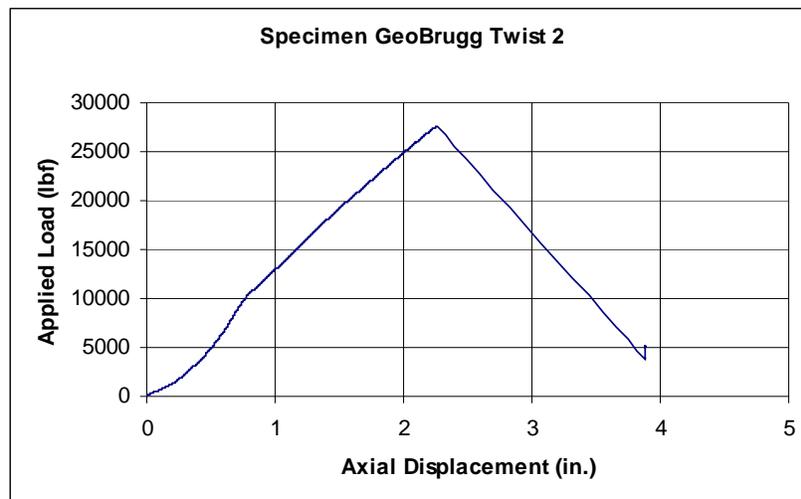
Figure 5. Testing Typical Load Versus Displacement Plot for Determining Elastic Modulus Values

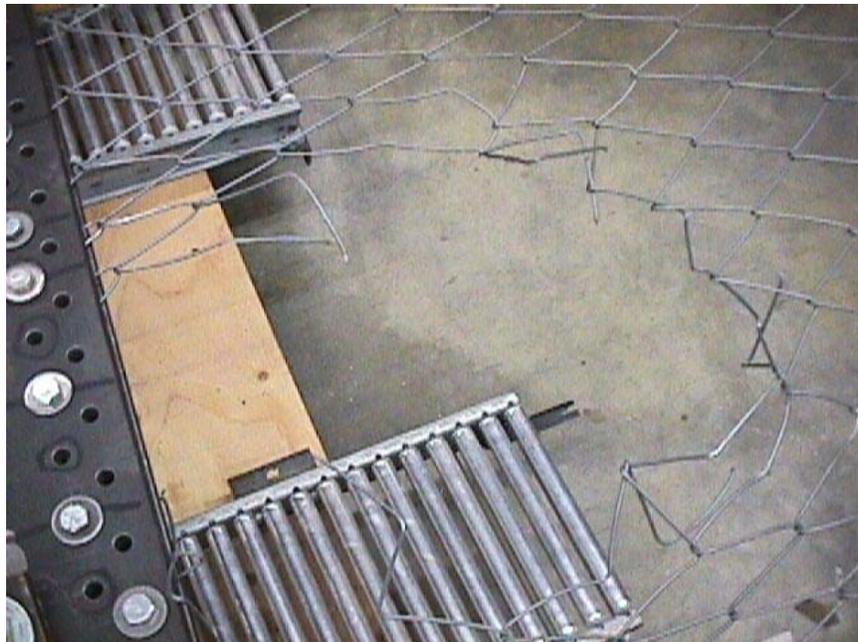
Figure 6. Typical Failure for GeoBrugg Twist Meshes

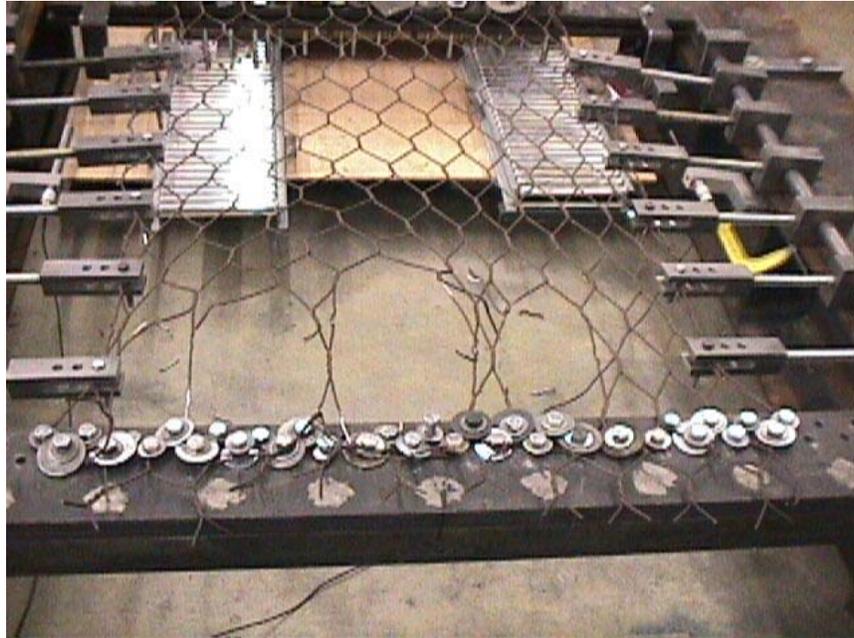
Figure 7. Typical Failure for Maccaferri Twist Meshes

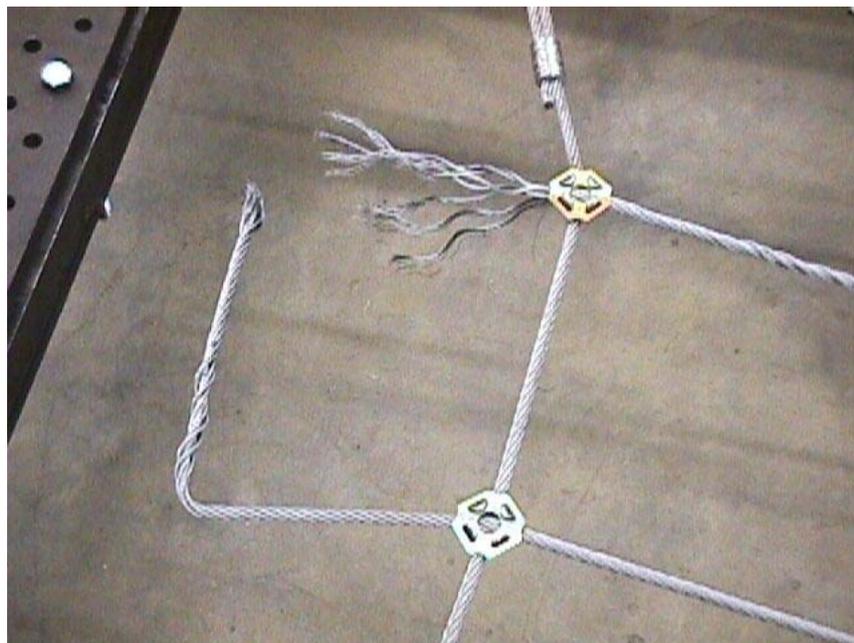
Figure 8. Cable Breaking Failure of GeoBrugg Cable Specimens

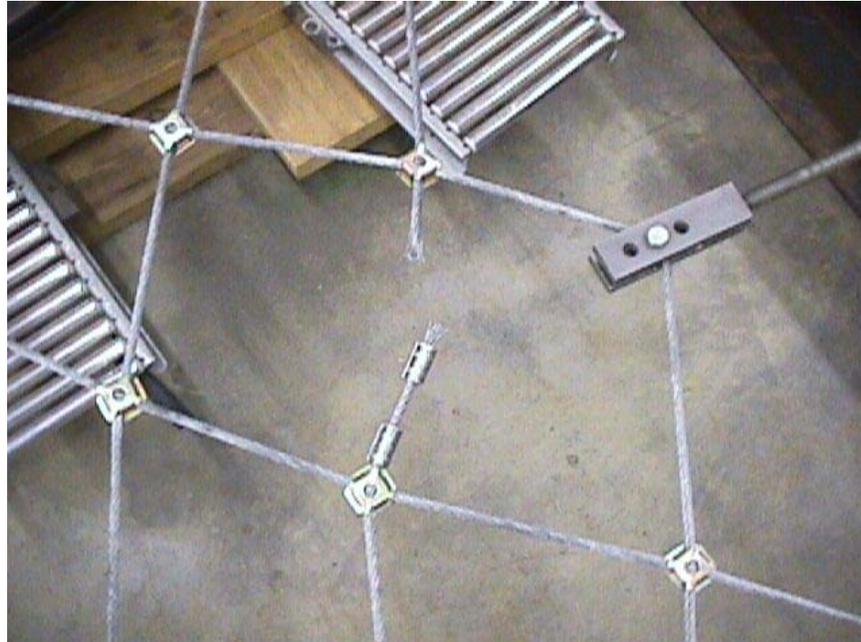
Figure 9. Cable Slippage Failure of GeoBrugg Cable Specimen

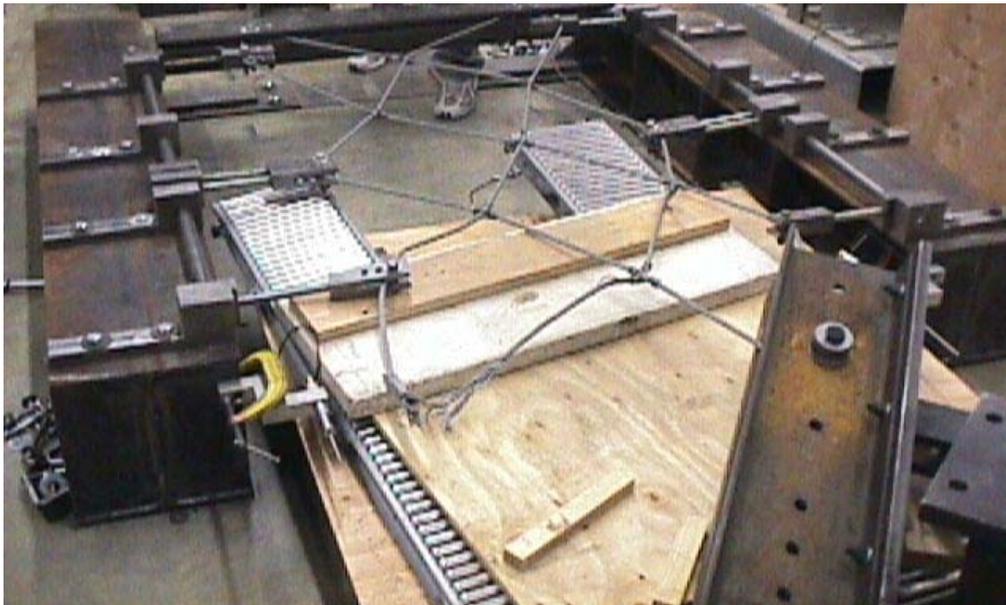
Figure 10. Typical Cable Failure of Maccaferri Cable Net Specimens

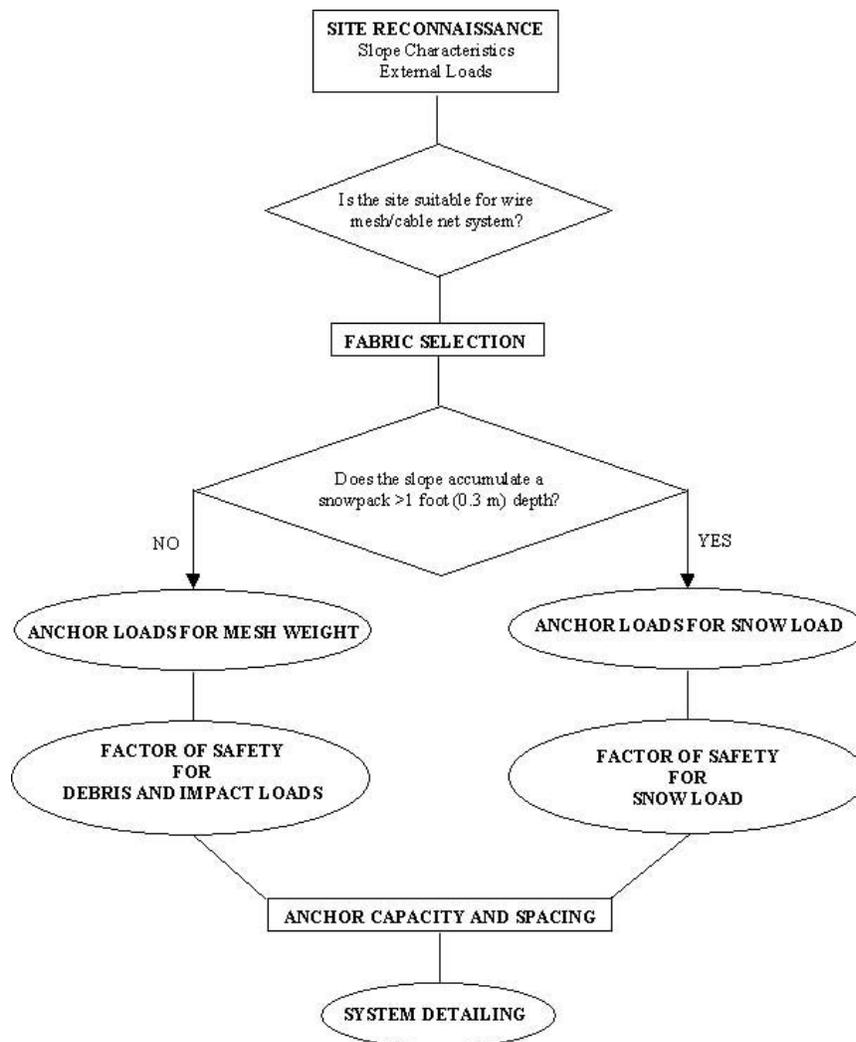
Figure 1. Recommended design approach for wire mesh/cable net systems.

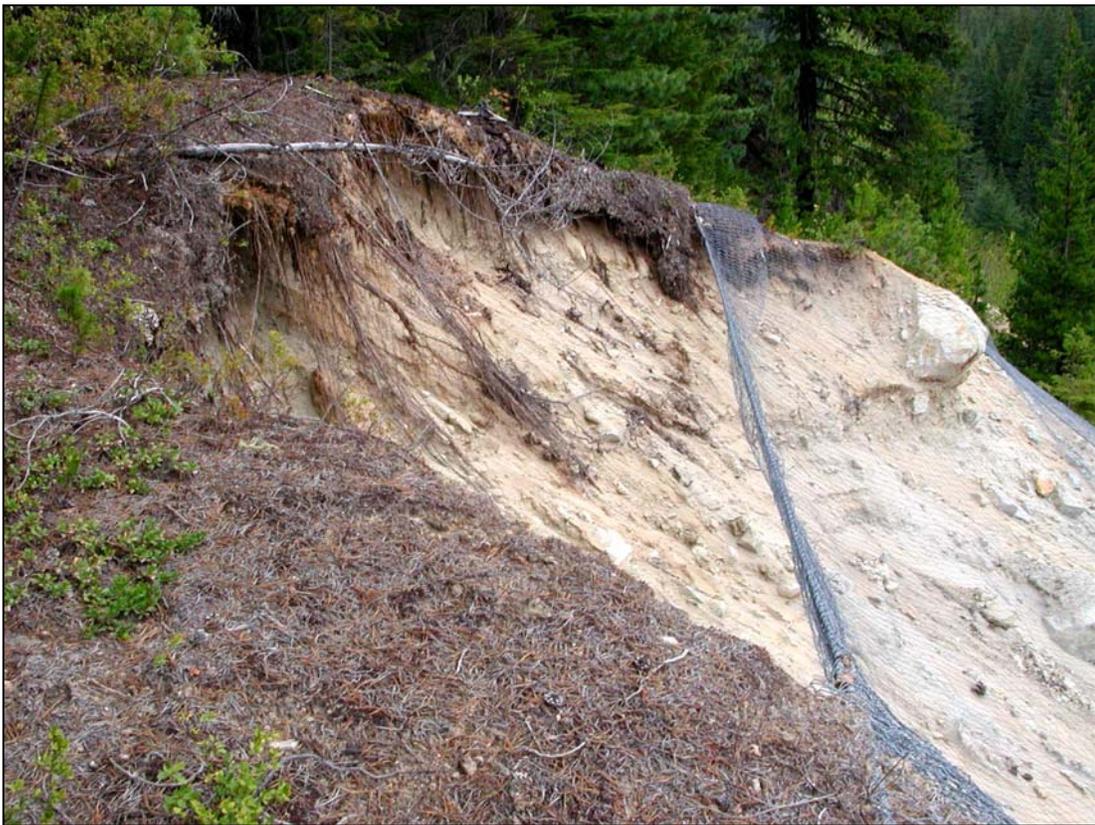
Figure 3. Ongoing erosion threatens a wire mesh system installed in the late 1980s in the North Cascades of Washington.

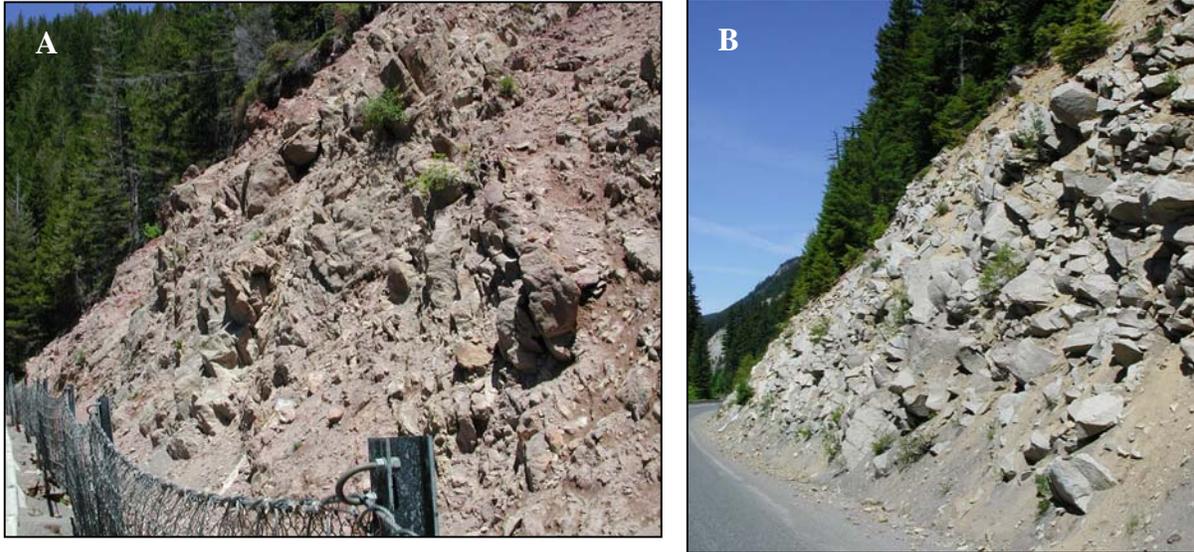
Figure 4. Rough slopes exhibit a high degree of surface roughness with planar, uniform profiles.

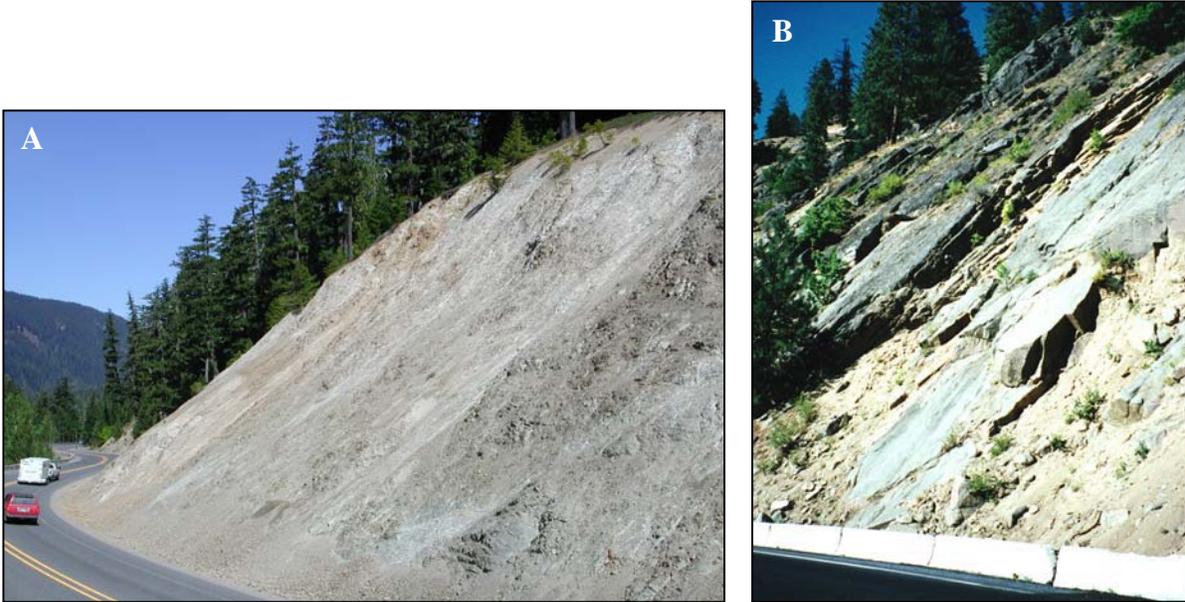
Figure 6. These planar slopes exhibit little surface roughness or slope irregularity. In the case of (A), the slope profile is controlled by the very highly fractured condition of the rock mass. The slope profile in (B) is the result of a highly persistent set of discontinuities that dips coincident with the slope.

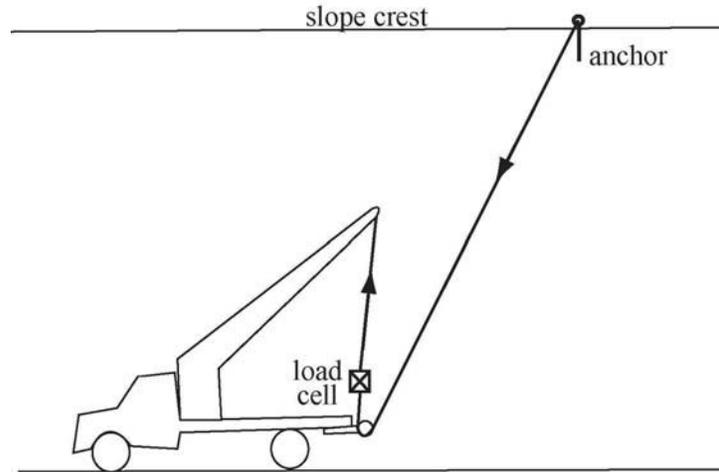
Figure 8. Testing setup of anchors in a sub-horizontal direction.

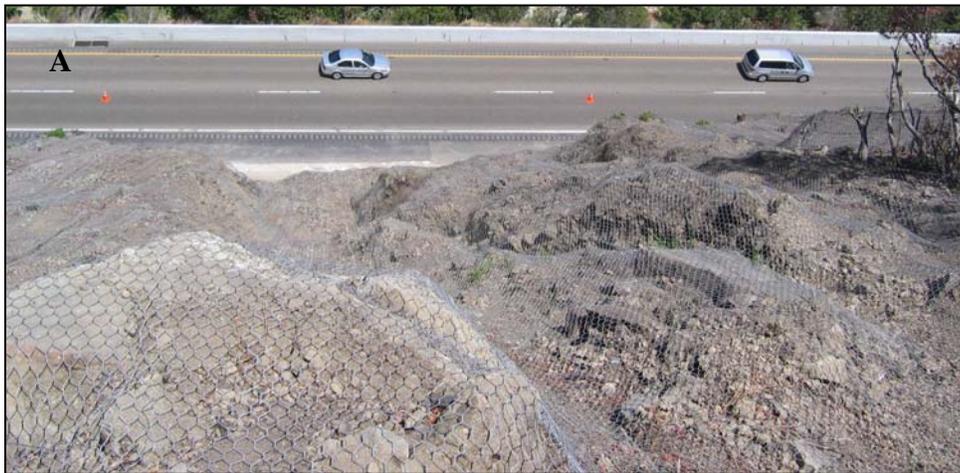
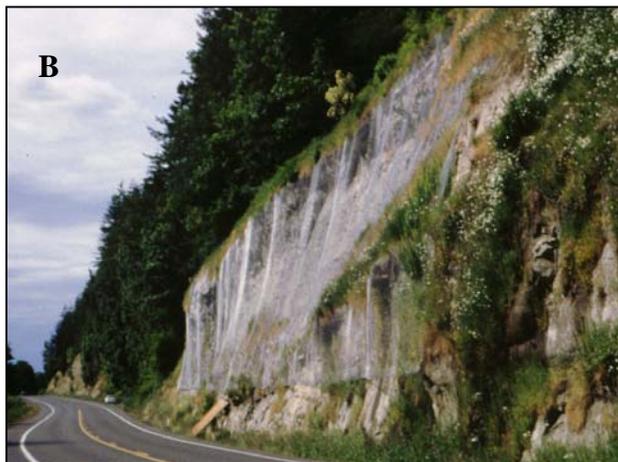
Figure 9. (A) The mesh was carefully installed to closely conform to this moderately inclined slope. (B) On a steep to overhanging slope where mesh conformance is generally more difficult to achieve, the mesh can become more visually apparent.
