1. REPORT NUMBER  CA00-0747	2. GOVERNMENT ASSOCIATION NUMBER	3. RECIPIENT'S CATALOG NUMBER	
4. TITLE AND SUBTITLE  Driver Behavior at Rail Crossings: Cost-Effective Improvements to Increase Driver Safety at Public At-Grade Rail-Highway Crossings in California		5. REPORT DATE March 2009	6. PERFORMING ORGANIZATION CODE

7. AUTHOR(S) Douglas Cooper and David Ragland	8. PERFORMING ORGANIZATION REPORT NO. UCB-ITS-PRR-2009-24		10. WORK UNIT NUMBER
9. PERFORMING ORGANIZATION NAME AND ADDRESS  California PATH Program University of California, Berkeley 1357 S. 46 <sup>th</sup> Street Richmond, CA 94804		11. CONTRACT OR GRANT NUMBER  65A0161 TO5208

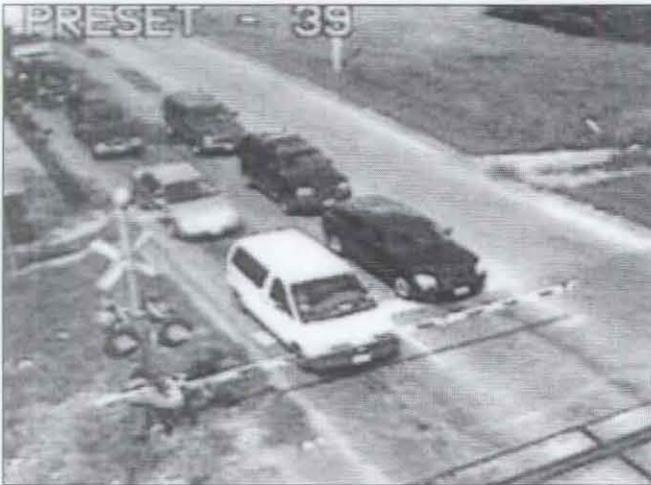
# Figure 16

## COLLEGE STATION, TEXAS, HOLLEMAN DRIVE CAMERA VIEW

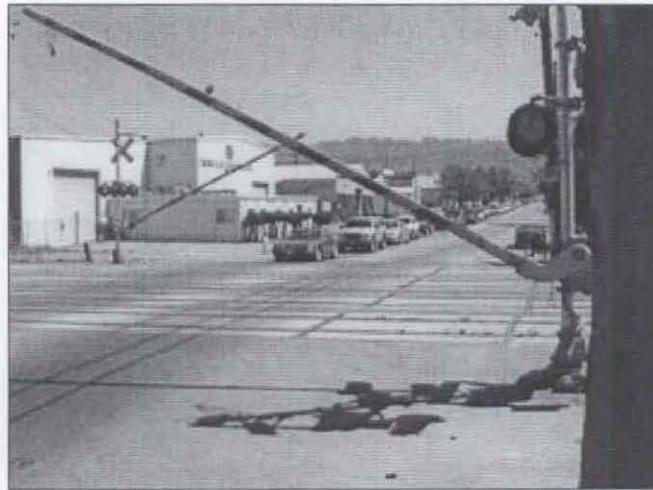
**Figure 17**  
**GILMAN AVENUE CROSSING**  
**BERKELEY, CALIFORNIA**

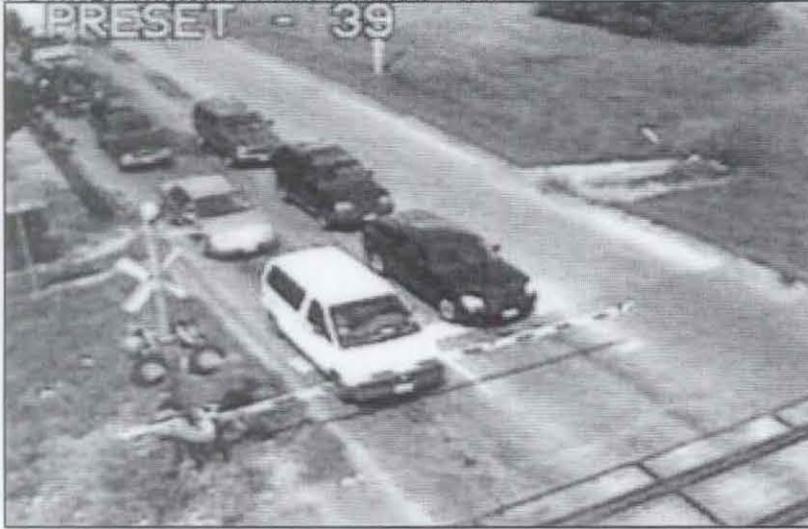
**Figure I-1: College Station, Texas, Camera View**

The camera used for our observations is located on a pole on the southwest corner of the intersection of Holleman Drive and Wellborn Road where the tracks cross Holleman. Since we did not control the camera, our view was limited to the west side of the tracks as Holleman approaches Wellborn. The camera view is shown in Figure 1. This is not an ideal location for driver behavior research in that there is room for only one car per lane between the tracks and Wellborn (Figure 2). This space is quite often full, thus taking away the possibility of driving under or around the rail line crossing gates. Also, the position of the camera did not allow us to observe the flashing lights.

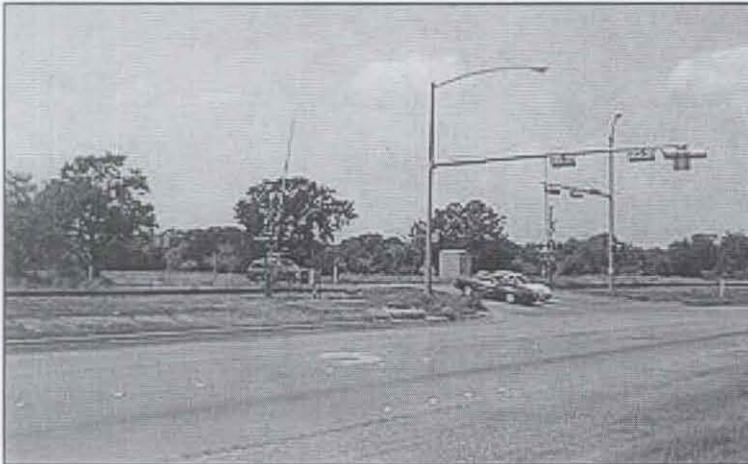
**Figure I-2: Holleman and Wellborn Intersection**

Approximately 300 hours of live video feed from the College Station Holleman Avenue camera was downloaded from the internet and stored, using the MPEG4 format, for a total of 24 weekdays between June 22, 2005 and September 2, 2005. The number of hours of video we recorded in a day varied considerably due to the fact that if the signal was lost, even momentarily, the recording stopped. Since we did not have someone constantly monitoring the recording, it could be several hours before the recording was started up again. There were also days when the camera was not directed at the crossing.
