1. Report No. CA 13 2247		2. Government Accession No.		3. Recipient's Catalog No.	
4. Title and Subtitle Evaluation of Methods to Reduce Speed in Work Zones				5. Report Date June 28, 2012

## **Evaluation of Methods to Reduce Speeds in Work Zones**

AHMCT Research Report: UCD-ARR-12-06-30-06  
Final Report of Contract: 65A0275, Task ID: 2247

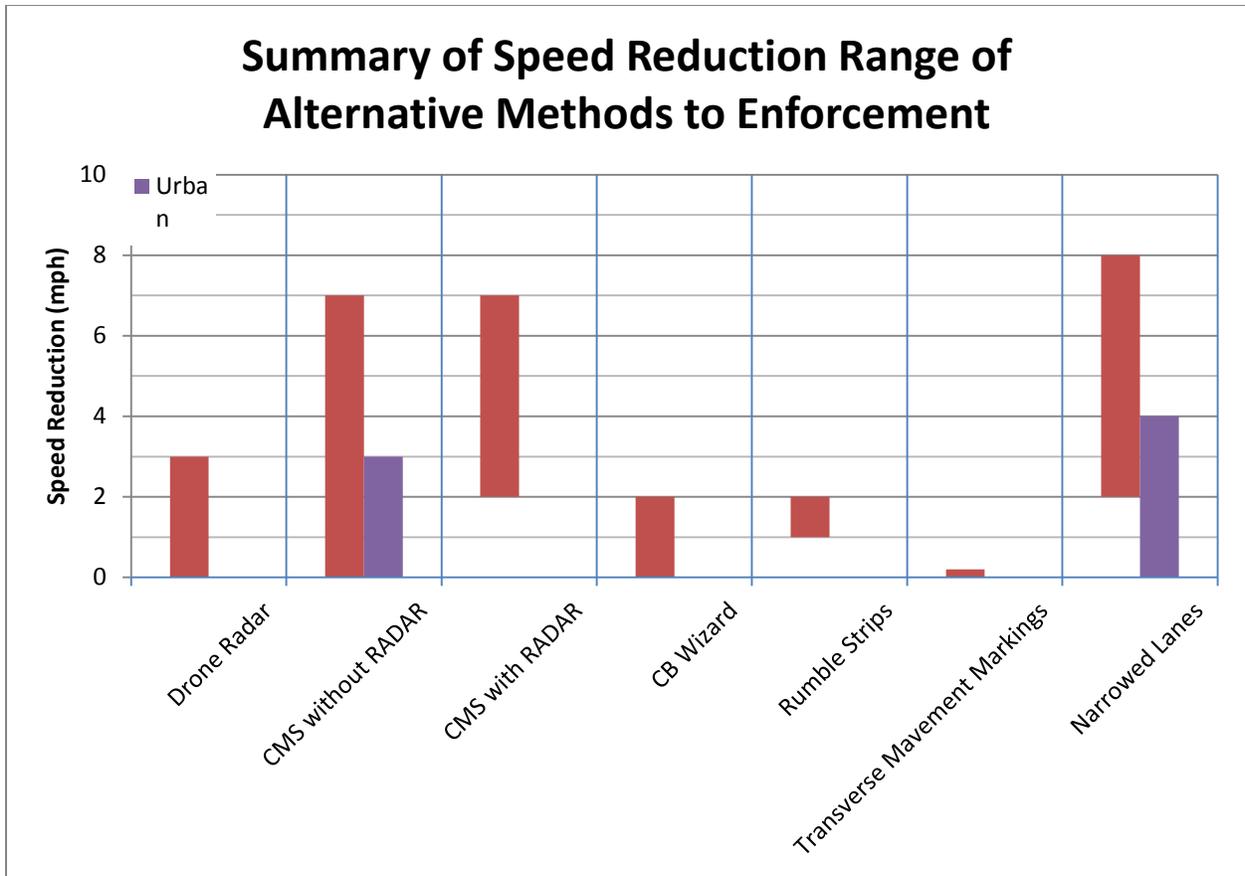
Alternative methods of using police units on highways for speed reductions have been examined in the past. Many of the previous studies are discussed and summarized in a NCHRP report [2]. A plot of this summary in the form of a bar chart is depicted in Figure 1.

Figure 1: Summary of alternatives to the use of police enforcement (from data in [3], page 8)

It is clear from the data in this figure that use of CMS units with radar results in the largest speed reduction among the alternative enforcement methods considered. This suggests that the introduction of the CMS type device as a candidate to supplement COZEEP/MAZEEP operations in work zones can result in speed reduction without employing additional dedicated uniformed officer(s) and patrol vehicle(s) on site. Evaluating this and developing field experience in using a specific type of CMS unit that is presently used by CHP form the main part of this research.

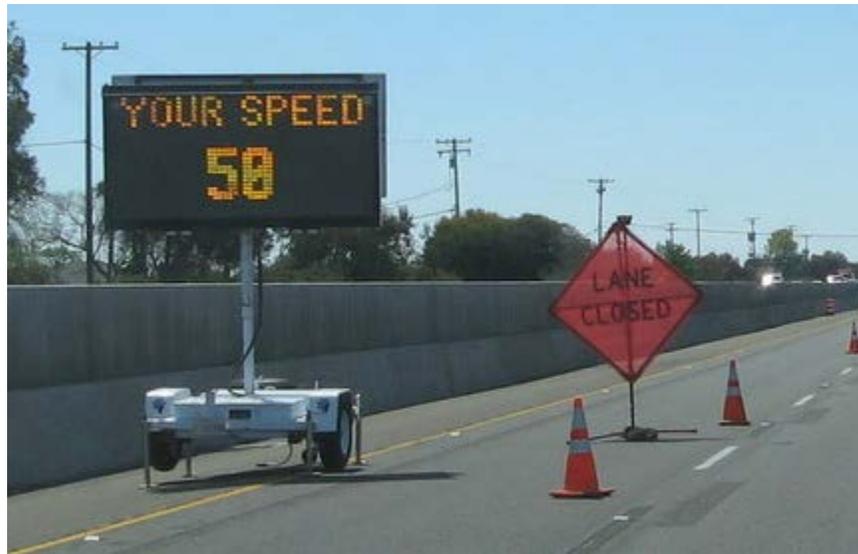
The particular CMS unit used in this study consisted of a display panel approximately eight feet wide and four feet high with an active LED matrix capable of displaying several lines of message. The entire unit was mounted on a trailer that would allow it to be towed to any location on the highway (Figure 2). The entire system is mounted on a self-contained, solar powered trailer which also houses the computer that manages the message displayed. The CMS with radar is an OEM (Original Equipment Manufactured) and all modifications are performed by CHP. The CHP-CMS trailer can be programmed to display messages such as lane closure advisories and reduced work zone speed limits. An onboard Doppler Effect radar unit is used to determine the speed of oncoming traffic and triggers a warning message display if the measured speed exceeds a certain preset threshold value. The programmed messages can be displayed intermittently with the measured speed to remind the oncoming vehicle of its speed.

**Figure 2: The CHP-CMS Trailer**

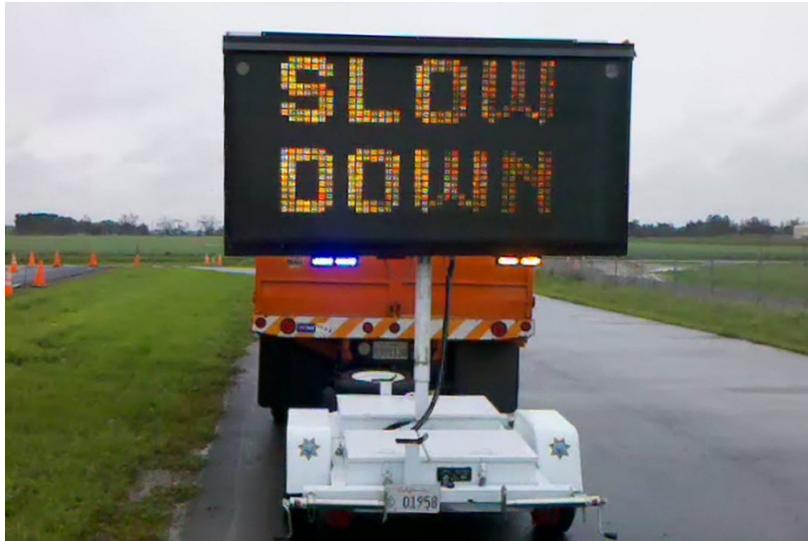
This CMS unit is owned and operated by the CHP and it is equipped with a blue and amber flashing light (standard color light used on CHP vehicles) mounted on the bottom of the display panel. At distance, the flashing light mimics the presence of a CHP patrol vehicle (hence the name CHP-CMS) thus strengthens the CMS's figure of authority. In case of driver being distracted from road condition, the flashing light is intended to capture driver's attention due with its strong visual cue and improves alertness (Figure 3).

**Figure 3: CHP-CMS Trailer Showing Blue and Amber Lights**

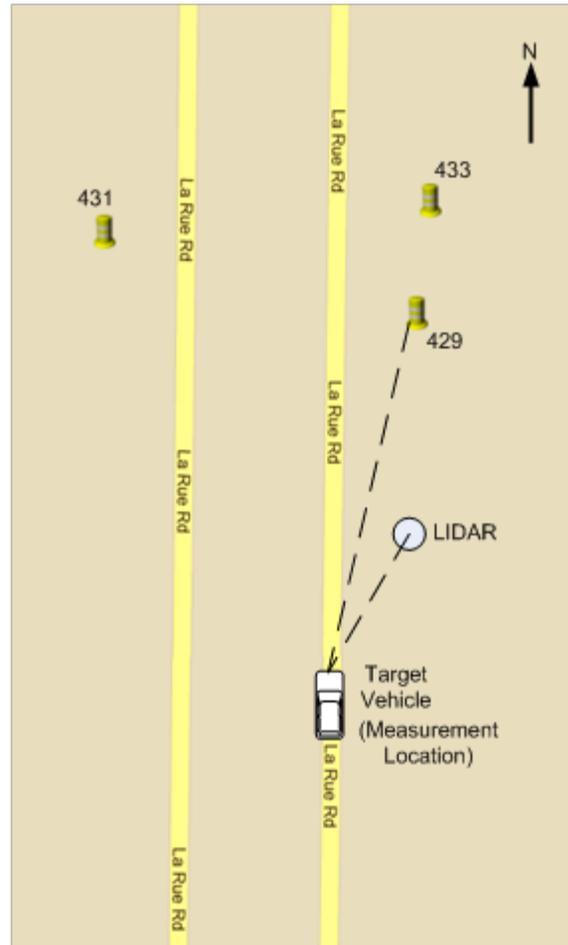
A set of tests were conducted on a north-south segment of La Rue Road near UC Davis on November 12, 2010. This road is a two-way, four-lane (two lanes in each direction) street with a median approximately the width of one lane and a speed limit of 30 MPH. Three iCones and one LIDAR unit (with an operator) were placed as shown in Figure 4.

Figure 4: iCone placements in speed accuracy test (not drawn to scale)  
(Map data ©2013 Google)

iCone 429 was positioned downstream of the measurement location and aimed upstream at the northbound traffic. The iCone's specification indicates a detection range of approximately 150 to 200 feet from the iCone's location. Therefore, the LIDAR operator was positioned between the iCone and measurement location, approximately 130 feet upstream of iCone 429. At this location there was a tree that was used to help the operator stay out of sight of the driver's view for as long as possible. In this set up, the LIDAR operator tracked vehicles and obtained a speed reading for vehicles approximately between 20 to 70 feet upstream of his/her location, which would be the segment of roadway where the iCone is likely to obtain a speed reading. Only northbound traffic was recorded with the LIDAR gun. In order to determine whether iCone measurements are biased towards the lane adjacent to their placements, iCones 431 and 433 were placed approximately across from each other, both aiming north, covering a approximately five

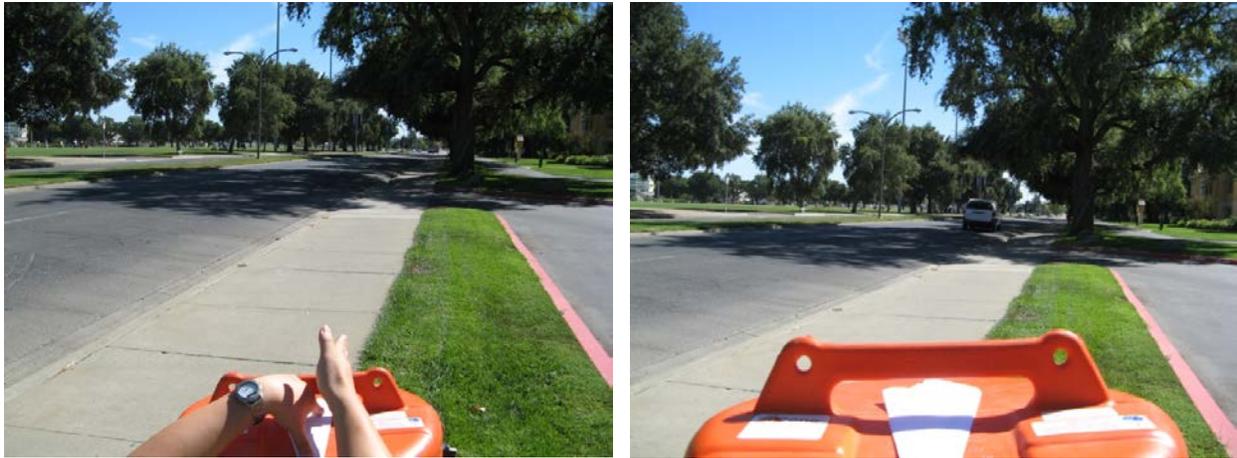
In aiming the iCones, each iCone arrow was initially placed parallel to the road and then the iCone was rotated slightly towards the roadway. Figure 5 shows the iCone aiming process from the operator’s point of view.

Figure 5: Aiming iCones.

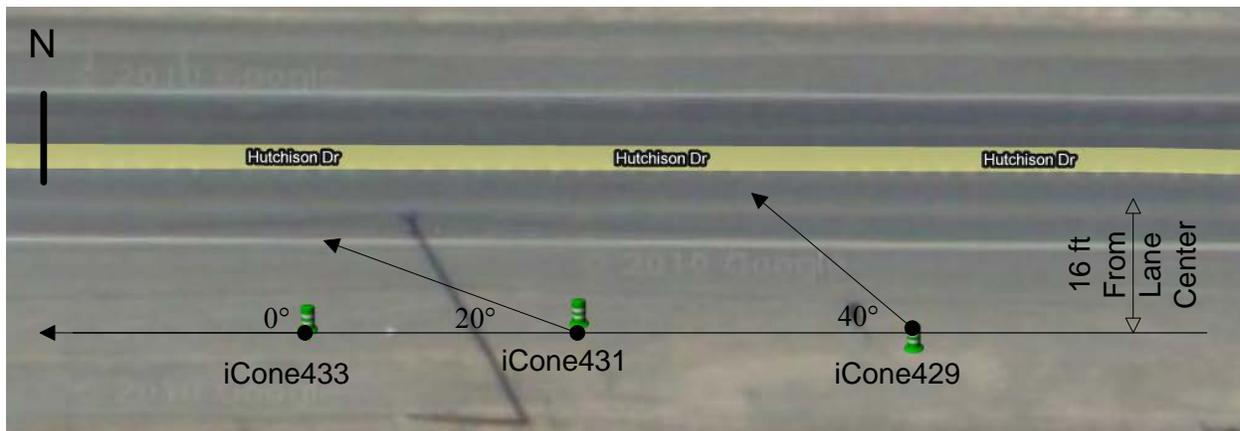
In the orientation test, three iCones were placed the same distance from the lane center, as shown in Figure 6. In this test, iCone 433 was placed with an orientation of  $0^\circ$ , parallel to the road. iCone 431 was oriented at  $20^\circ$  towards the road and iCone 429 at  $40^\circ$  towards the road. All iCones had the same offset of 16 feet from the center of the nearest lane. The offset of 16 feet was selected to represent placement of the iCones outside a 10 foot shoulder. The target of speed measurements was assumed to be at the center of the nearest lane (6 feet for half of the width of the target lane and 10 feet for the width of the shoulder).

**Figure 6: iCone placement for orientation test**  
(Map data ©2013 Google)

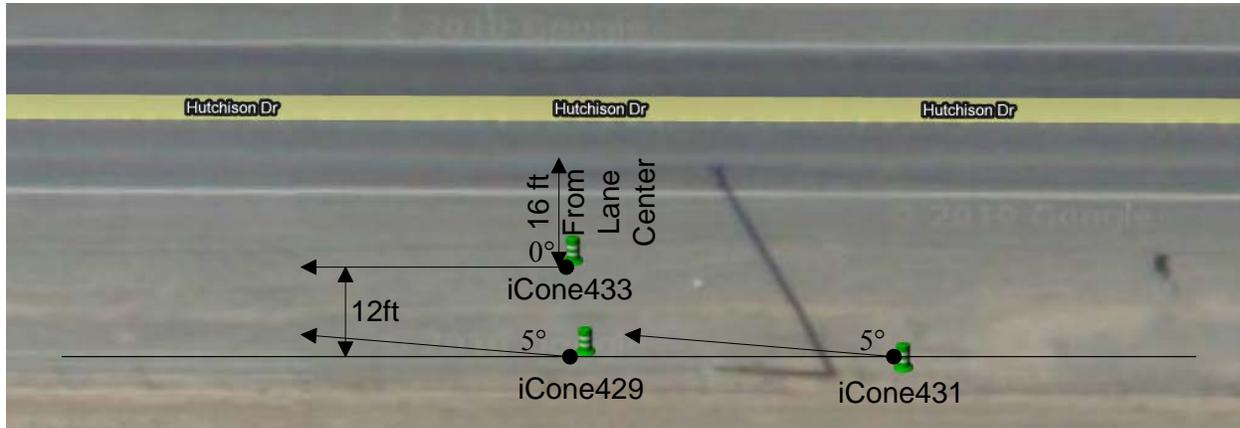
In the position test, the configuration of the iCones is shown in Figure 7. The iCones 433, 431 and 429 were placed, respectively, with offsets of 16 feet, 28 feet and 28 feet from the center of the target lane. The 28 feet distance was selected to represent one additional lane of offset.

**Figure 7: iCone placement for position test**  
(Map data ©2013 Google)

Speed data was collected using all three iCones positioned as described. The test data results are summarized in Table 3. The data in this table does not show any significant differences in the speeds measured, which indicates that iCone speed measurements are not sensitive to their placement in terms of their offset position and orientation. This would make iCones ideal for field usage when rapid deployment of the speed sensing system is needed.

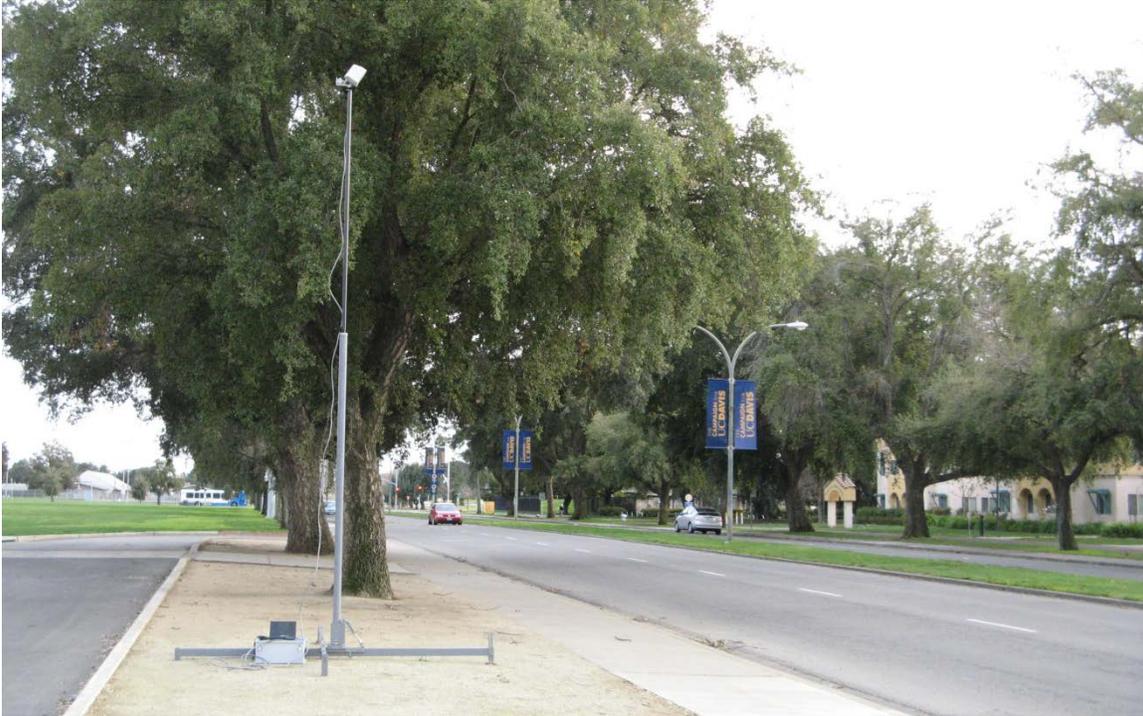
In this test, the number of vehicles detected by the RTMS for each lane was used to calculate traffic volume/count and was tested against manual counting of traffic volume/count. The test was performed on November 12<sup>th</sup>, 2010 at the same location as the iCone test of that date. In order to test the RTMS, an easily deployable mast was designed to mount the RTMS unit at a height. The mast is shown in Figure 8. The mounting height of the RTMS as shown in this figure was 19 feet and during the test on November 12<sup>th</sup> 2010, it was placed with an offset of 12 feet to the edge of the road.

**Figure 8: RTMS Mast for Rapid Deployment (View Looking South, Nov 12, 2010)**

The offset distance of 12 feet was chosen to emulate the scenario where the RTMS is set up beyond the shoulder of the freeway in a work zone evaluation. During the test, manual counting of vehicles passing in the area measured by the RTMS was performed for all lanes of traffic. As shown in Figure 8, there were two northbound lanes and two southbound lanes with a median which was one lane wide. The RTMS unit was placed next to the northbound lanes. The test data was collected for a period of 20 minutes and showed 123 northbound vehicles and 174 southbound vehicles in manual counting versus 120 northbound and 151 southbound vehicles in RTMS counting. This data indicates that the RTMS unit missed the number of vehicles by 2.4% in the near side lanes and by 13.2% in the far side lanes. This can be due to the shadowing effects (See Appendix B). Observation of the RTMS display unit during the testing showed that the system was, sometimes, registering “ghost” vehicles outside the boundaries of the far side lanes. This effect was mitigated by manually adjusting the lane range assignments on the RTMS. The final conclusion from this test is that RTMS units can provide relatively accurate measurement of traffic volume/count for near side lanes. It is therefore recommended that RTMS units be used in the manner described here for obtaining traffic volume/count in work zone testing for near side lanes. Near side lanes are defined as lanes adjacent to the location of the RTMS mast.

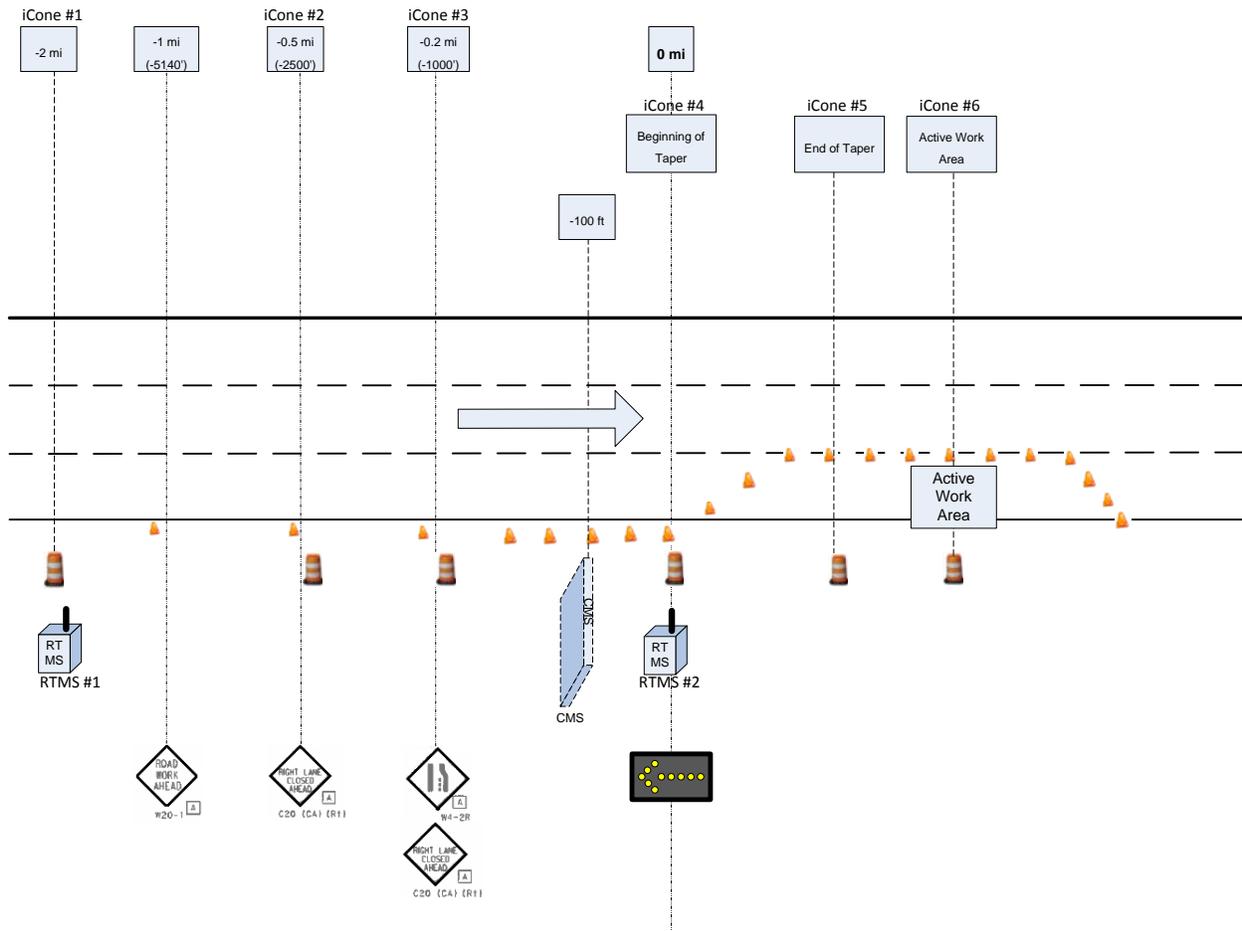
to obtain base-line values for average traffic speed, volume and headway. Discussions with Caltrans field personnel indicated that an approximate distance of two miles upstream of the beginning of taper is the proper location for these first set of sensing units. The next two iCones were distributed in-between the first work zone sign (stating: “Road Work Ahead”) and the beginning of taper. Data from these two iCones can provide information on speed changes due to the advisory signage for the work zone. The next set of iCone/RTMS pair was positioned at the beginning of taper to measure the number of vehicles remaining in the closing lane. This was also near the location of the CMS sign as recommended by Caltrans field personnel for the first test on March 22<sup>nd</sup>, 2011. The fifth iCone was then positioned at the end of taper which was upstream of where highway workers would be present. This was also the area that the reduction in lane(s) was completed in the work zone. The sixth and last iCone was positioned somewhere in the active work area of the work zone preferably approximately in the middle of this area to provide data on the final average traffic speed in the area closest to the highway workers. In the test performed, the work zone was along the fast lane of the highway (left side). The mirror image of this layout as shown in Figure 10 is used.

Figure 9: Proposed Sensor Layout for Work Zone Testing.

The sensor layout discussed served as a baseline configuration for field testing. The layout was adjusted to its final configuration based on logistics at a specific work zone and the requirements set forth by the Caltrans personnel in charge of a work zone.

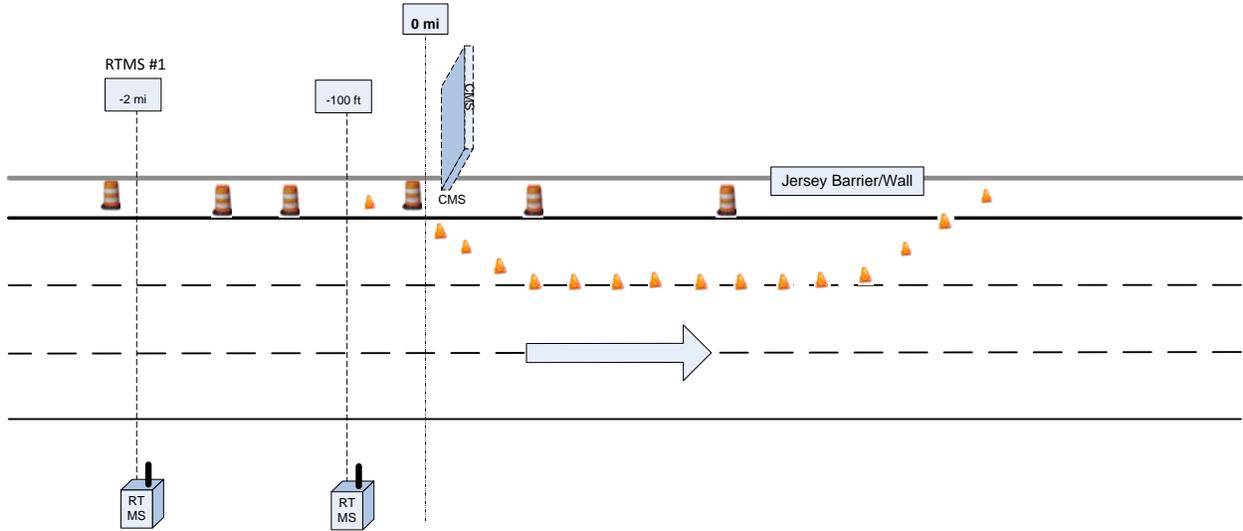
**Figure 10: Proposed Sensor Layout for Work Zones on the Left Side of a Highway.**

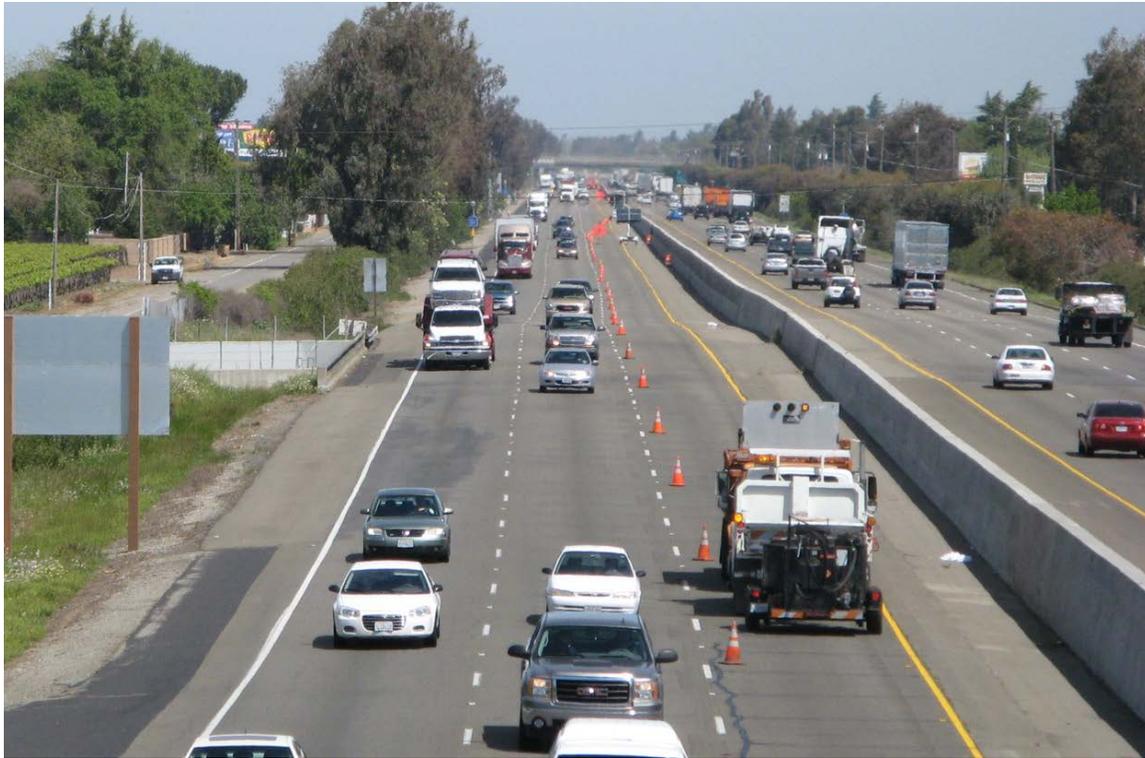
The work zone for the two April 15<sup>th</sup>, 2011 tests is shown in Figure 11. The test on March 22<sup>nd</sup>, 2011 was performed on the same highway upstream of the depicted location. A visual walk through of the April 15<sup>th</sup> work zone as seen from the view of the driver is depicted in Figure 12.

**Figure 11: View Looking Down At the Test Work Zone of April 15, 2011.**

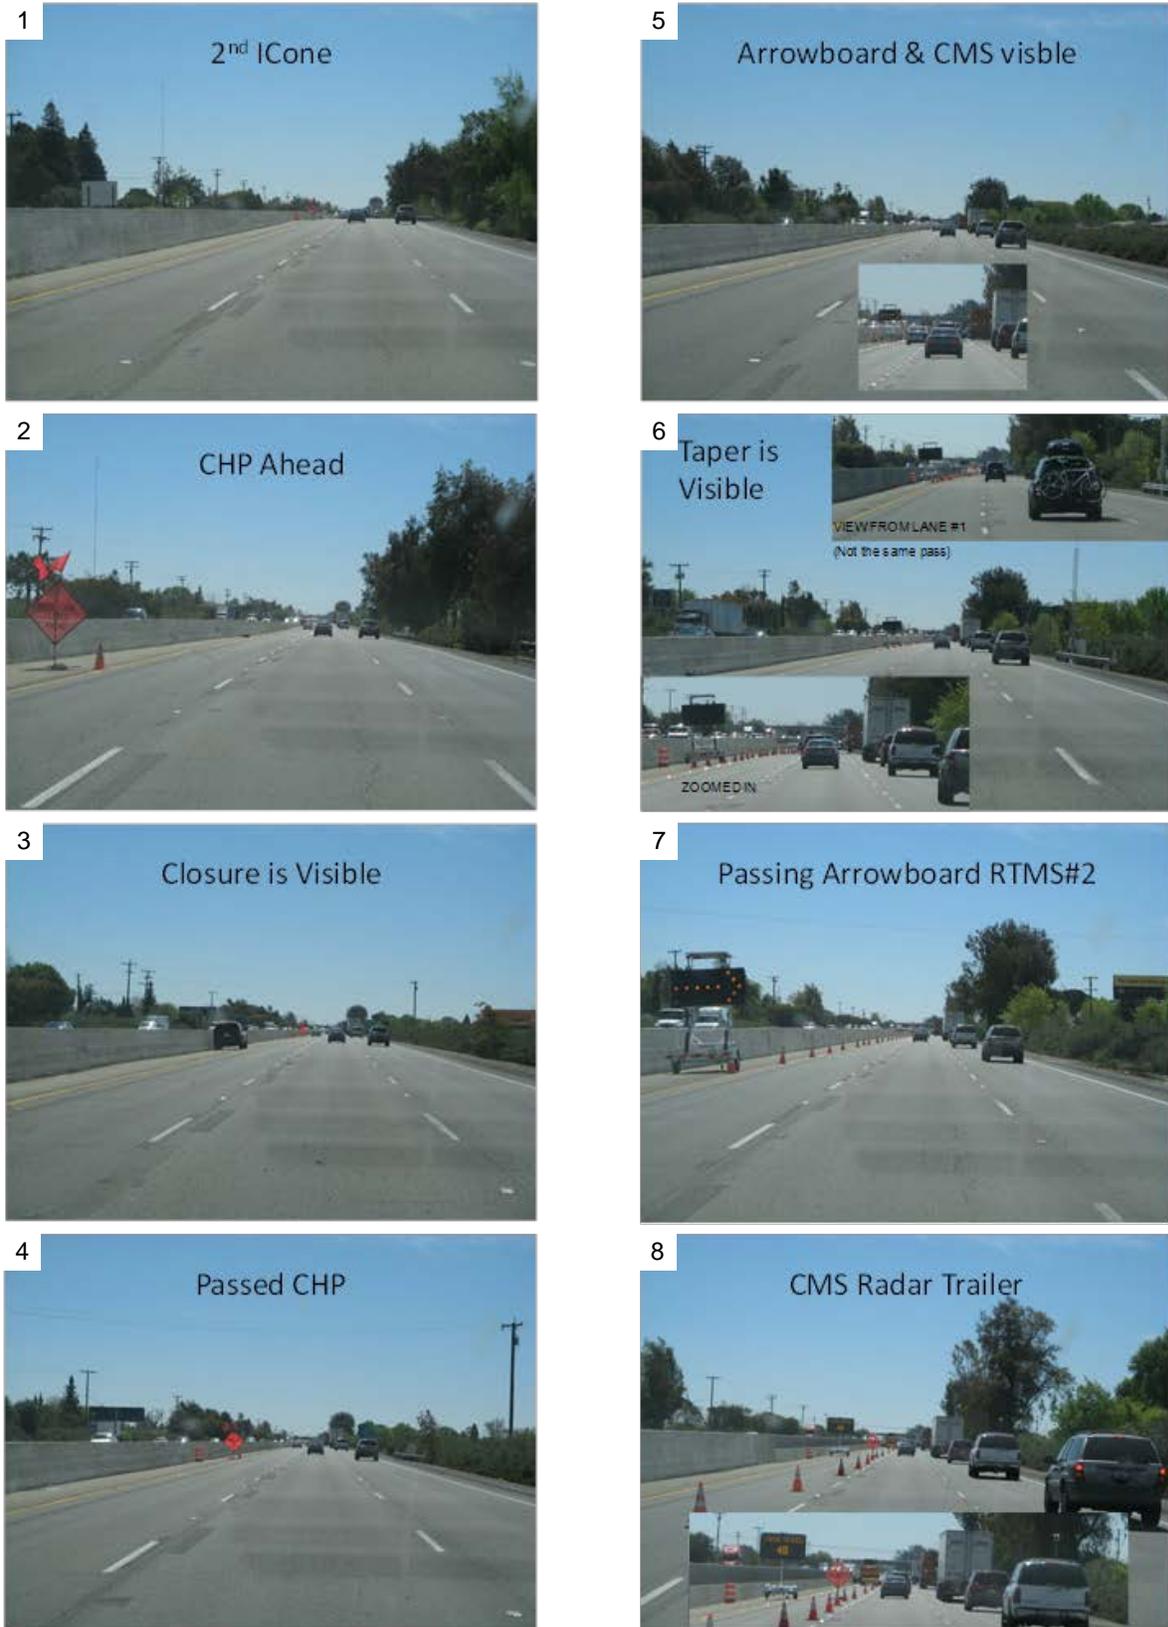
Figure 12: Pictorial Walk Through of the Test Work Zone on April 15, 2011

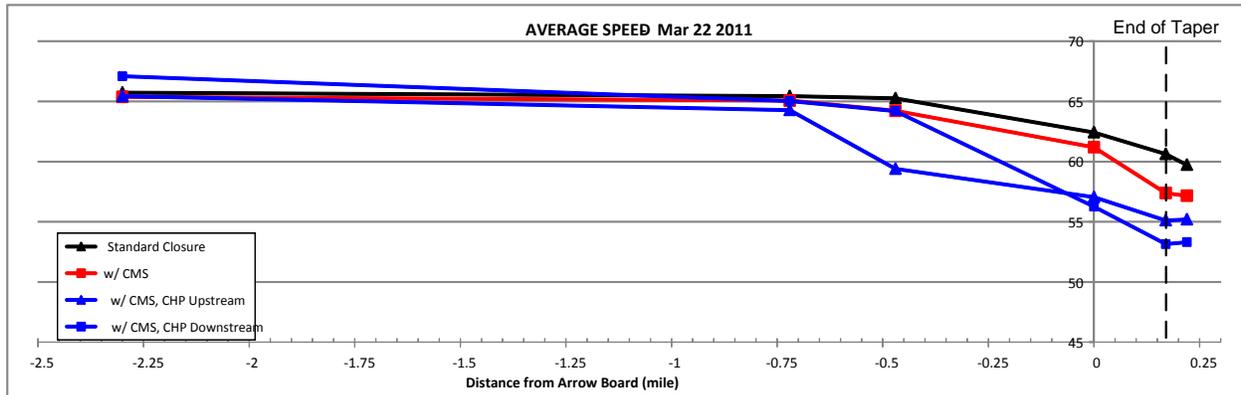
In this section, the test data from the six iCones from the three tests is discussed followed by the data obtained from the downstream RTMS. Figure 13 provides a summary plot of the six iCone speed measurements for testing of four different configurations on March 22<sup>nd</sup>, 2011. The horizontal axis plots the iCone location from the zero reference point in miles. The vertical axis is the average speed measured by the iCones in MPH. The four configurations consist each of speed measurements with no CHP-CMS and no CHP vehicle (indicated in black), CHP-CMS unit in place (indicated in red), CHP-CMS unit and CHP vehicle upstream (indicated in blue triangle), and CHP-CMS unit and CHP vehicle downstream (indicated in blue square).

Figure 13: iCone data from March 22, 2011 test.

The data in these plots clearly show that the CHP-CMS unit is effective (at least in the three tests) in positively influencing the driver behavior resulting in a reduction in average traffic speed from the upstream highway speed of approximately 8.0 to 12.6 MPH at the end of taper (fifth iCone or the second to last mark from the right in the plots). Furthermore, the same data indicates that the closure alone may be responsible for approximately 5.1 to 5.7 MPH of this reduction. The data also indicates that when there is a CHP vehicle upstream of CHP-CMS there is a local reduction of speed near the CHP vehicles but the speed at the end of taper is not significantly affected. The same local effect of the CHP vehicle in speed reduction was also observed in Test 2 of the April 15<sup>th</sup> test. This is illustrated in Figure 15. During this test, an unusual level of traffic congestion was developed, therefore it was not clear how much of the reduction in speed shown in Figure 15 is from the local effect of the CHP vehicle and how much is from the intrinsic traffic congestion. The main conclusion is that the data clearly indicates that the CHP-CMS trailer can be an effective deterrent for reduction of average traffic speed in a work zone.

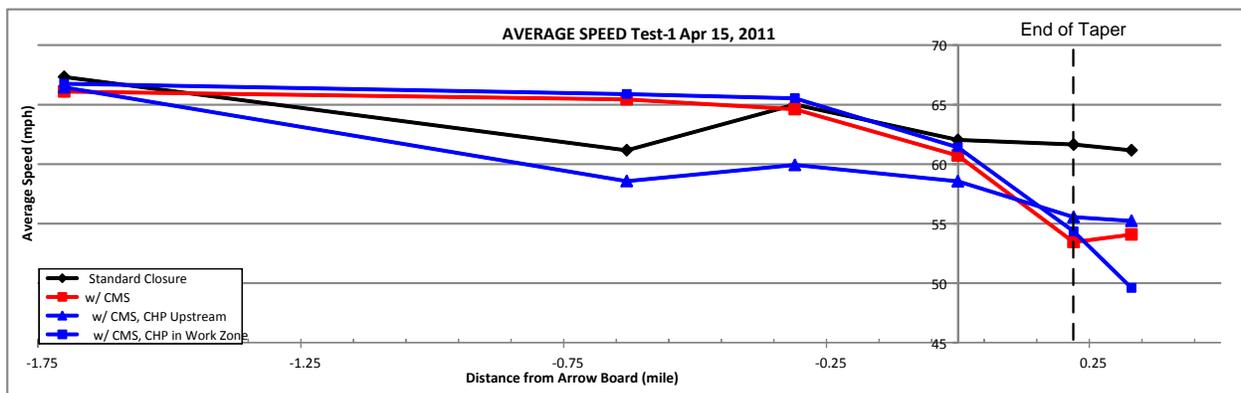
In the April 15<sup>th</sup> series of tests the CHP-CMS unit was positioned at the end of the taper rather than at the beginning due to lack of available shoulder space in the location of the taper. Plots in Figure 14 and Figure 15 represent average traffic speeds for the same configurations described for the March 22<sup>nd</sup> test. The plots in these three figures in combination with aerial views of the highway section where the iCones were placed are provided in Appendix C.

Figure 14: iCone Data from Test 1 (Morning Hours) on April 15, 2011.

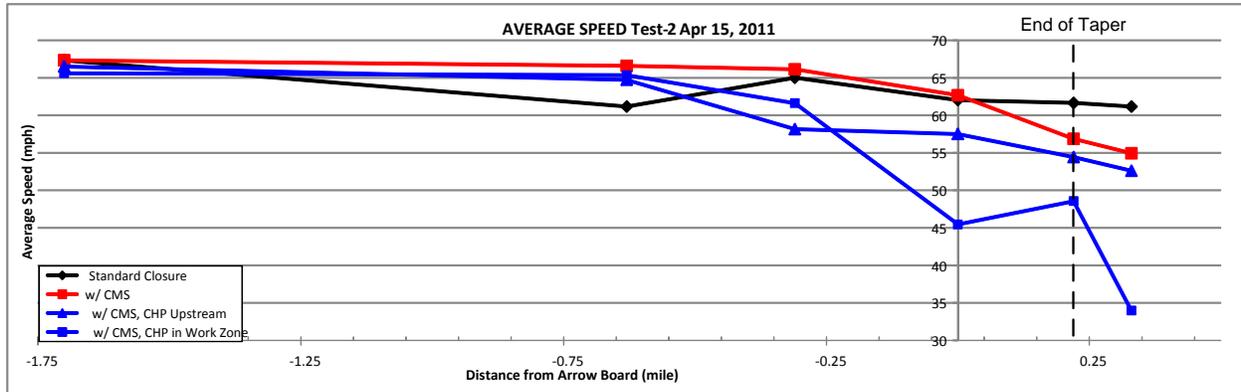
Figure 15: iCone Data from Test 2 (Afternoon Hours) on April 15, 2011.

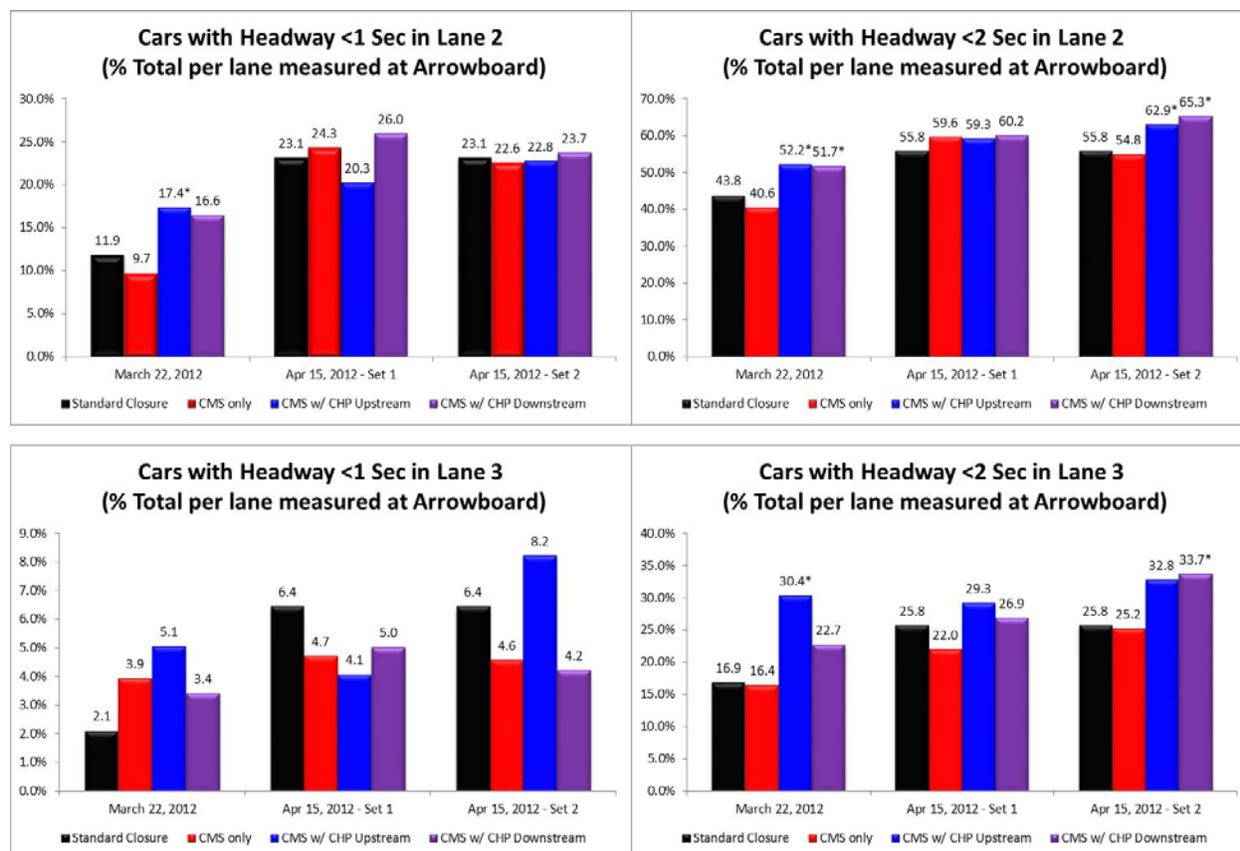
Finally the CHP-CMS unit with the CHP vehicle downstream of the CHP-CMS location is shown in purple. There are a total of four plots, two plots for the number two lane and two plots for the number three lane. Each of the two threshold values for headway is plotted per lane.

Figure 16: RTMS Data: Headway Data from All the Three Tests

A visual inspection of the data in the plots shows that the addition of the CHP-CMS unit to a standard lane closure produced no consistent effect on the percentage of vehicles with less than ideal and minimally ideal headways. A similar observation can be made for the addition of a CHP vehicle, both upstream and downstream of the CHP-CMS unit.

A chi-square ( $\chi^2$ ) test using a 2 x 2 contingency table was conducted to determine the statistical significance of the differences between the standard closure and other conditions. A difference is considered significant if  $\chi^2 \geq 3.841$ , indicating a probability level (p-value) of less than 0.05. The significant differences are denoted with “\*” in Figure 16. The CHP-CMS unit’s effect on headway is inconclusive. The existence of significant increases in percentage points in some plots of the CHP-CMS with the CHP vehicle suggests that there may be a risk of causing drivers to follow each other too closely.

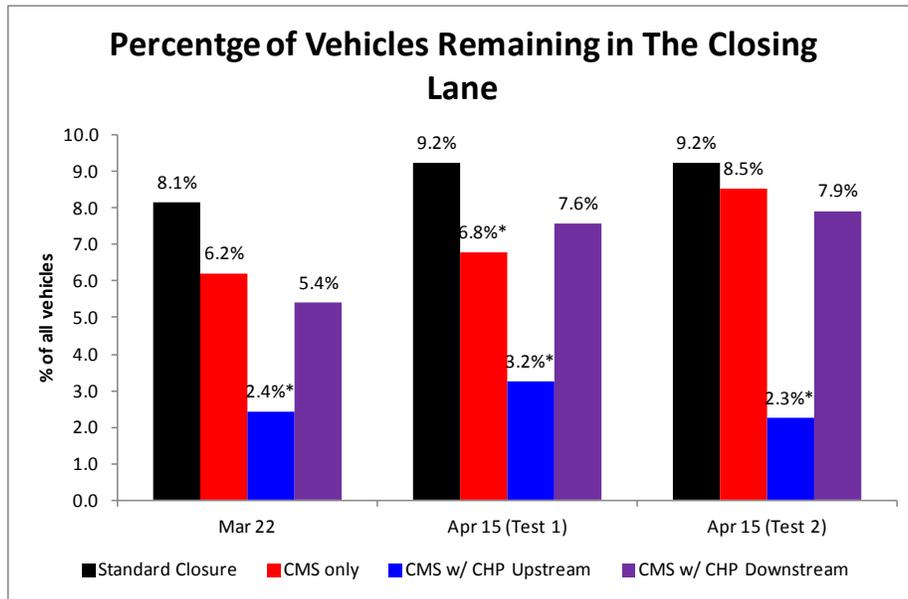
The other aspect of the RTMS data is the per-lane traffic volume/counts. This data is obtained by manually counting all vehicles in the video footage produced by the onboard camera of the RTMS. The percentage of vehicles remaining in the closing lane (No. 1 lane) is then used as an indicator of late merging behavior. The percentage data is plotted in Figure 17.

**Figure 17: RTMS Data: Percentage of Vehicles Remaining in Closing Lane at the Beginning of Taper from All Three Tests**

The data suggests there are reductions in the percentage of vehicles remaining in the closing lane at the beginning of taper. The Chi-square analysis was also performed for this set of data. The presence of the CHP-CMS unit only resulted in significant reduction for one of the three tests ( $\chi^2 = 5.1872$  for Test 1 of April 15<sup>th</sup>). The presence of the CHP-CMS with the addition of the CHP vehicle upstream resulted in significant reduction in all three tests ( $\chi^2 = 16.4471, 34.7272, 28.9308$ , for March 22<sup>nd</sup>, Test 1 of April 15<sup>th</sup> and Test 2 of April 15<sup>th</sup>, respectively). The presence CHP-CMS unit with the CHP vehicle downstream resulted in no significant reduction of late-merging vehicles. The reductions associated with the CHP vehicle located upstream are consistently significant.

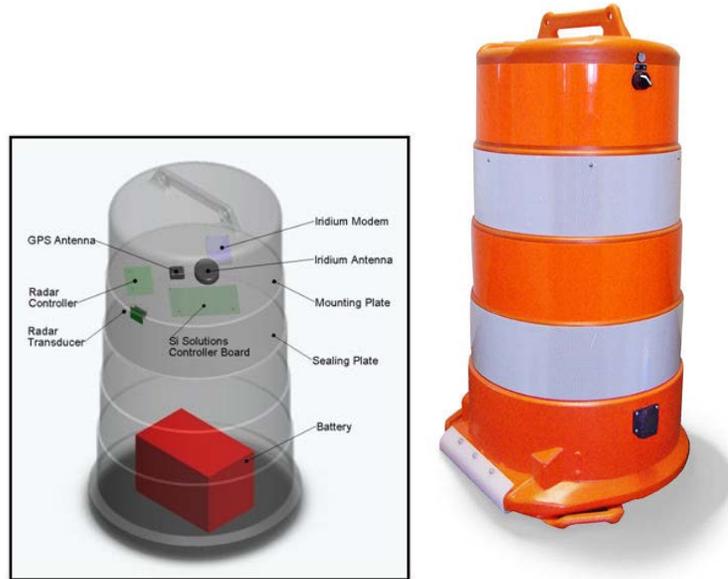
**Figure A - 1: Inside/Outside of an iCone (Note the switch near the top and charging port on the base).**

The electronics are located towards the top of the barrel, whereas the battery is fixed to the base of the barrel. The overall appearance of the iCone closely resembles that of a regular traffic control barrel, but there are a few subtle differences: there is a switch near the top of the barrel, a charging port on the base, and an arrow sticker on the top of the iCone to aid in aiming during deployment. This non-threatening appearance minimizes its influence on the motorists, making the iCone system an ideal candidate for recording traffic speed data inconspicuously. A device that catches a driver's attention may cause them to slow down, thus introducing bias in the data collected.

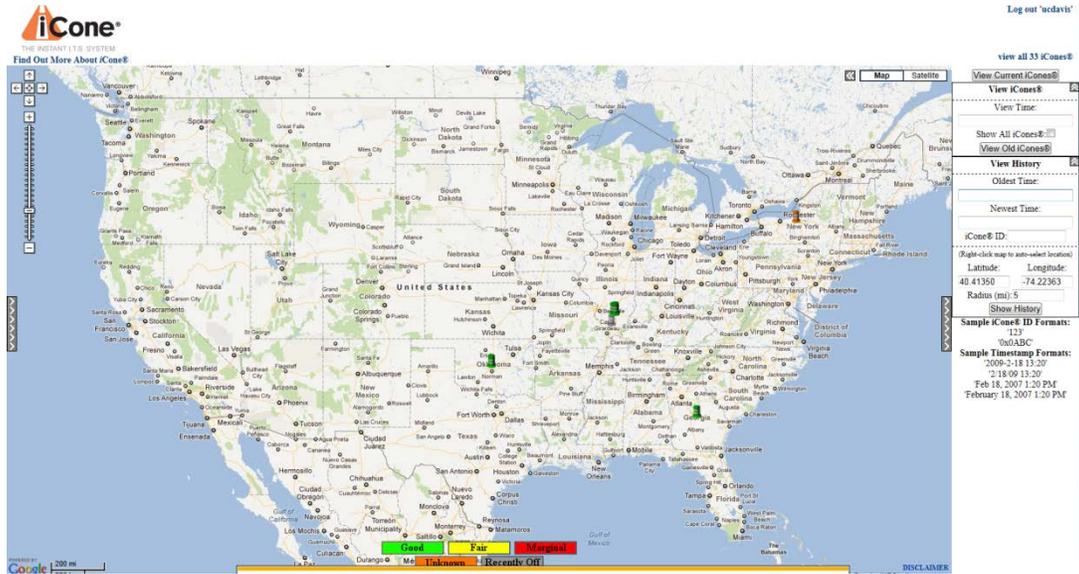
Figure A - 2: US map with iCone locations

The iCone is generally managed through a web application which can be accessed on most standard web-browsers. The reader can access the web application at [www.iConeTraffic.com](http://www.iConeTraffic.com). The home page (Figure A - 2) of the web site is viewable by the public and provides qualitative access to data that has been designated as 'public'. The site is based upon the Google Maps API and is navigated in a similar manner. Selecting an iCone icon brings up details of the iCone's settings and the conditions of the traffic that is being monitored. Within there are buttons that allow the user to retrieve the historical speed record as either a plot (\*.jpg) or a text file (\*.csv). For example, iCone 335 was chosen and its location is shown in Figure A - 3 below.

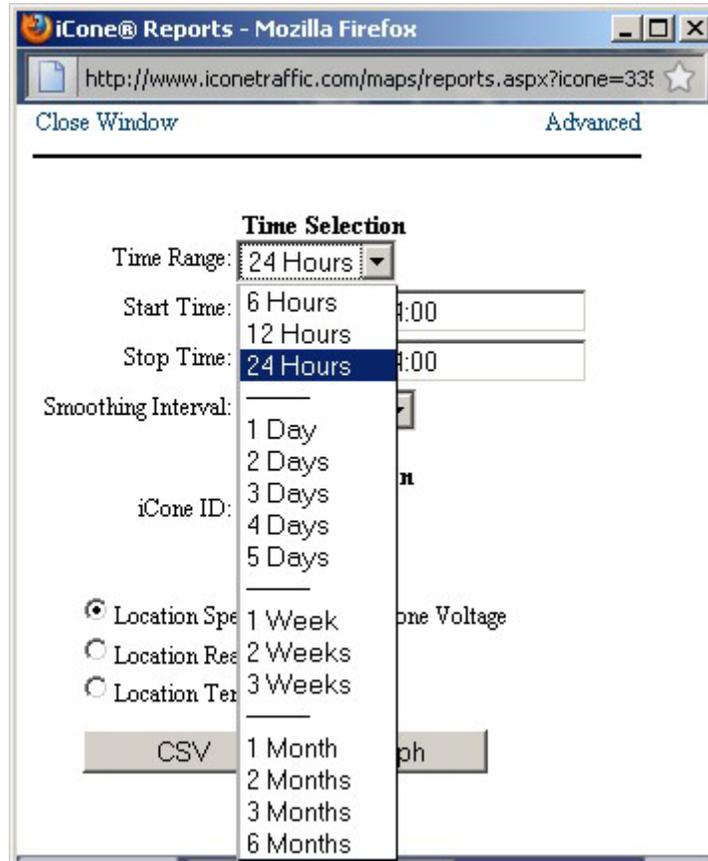
Figure A - 4: Pop up window with time range selections

Upon clicking on “ Get Historical Report”, a pop-up window presents the user a selection of items such as the desired time, the time interval (Figure A - 4), the smoothing interval (Figure A - 5), etc., to view or download for post processing. The data can be exported to a text file (Figure A - 6) or plotted on an image (Figure A - 7), as shown below.

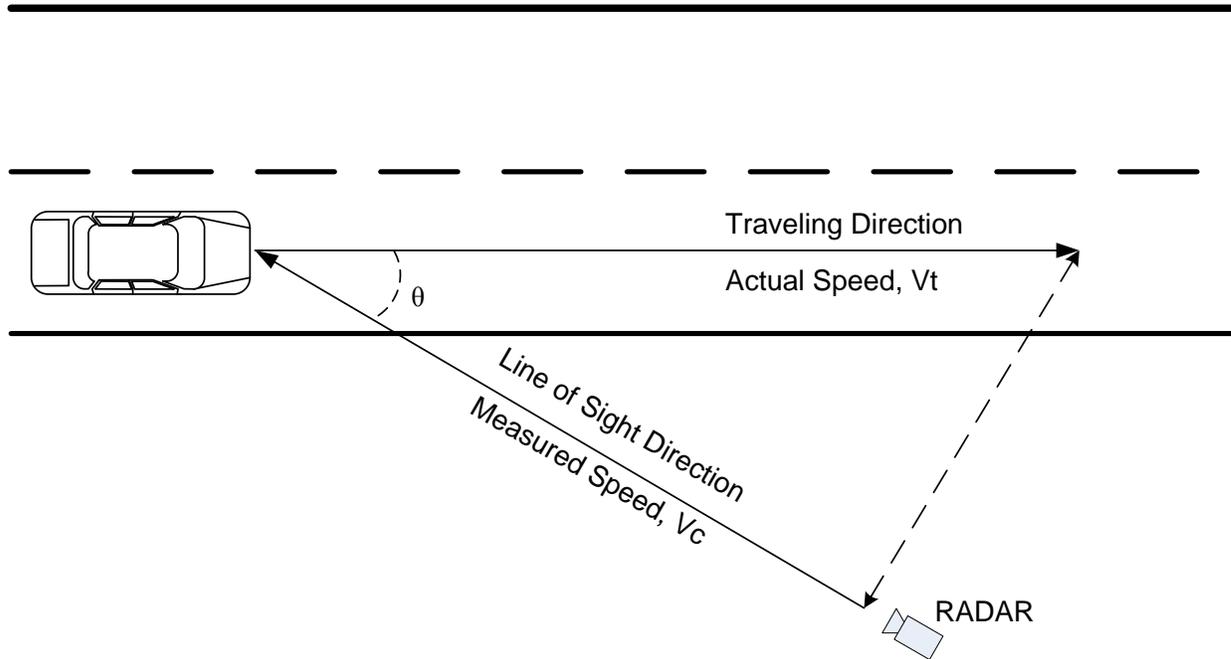
The radar unit inside the iCone detects the relative speed between the observers and the observed based on the Doppler Effect. In the case of traffic monitoring, the “line of sight” of the radar doesn’t always match the target vehicle’s direction of travel, as depicted in Figure A - 8. This mismatch causes the measured relative speed between the observer and the target vehicle being different from the actual traveling speed of the vehicle. This phenomenon is called the Cosine Effect. The speed measured by the radar is merely a component of the vehicle’s velocity parallel to radar’s line of sight and is therefore less than the actual traveling speed of the vehicle.

**Figure A - 8: Radar device on the shoulder, not in line with the car's traveling direction. The relative velocity between the vehicle and the radar was less than the vehicle's actual traveling speed.**

The relationship between the actual traveling speed and the measured speed can be determined from Figure A - 8 in the following equation:

In most cases the angle is small such that  $v_t \approx v_c$  with  $\theta \rightarrow 0$  is an adequate approximation of the traveling speed of the target vehicle. The opposite extreme case is when the radar's line of sight direction is perpendicular to the traveling direction, i.e.  $\theta = 90^\circ$ . In this case the measured speed will be zero regardless of the traveling speed of the target vehicle. However, this situation assumes the ideal condition where the angular beam width of the radar is infinitely narrow. For practical purposes, it can be assumed that the beam width of the iCone's radar is wide enough such that the Cosine Effect is negligible. The sensitivity of to the Cosine Effect is evaluated by placing multiple iCones at different angles and comparing the measured speeds on the same section of a road. The evaluation result can be found in the main body of this report.

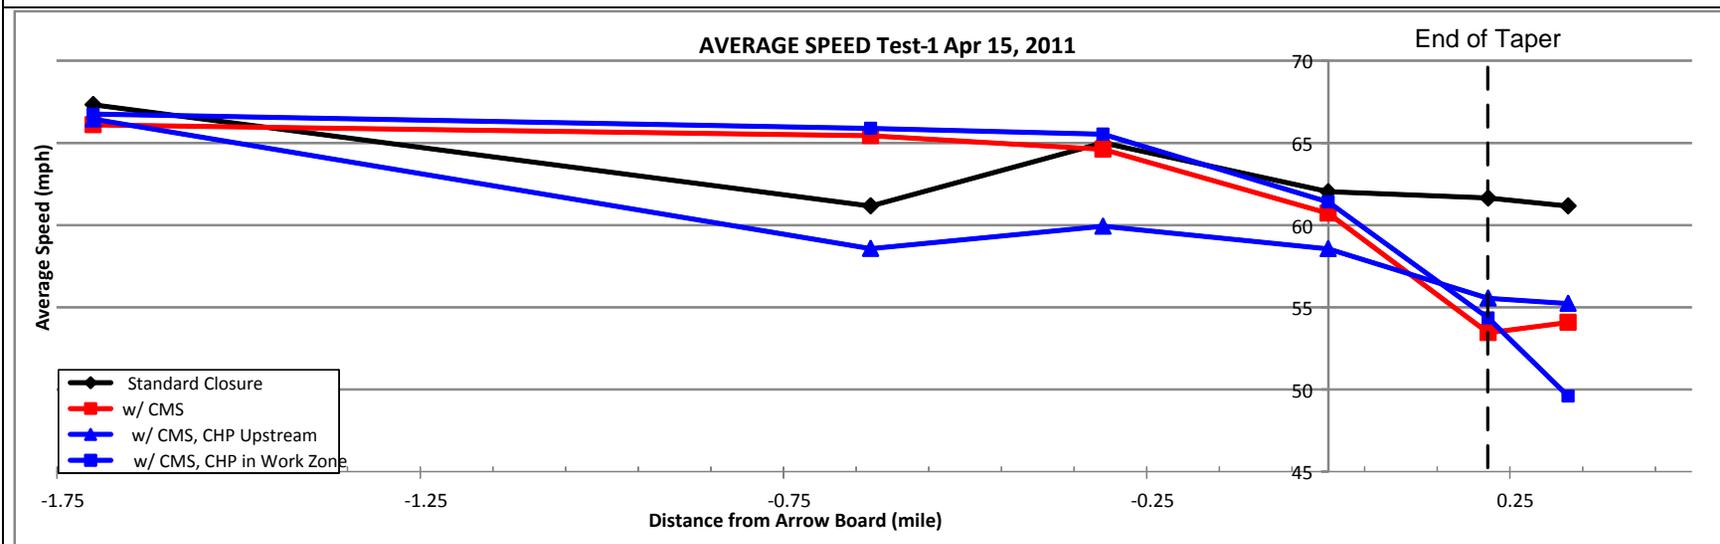
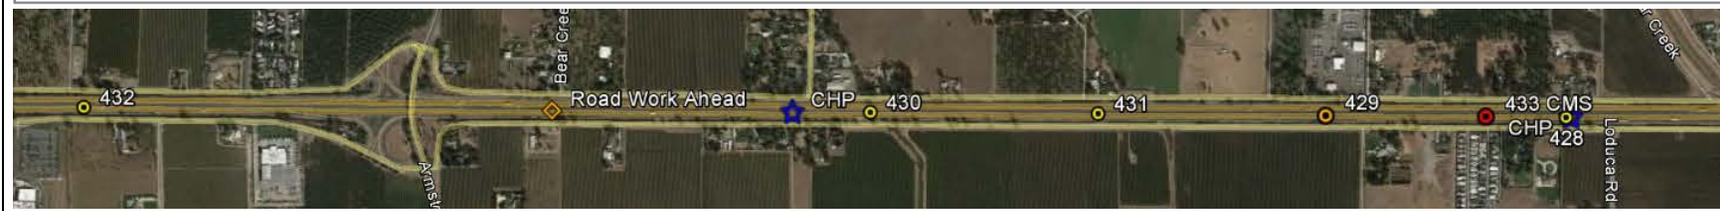
April 15, 2011 – Test 1  
 (Map data ©2013 Google)

### APR 15, 2011 - 99 Southbound – E 8 Miles Rd, Test 1
