1. Report No. CA 13 2247		2. Government Accession No.		3. Recipient's Catalog No.	
4. Title and Subtitle Evaluation of Methods to Reduce Speed in Work Zones				5. Report Date June 28, 2012

## **Evaluation of Methods to Reduce Speeds in Work Zones**

AHMCT Research Report: UCD-ARR-12-06-30-06  
Final Report of Contract: 65A0275, Task ID: 2247

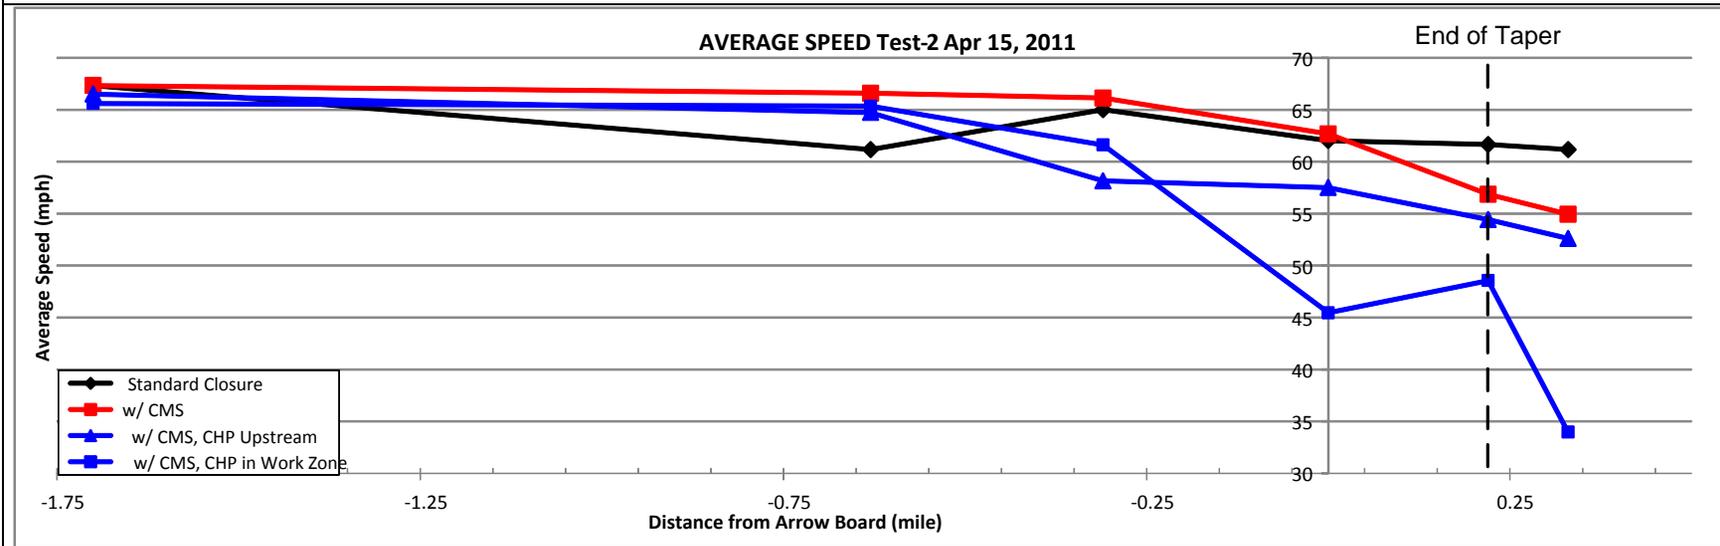
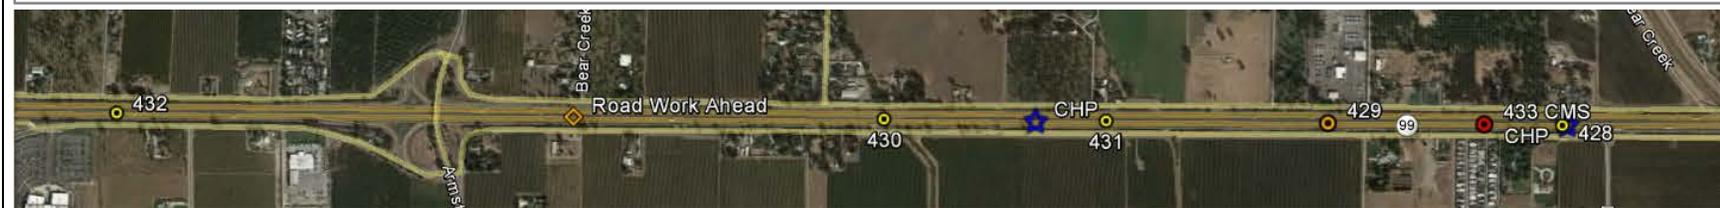
April 15, 2011 – Test 2  
 (Map data ©2013 Google)

### APR 15, 2011 - 99 Southbound – E 8 Miles Rd, Test 2
