ASBESTOS AND LEAD-CONTAINING PAINT SURVEY

**South Coast 101 HOV Lanes
Between 0.44 Mile South of
Carpinteria Creek, Carpinteria, and
Sycamore Creek in Santa Barbara
Santa Barbara County, California**

**GEOCON PROJECT NO. S9200-06-81
TASK ORDER NO. 81, EA 05-0N7000**

FEBRUARY 2010

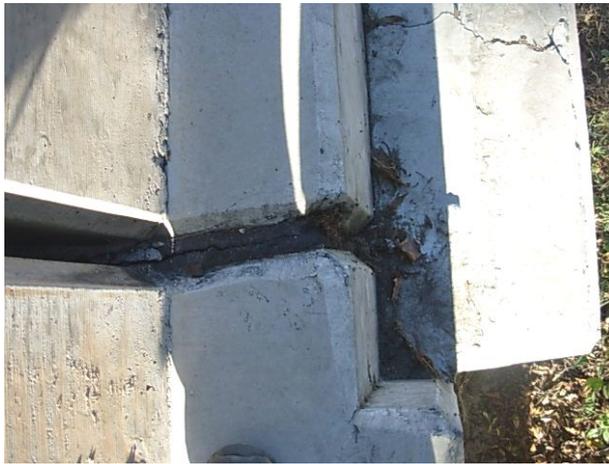
Photo 2 – Bridge 51-0086R joint fill material

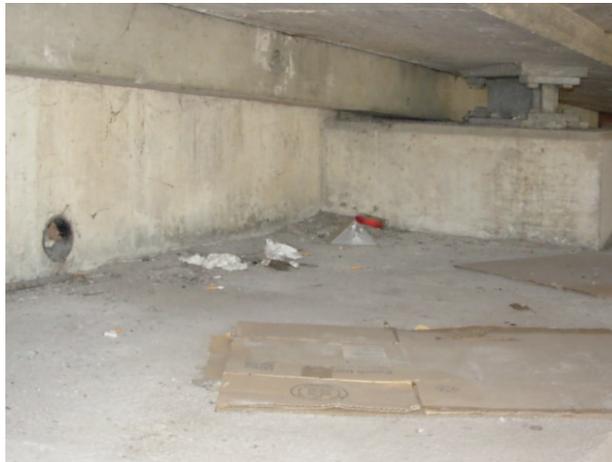
Photo 3 – Bridge 51-0086R bearings, headwall, and headwall drainpipe

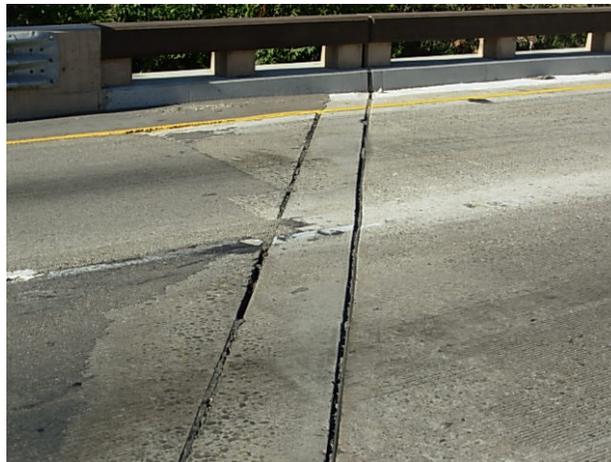
Photo 6 – Bridge 51-0086R deck seal (non-suspect)

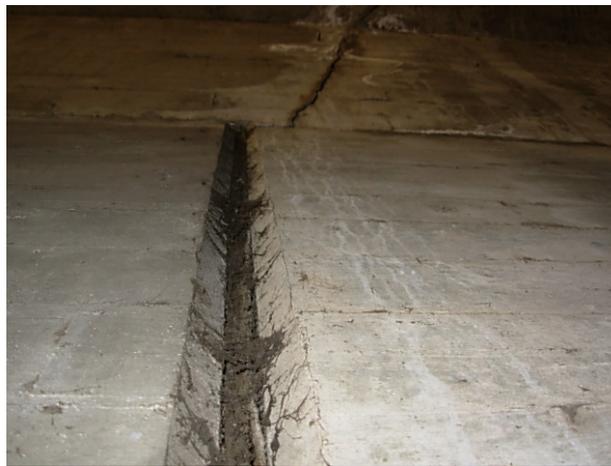
Photo 8 – Bridge 51-0086L joint fill material

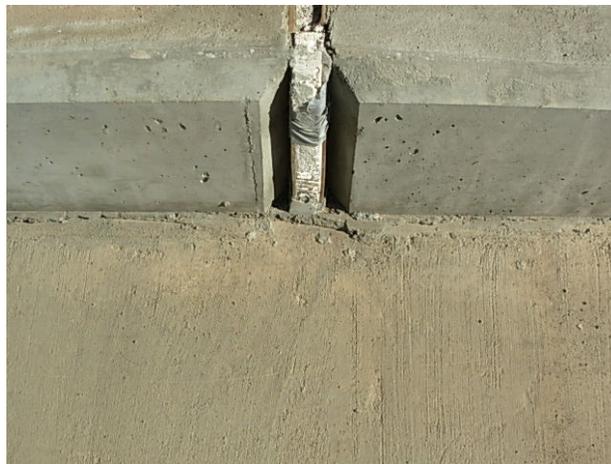
Photo 9 – Bridge 51-0086L span joint fill material (non-suspect)

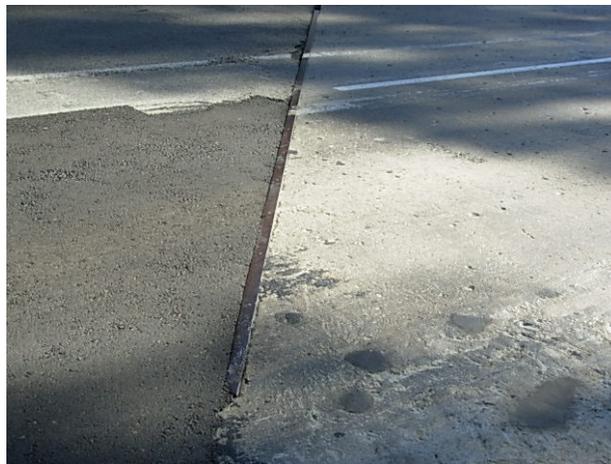
Photo 12 – Bridge 51-0086L deck seal (non-suspect)

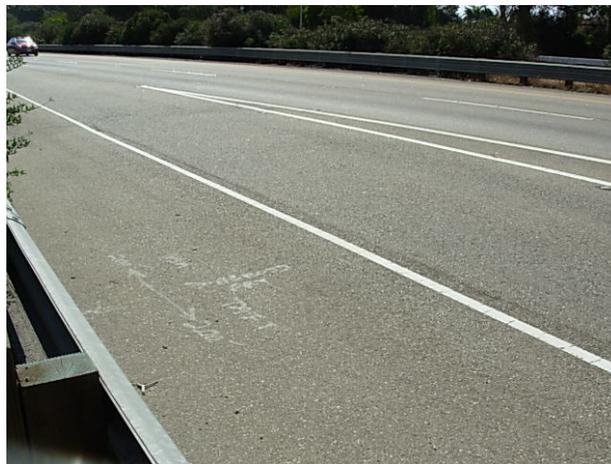
Photo 14 – Bridge 51-0188 deck seal (non-suspect)

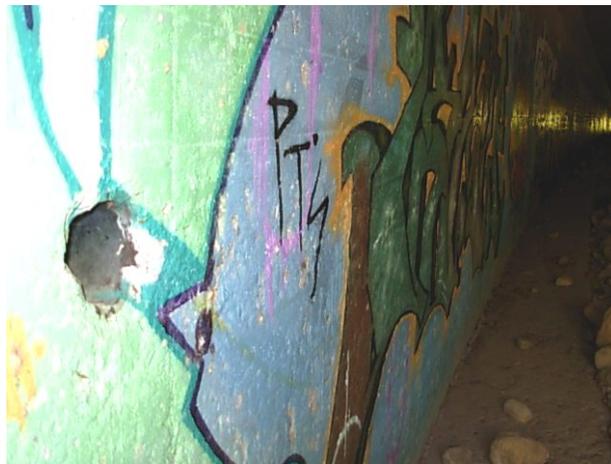
Photo 17 – Bridge 51-0187 drainpipe

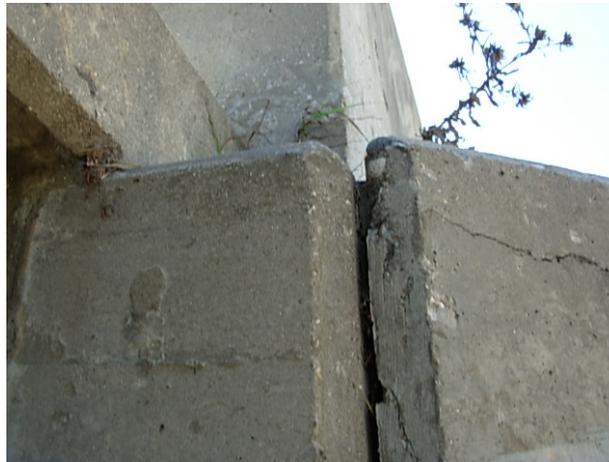
Photo 21 – Bridge 51-0133 abutment joint

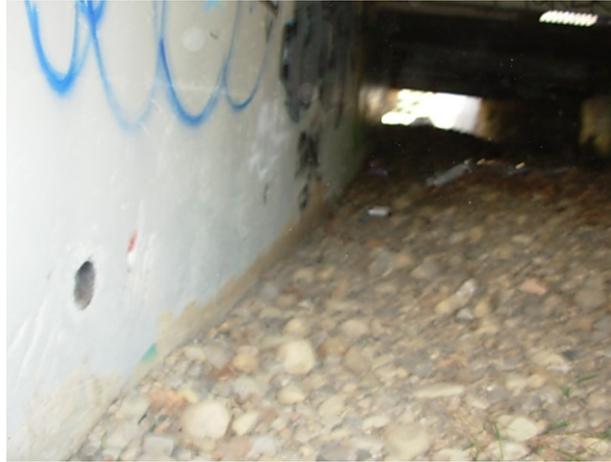
Photo 22 – Bridge 51-0133 drainpipe

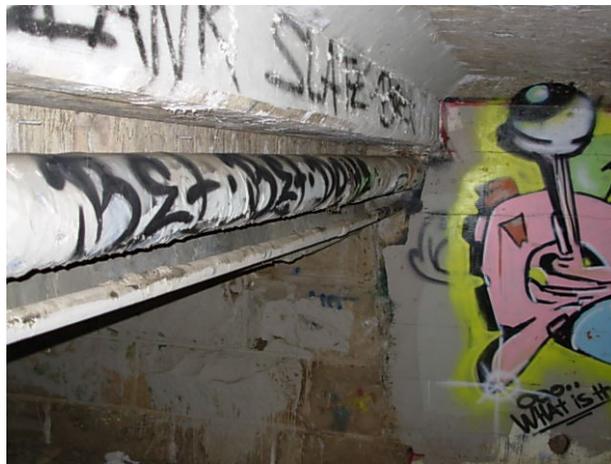
Photo 23 – Bridge 51-0133 asphalt pipe wrap

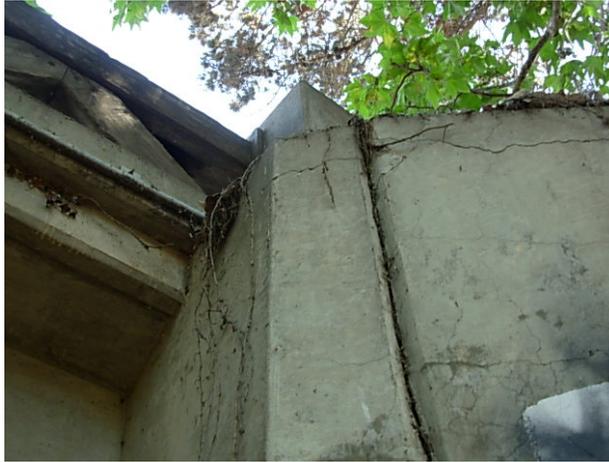
Photo 25 – Bridge 51-0047 abutment joint

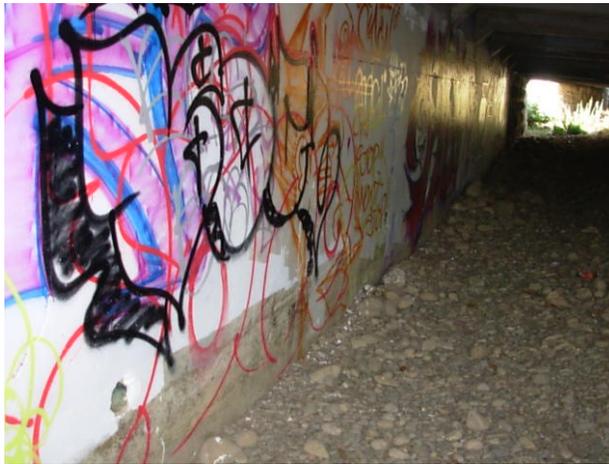
Photo 26 – Bridge 51-0047 drainpipe

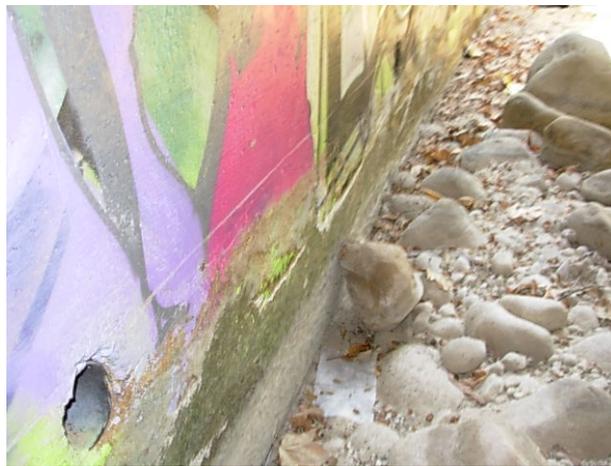
Photo 29 – Bridge 51-0053 drainpipe

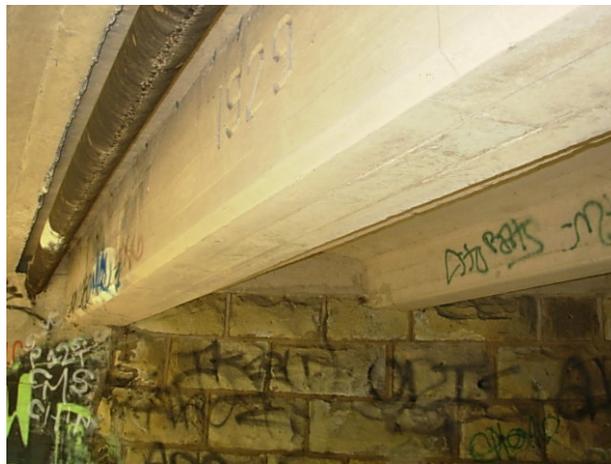
Photo 30 – Bridge 51-0053 asphalt pipe wrap

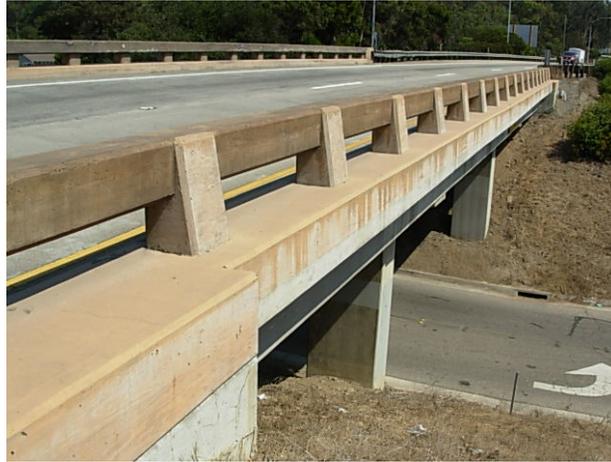
Photo 31 – Sheffield UC (51-0189R)

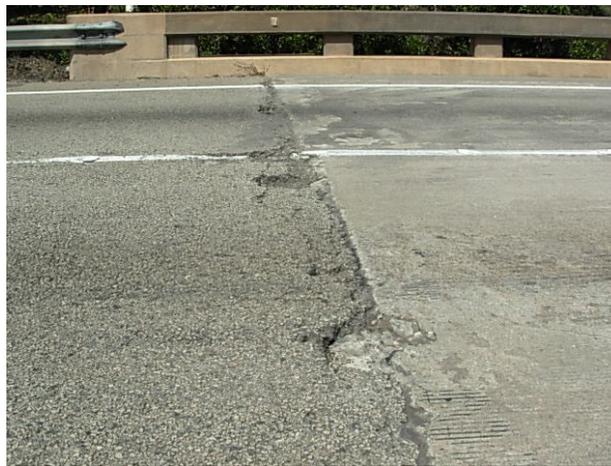
Photo 32 – Bridge 51-0189R deck joint (non-suspect)

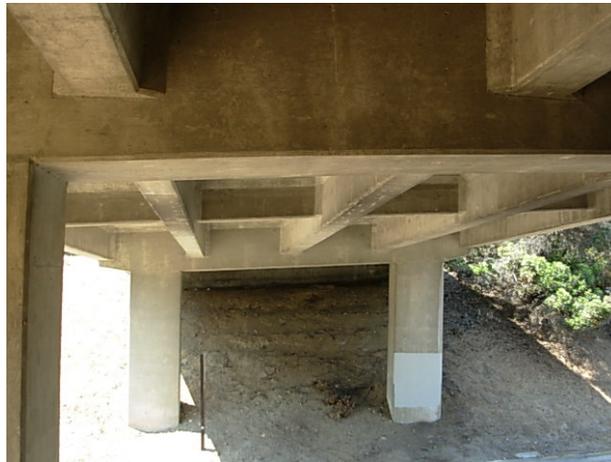
Photo 33 – Bridge 51-0189R concrete girder system

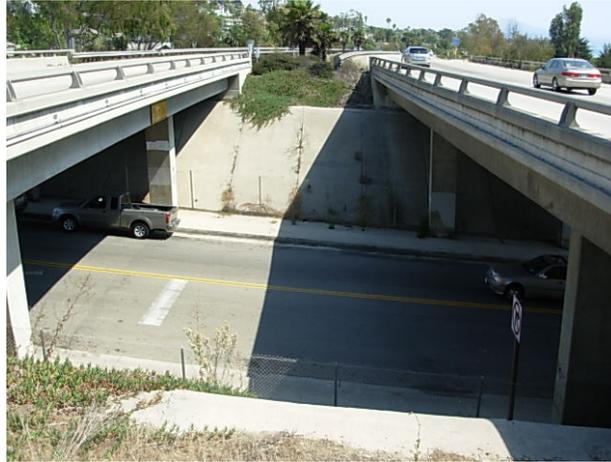
Photo 34 – Evans Avenue UC (51-0226L/R)

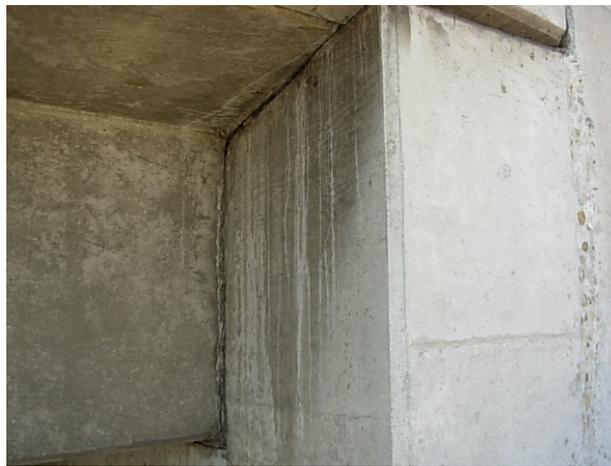
Photo 35 – Bridge 51-0226L/R abutment joint

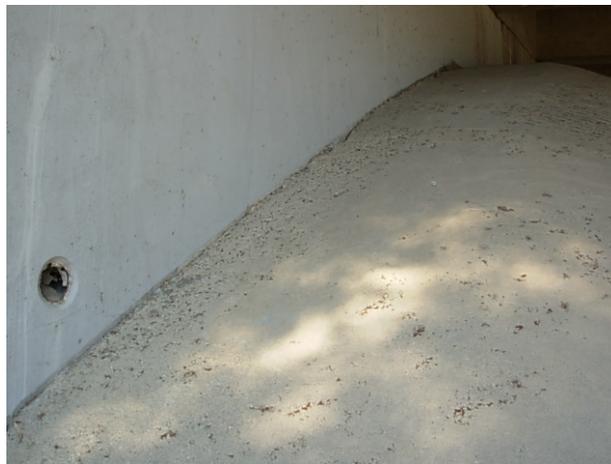
Photo 36 – Bridge 51-0226L/R drainpipe

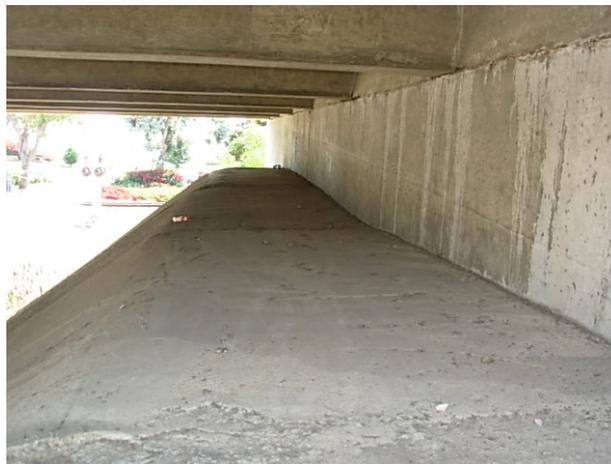
Photo 38 – Bridge 51-0226L/R headwall

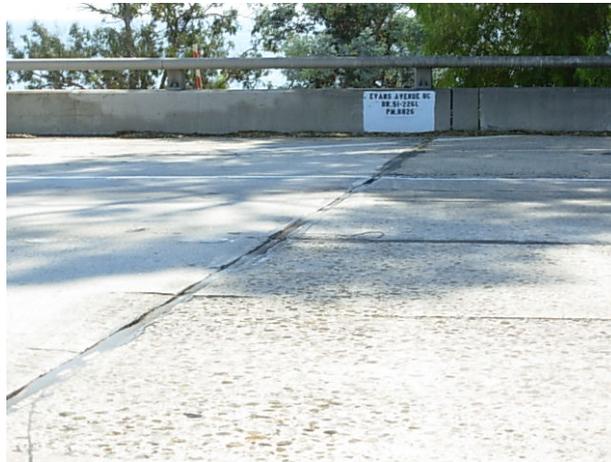
Photo 39 – Bridge 51-0226L/R deck joint (non-suspect)

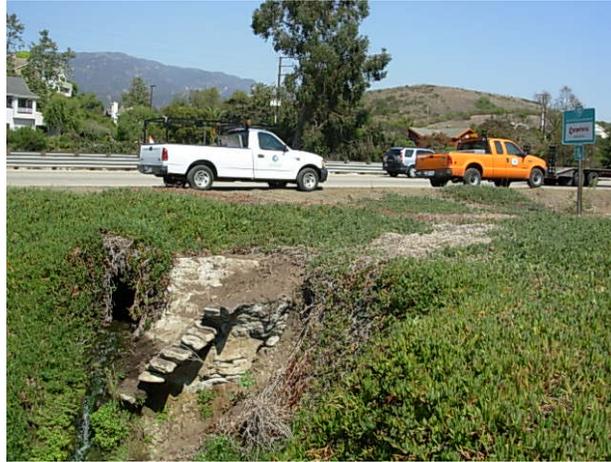
Photo 40 – Corrugated steel culvert (72-inch diameter) at postmile 7.72 (near Greenwell Avenue)

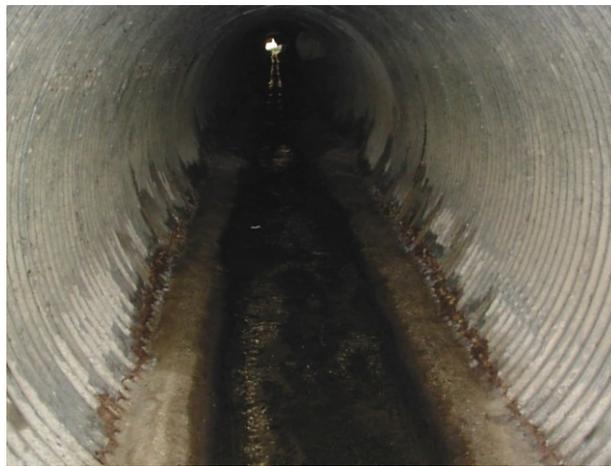
Photo 41 – Corrugated steel culvert (72-inch diameter) at postmile 7.72 (non-suspect)

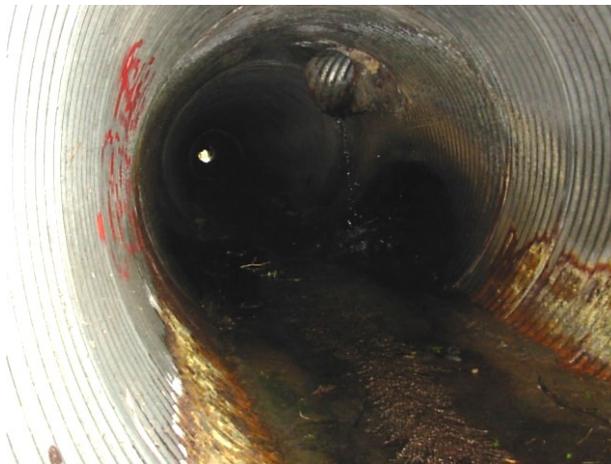
Photo 42 – Corrugated steel culvert (72-inch diameter) at postmile 7.72 (non-suspect)

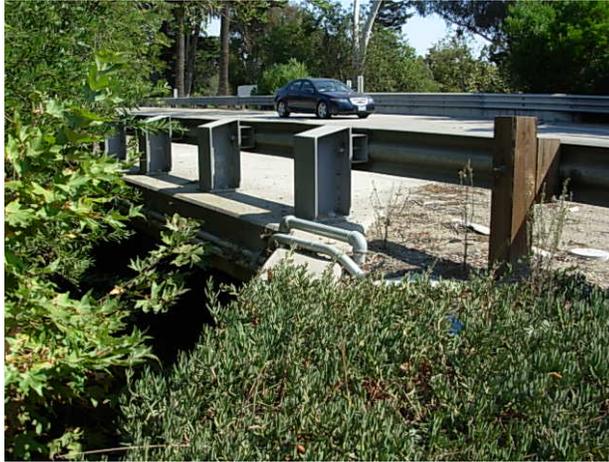
Photo 43 – Torro Canyon Creek Bridge (51-0054L/R)

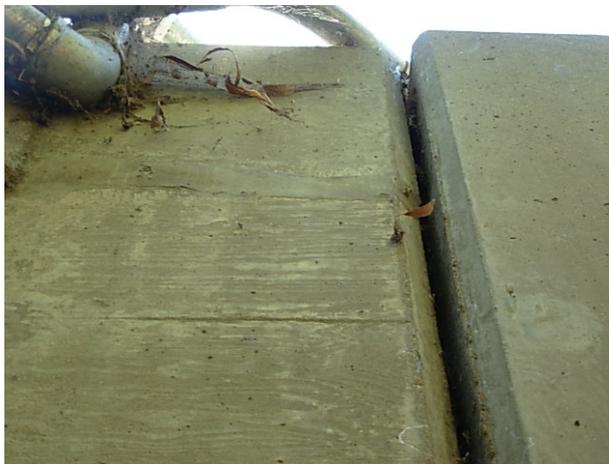
Photo 44 – Bridge 51-0054L/R abutment joint

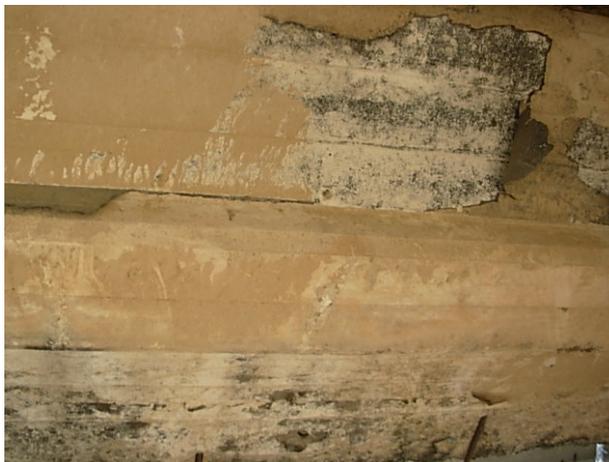
Photo 45 – Bridge 51-0054L/R vapor barrier

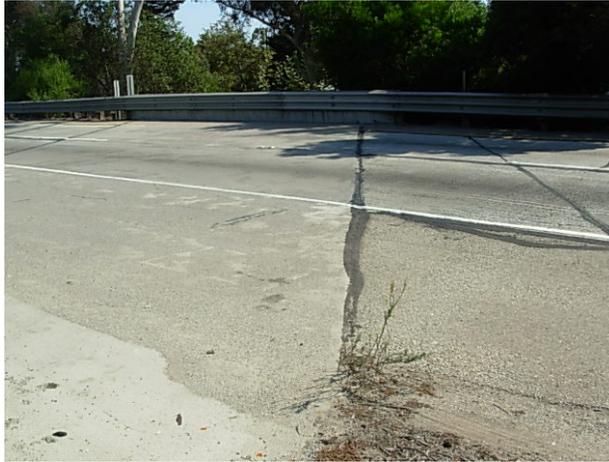
Photo 46 – Bridge 51-0054L/R deck joint (non-suspect)

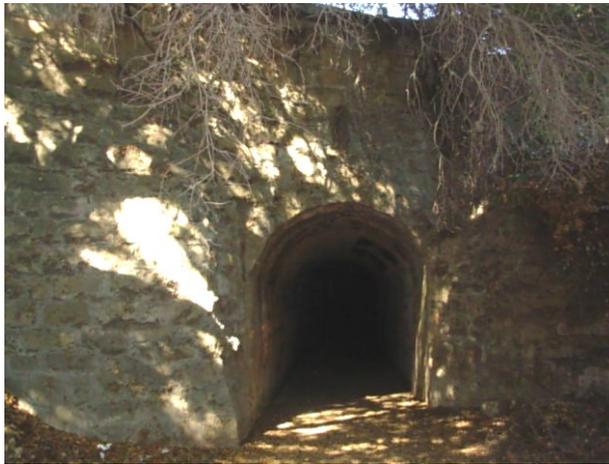
Photo 47 – Gararapato Creek box culvert at postmile 6.24

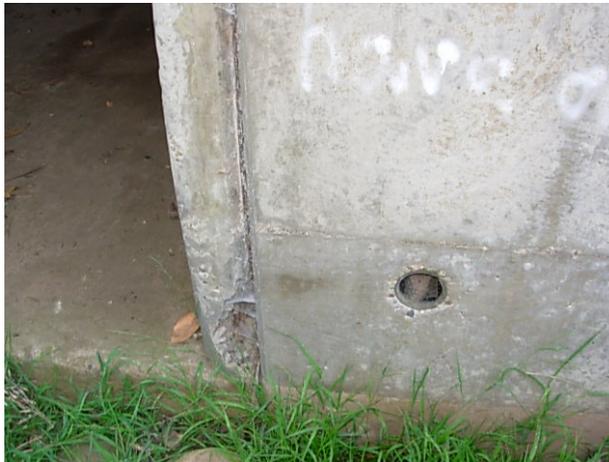
Photo 48 – Box culvert at postmile 6.24 (drainpipe)

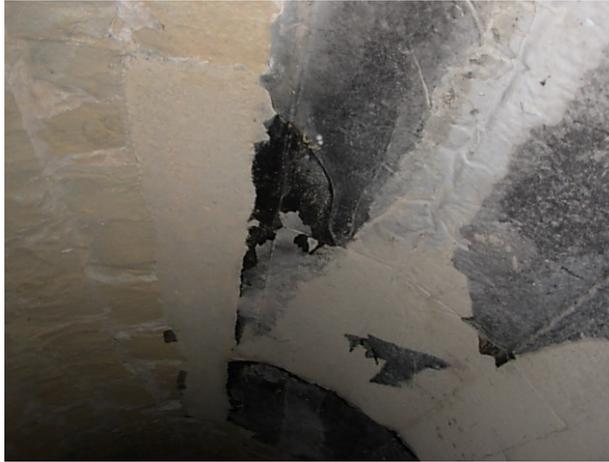
Photo 49 – Box culvert at postmile 6.24 (vapor barrier)

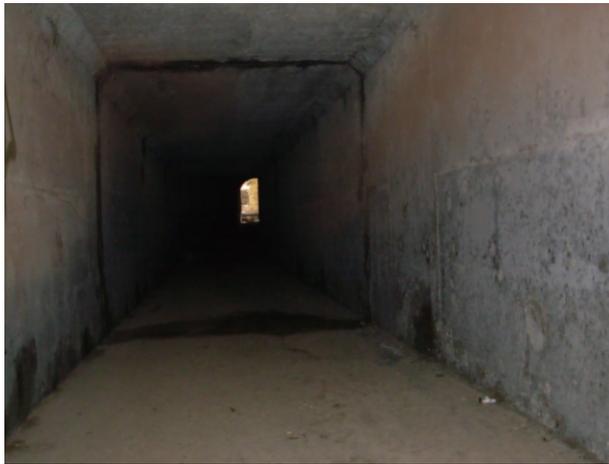
Photo 50 – Box culvert at postmile 6.24

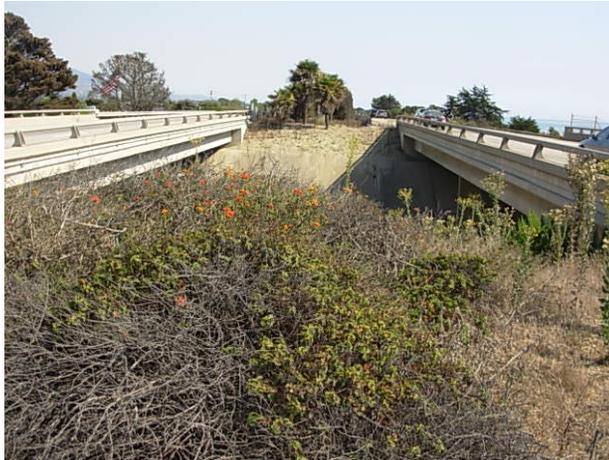
Photo 51 – South Padaro Lane UC (51-0228L/R)

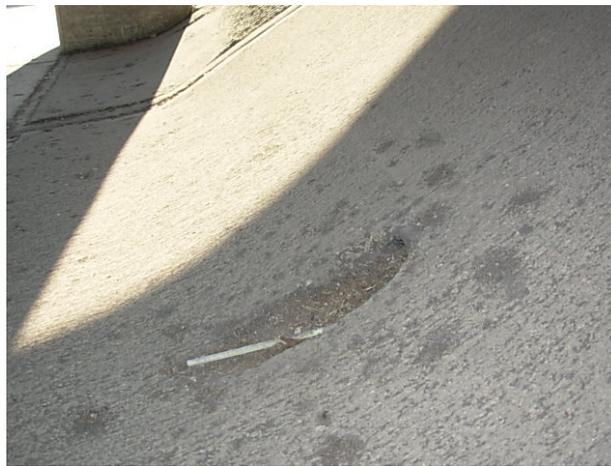
Photo 53 – Bridge 51-0228L/R drainpipe

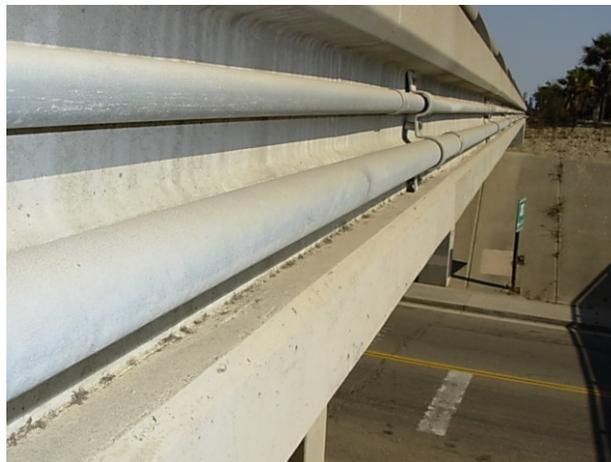
Photo 54 – Bridge 51-0228L/R conduit (non-suspect)

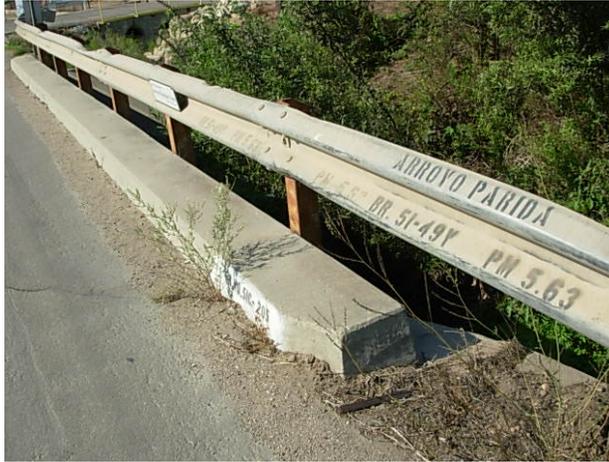
Photo 55 – Arroyo Parida Creek Bridge (51-0049Y)

Paint identified on the Arroyo Parida Creek Bridge (51-0049Y) during our survey would be classified as California and Federal hazardous based on lead content if stripped, blasted, or otherwise separated from the substrate.

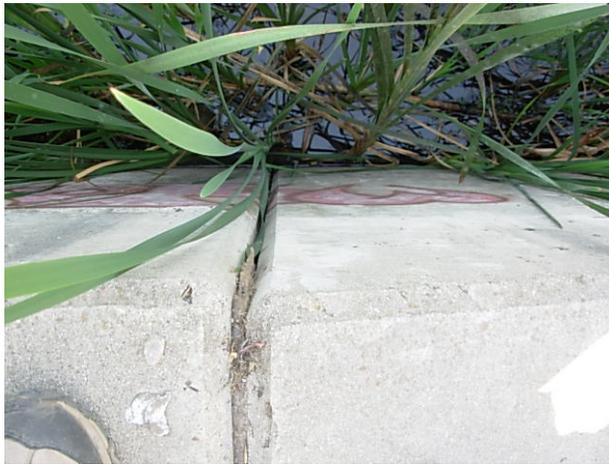
Photo 56 – Bridge 51-0049Y joint fill material

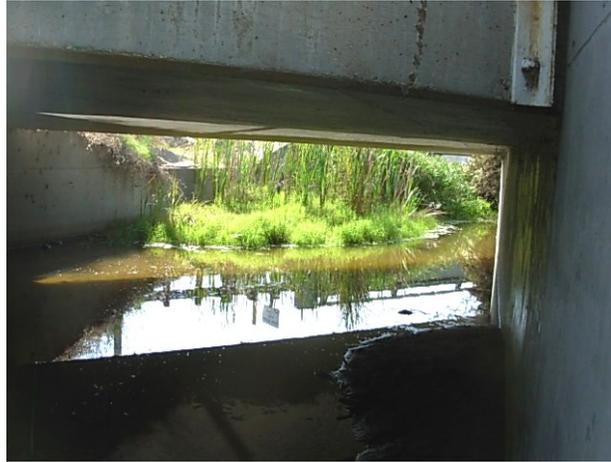
Photo 58 – Bridge 51-0049Y

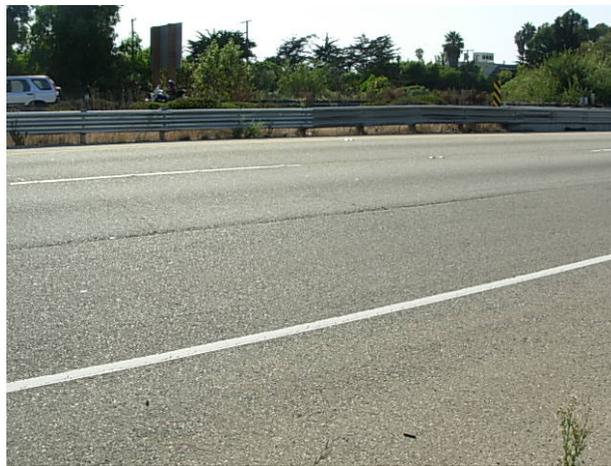
Photo 59 – Arroyo Parida Creek Bridge (51-0049L/R)

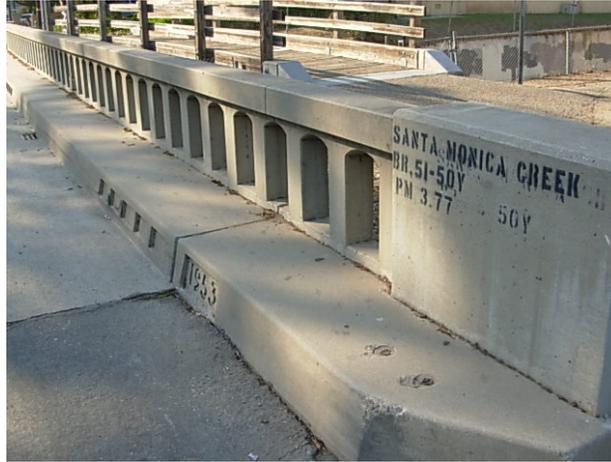
Photo 61 – Santa Monica Creek Bridge (51-0050Y)

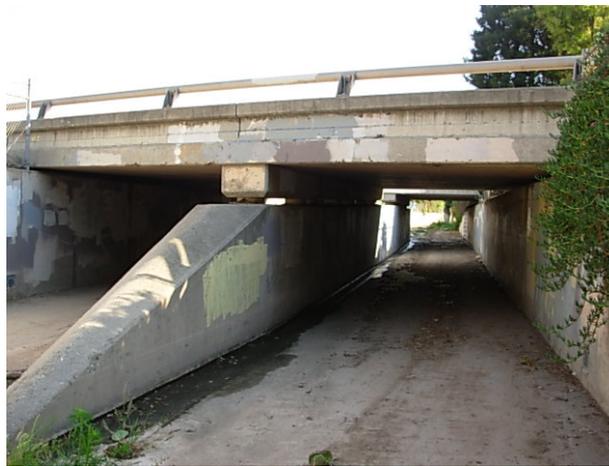
Photo 65 – Santa Monica Creek Bridge (51-0050L/R)

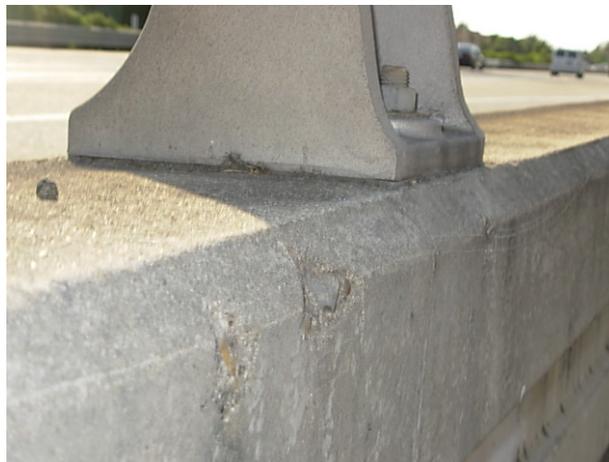
Photo 66 – Bridge 51-0050R barrier rail shims

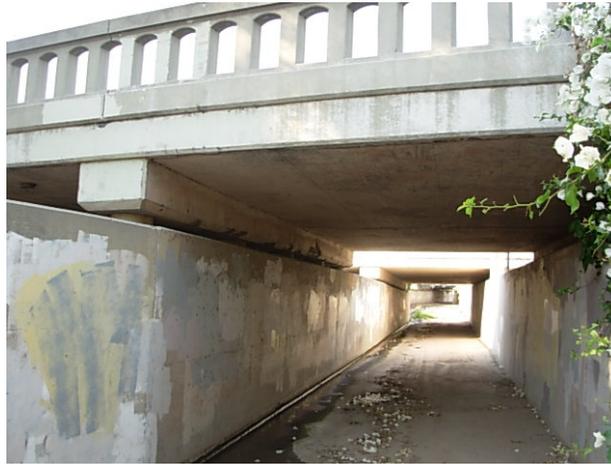
Photo 67 – Bridge 51-0050L/R

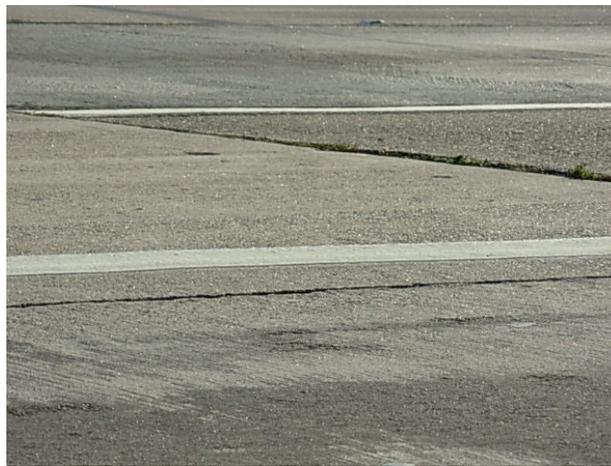
Photo 68 – Bridge 51-0050L/R deck joint (non-suspect)

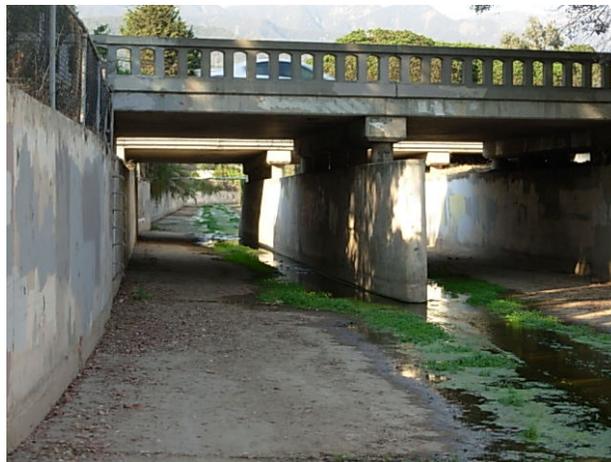
Photo 69 – Franklin Creek Bridge (51-0051L/R)

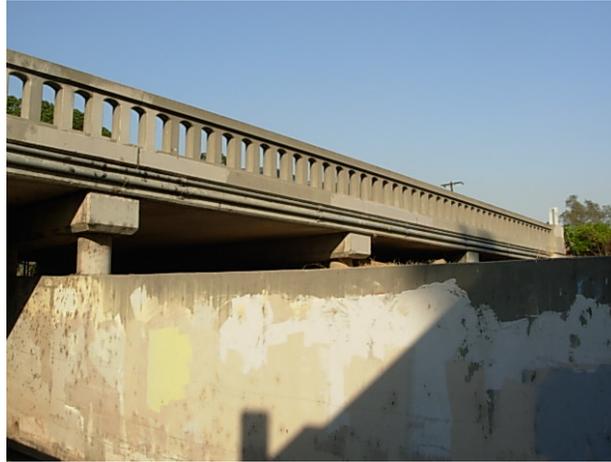
Photo 70 – Bridge 51-0051L/R

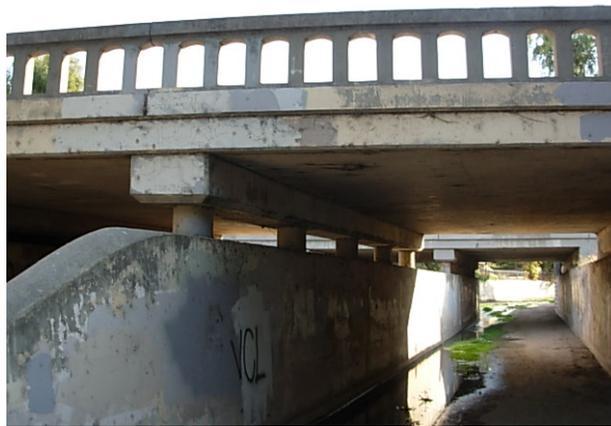
Photo 71 – Bridge 51-0051L/R

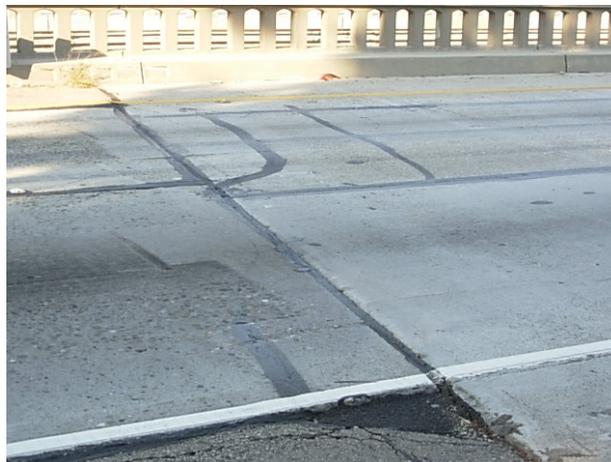
Photo 72 – Bridge 51-0051L/R deck joint (non-suspect)
