**FOR CONTRACT NO. 030000598
03-3M7604**

INFORMATION HANDOUT

PHOTOGRAPHS

03-NEV, PLA-20-VAR

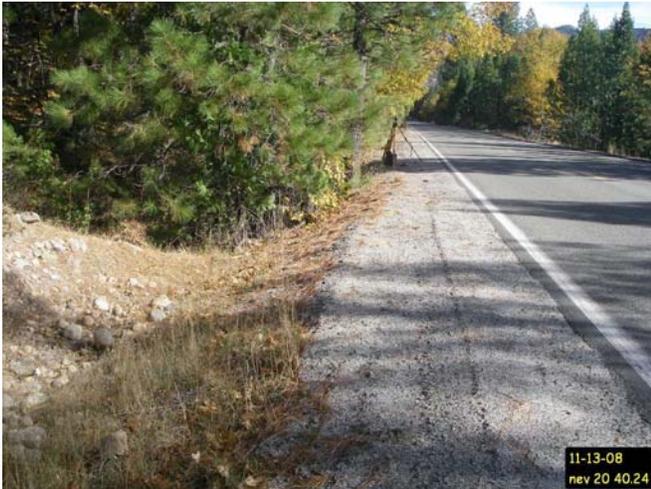
Location 2 Nev 20 40.24

Inlet: west of culvert looking east on north side

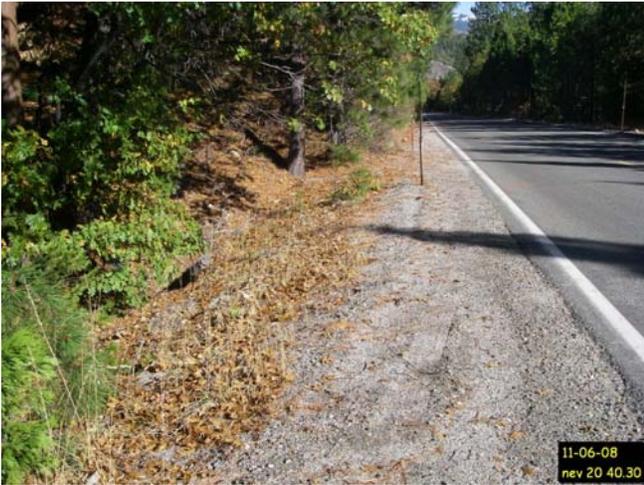
Location 3 Nev 20 40.30

Inlet: wb shoulder @ inlet north side of road

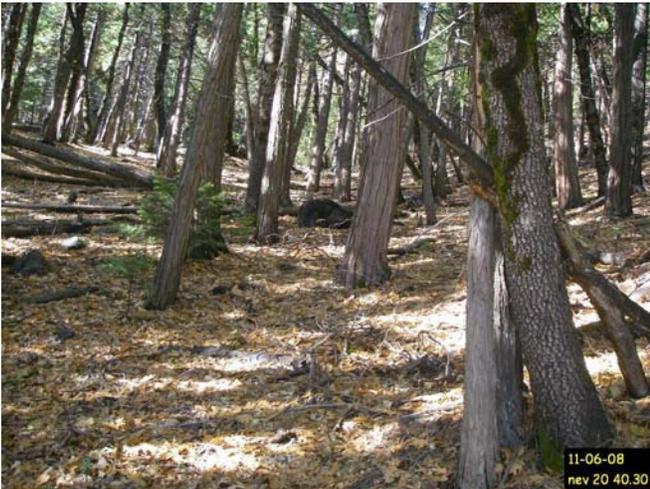
Inlet: looking upstream from inlet

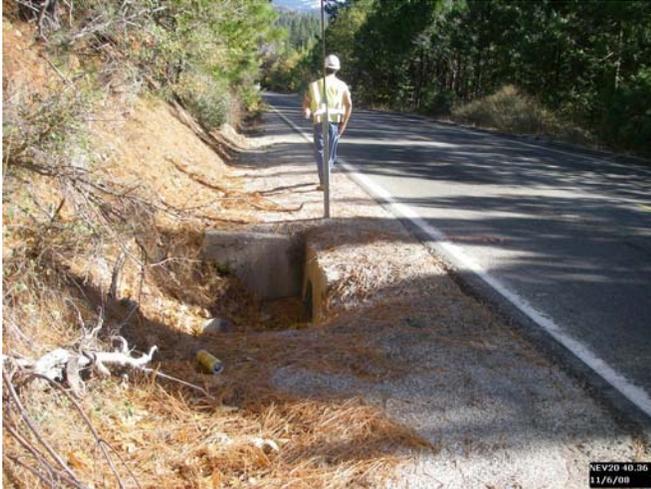
Location 4 Nev 20 40.36

Inlet: west of culvert looking east

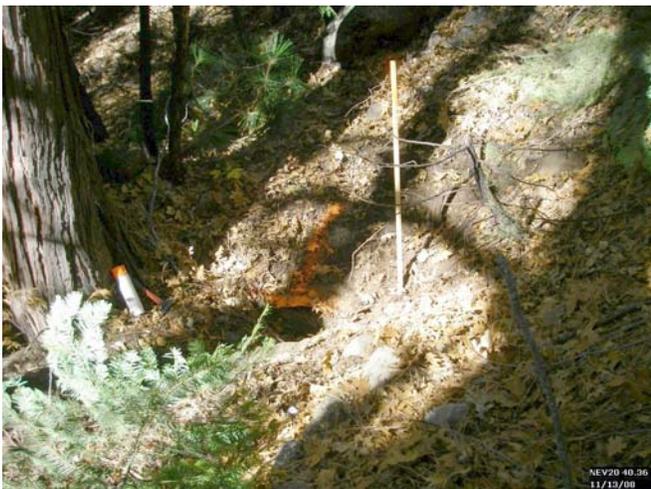
Outlet: ditch needs to be regraded

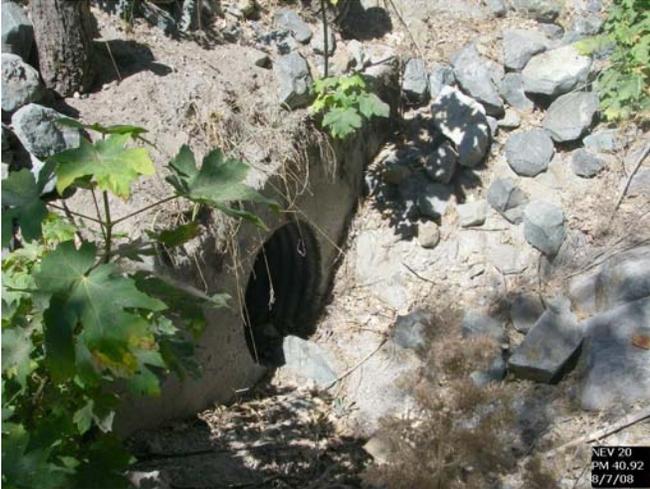
Location 6 Nev 20 40.92

Inlet: garden variety 24" cmp w/ headwall

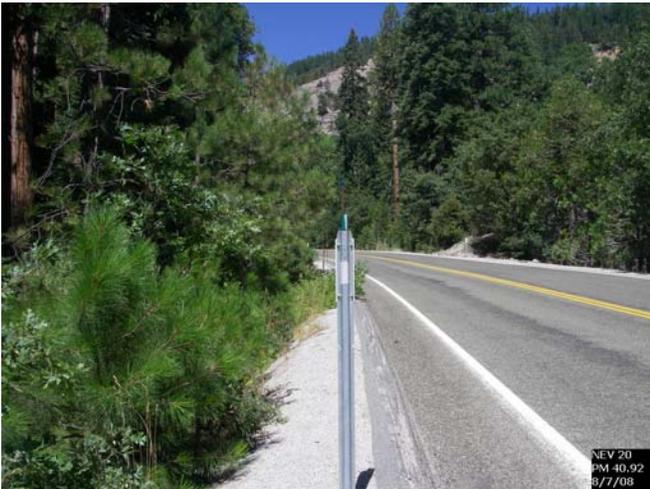
Outlet: looking west; high speed, not much shoulder

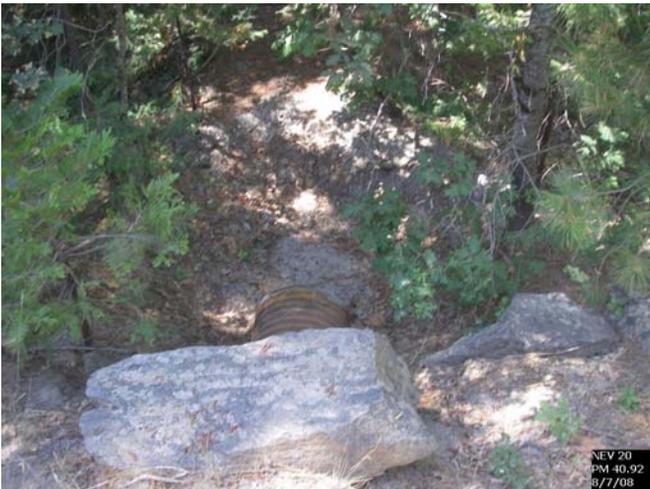
Outlet: culvert outfall @ toe of embankment

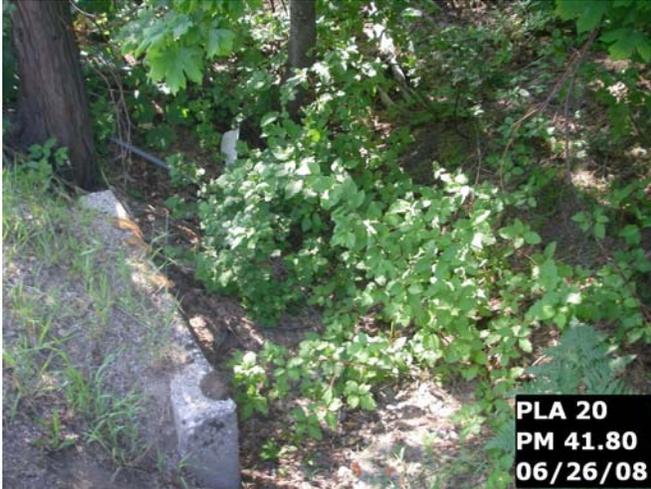
Location 9 Pla 20 41.80

Inlet: headwall well off the traveled way

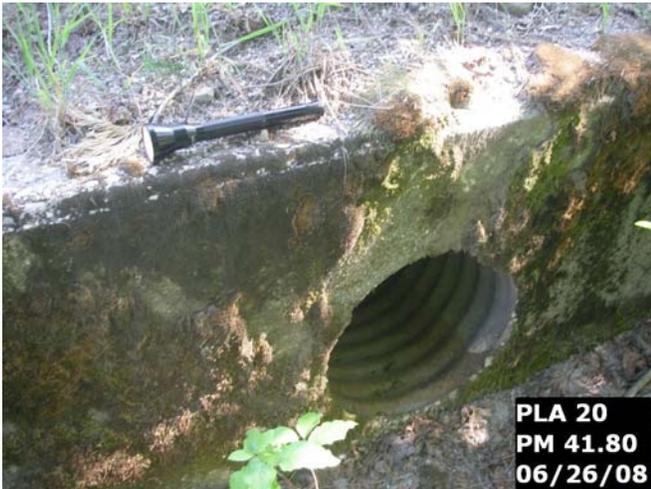
Inlet: 18" cmp with headwall

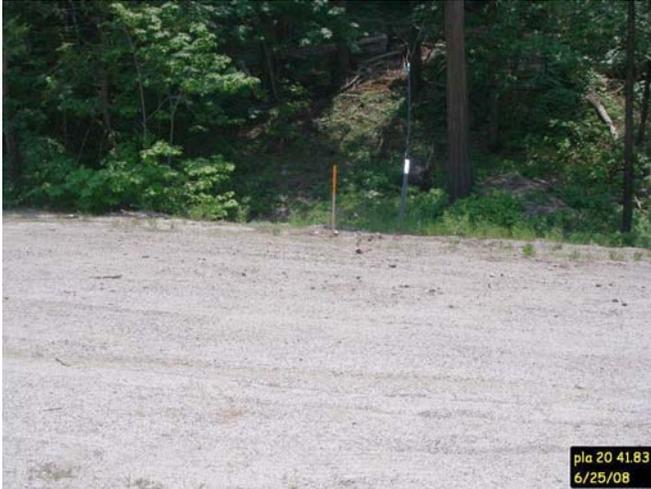
Location 10 Pla 20 41.83

Inlet: from EP, note wide shoulder area

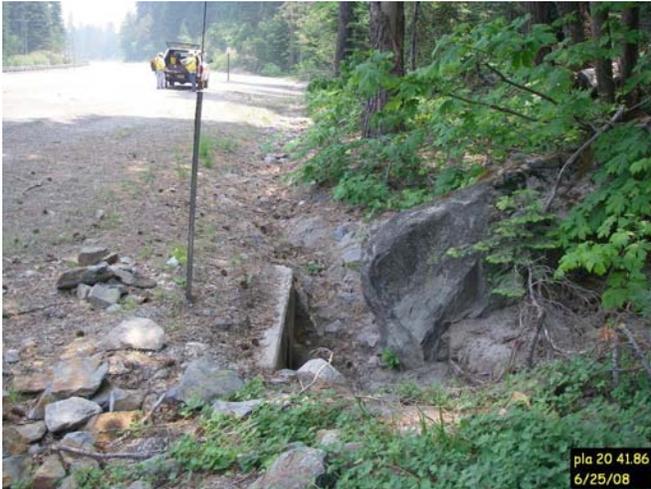
Inlet: near inlet looking east

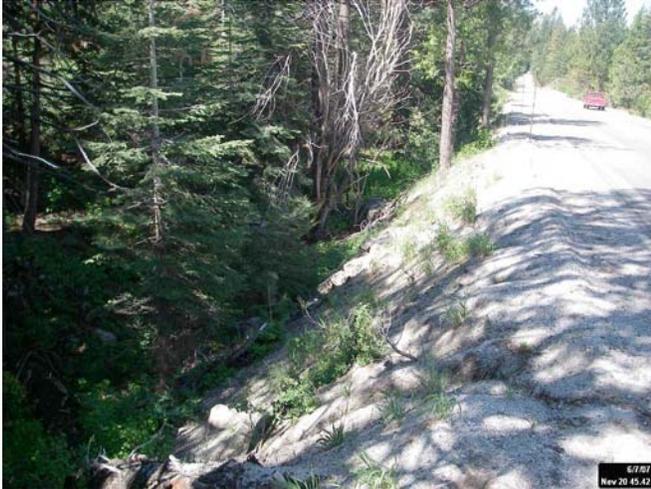
Location 13 (page 1) Nev 20 45.42

Inlet: looking west, not much shoulder here
