FHWA-CA-TL-78-4

Control of Slope Erosion Using Fiberglass Roving with Vegetation

October 1978

Office of Transportation Laboratory
California Department of Transportation
Sacramento, California 95819

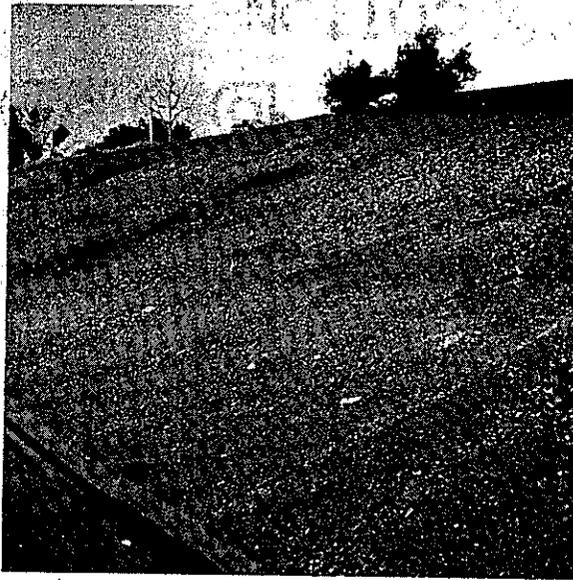
A second slope treated under this project is located on Route 101 near Asti in Sonoma County (04-Son-101, PM 47.5) about 31 miles north of Santa Rosa (Figure 4). The site is located in a small valley at an elevation of 360 feet above MSL. The soil is a brownish-red silty clay which contains some gravel. It faces to the west and was built in 1965 on a 2:1 angle. The climate is relatively mild with an average annual rainfall of about 40 inches. Sheet erosion from this slope was severe enough to prevent the natural establishment of vegetation (Plate 5).

Plate 5. Natural slope at Asti, Route 101.

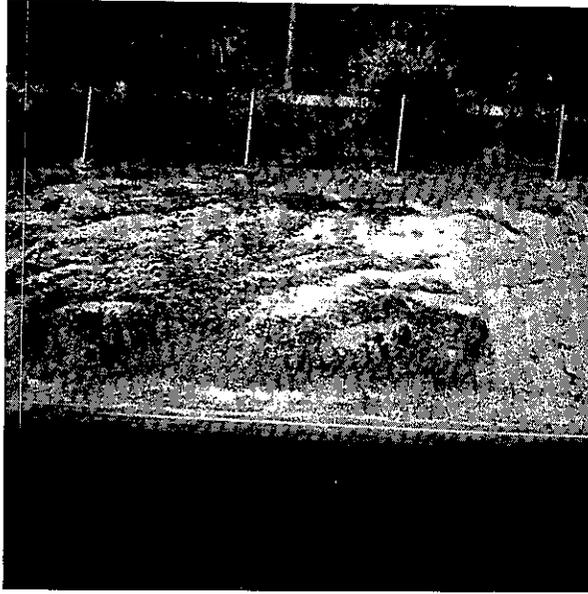
6. Broadcasting soil material over the top of plot "D" and sand over plot "C" did not improve the appearance significantly. A majority of the soil and sand was removed during the first rainstorm following application.

Plate 15 Section "C" Fiberglass Roving Tacked
With Asphalt Covered With Sand

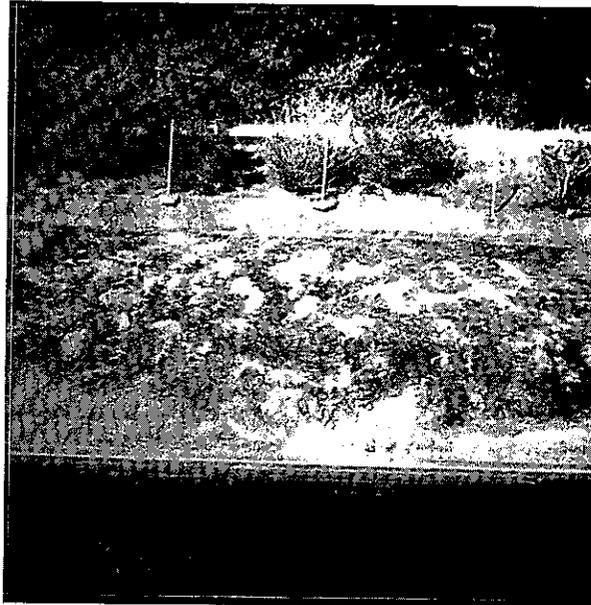
Plate 16 Section "D" Fiberglass Roving Tacked
With Asphalt Covered With Native Soil

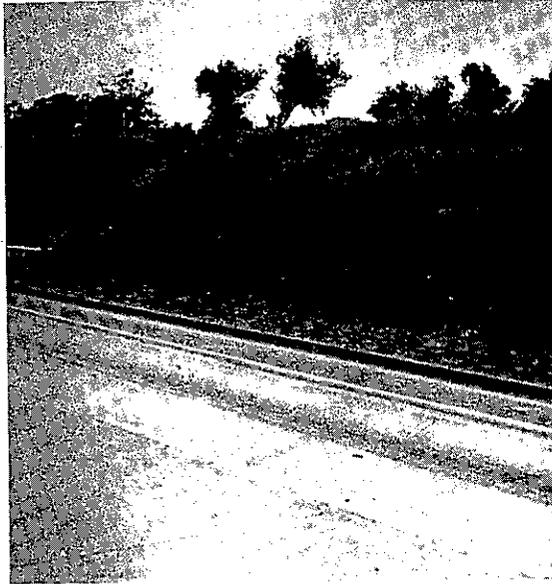
Plate 23 Cut Slope 13 Weeks After
Treatment April 17, 1978

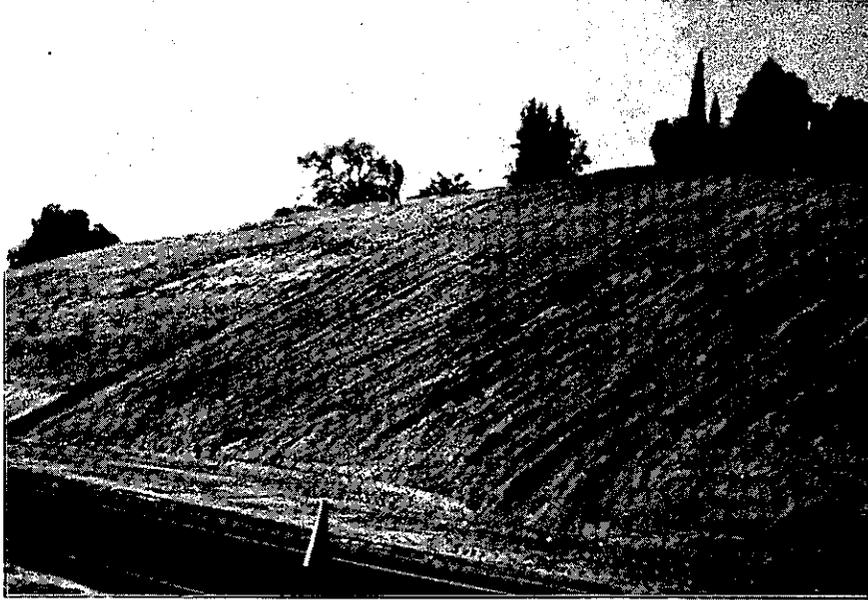
Plate 35 Cut Slope After Dressing and
Before Treatment October 18, 1976

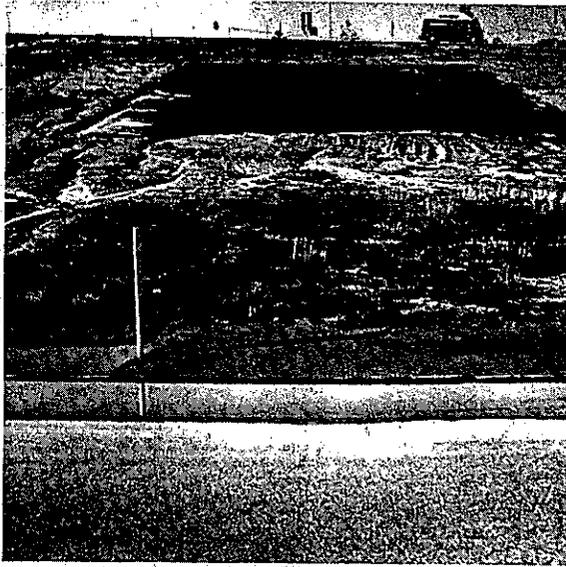
Plate 47 Slope 8 Months After Treatment
